Initial Report on Testing of Simulated Skyway Trestle Span Beams

December 12, 2006

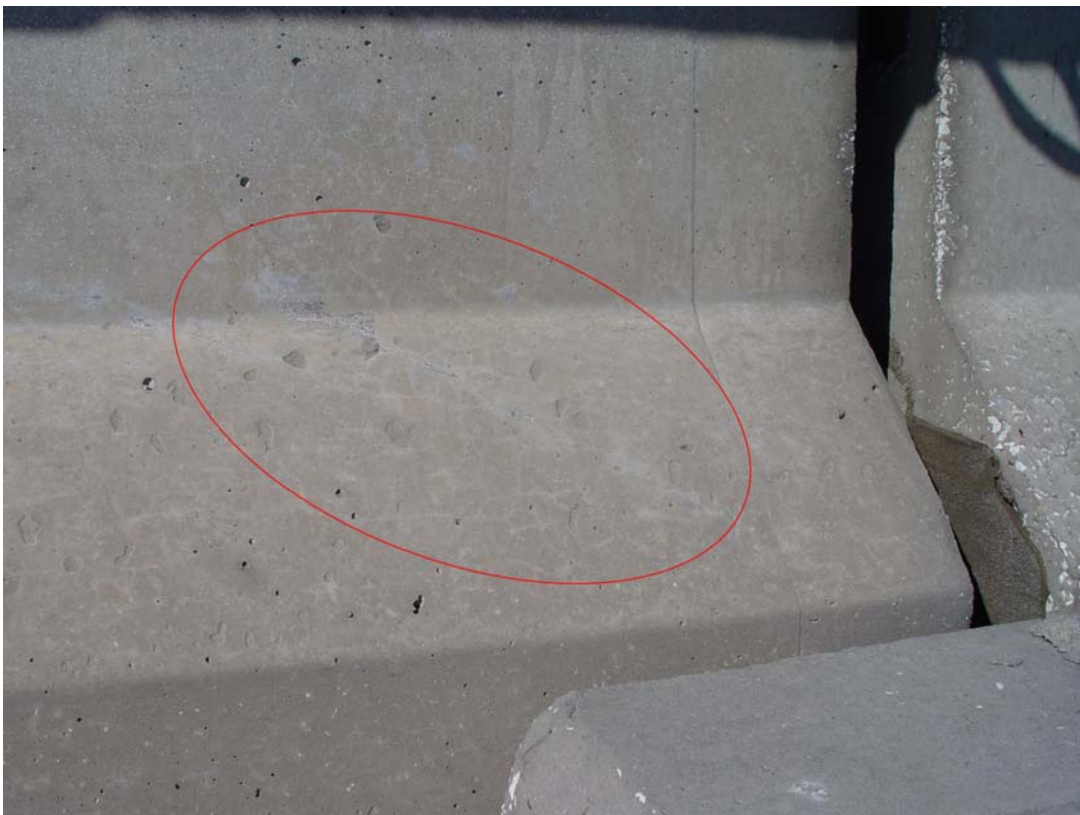
Figure 1

During the Spring of 2006 two 60 foot long Type IV AASHTO girders were constructed in the Dura-Stress yard in Leesburg, Florida to simulate the existing beams on the Skyway approach spans, in particular, the exterior girders that have cracking near the supports as shown in Figure 1. In late summer, eight-inch deep slabs were cast on these beams. A few weeks later, one end of each beam had the CFRP (carbon fiber reinforced polymer) wrap applied, as per the contract documents in the proposed repair. The materials and procedures complied with the winning bid. The beams were then tested to failure after allowing the carbon repairs one to two weeks to cure. Each end of each beam was tested thereby providing a test of the carbon wrapped section and an unwrapped section which functioned as a control.

This leads to bursting forces that result in strand slip and the loss of the tension tie and beam integrity. The strand slip failure is obvious for all of the tests from a review of Figures 6 through 9. The cracking for all of the tests was very similar and very similar to the crack in the field shown in Figure 1. In addition, tests were conducted on the original Skyway beams during the time of construction. Figure 14 is the result of one of these tests and the similarity with Figure 13 is apparent.

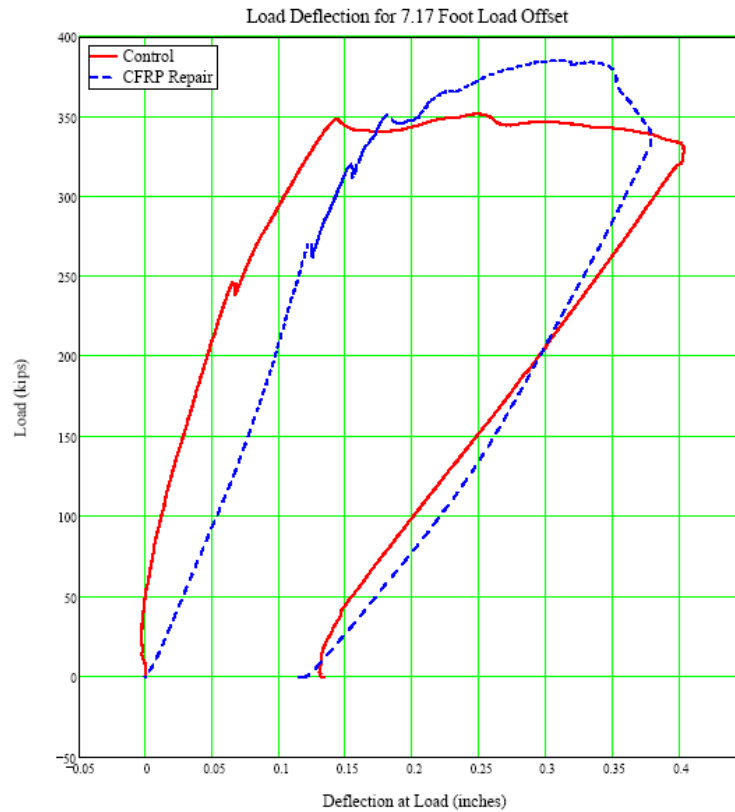
Figure 4 shows the load deflection curves for the two tests with the load offset 7 feet 2 inches.

The breaks on the ascending portion of the curves are locations where the loading was stopped and the beams were examined for cracks. Figure 5 is the load deflection graph for the two tests with the load offset 15 feet.

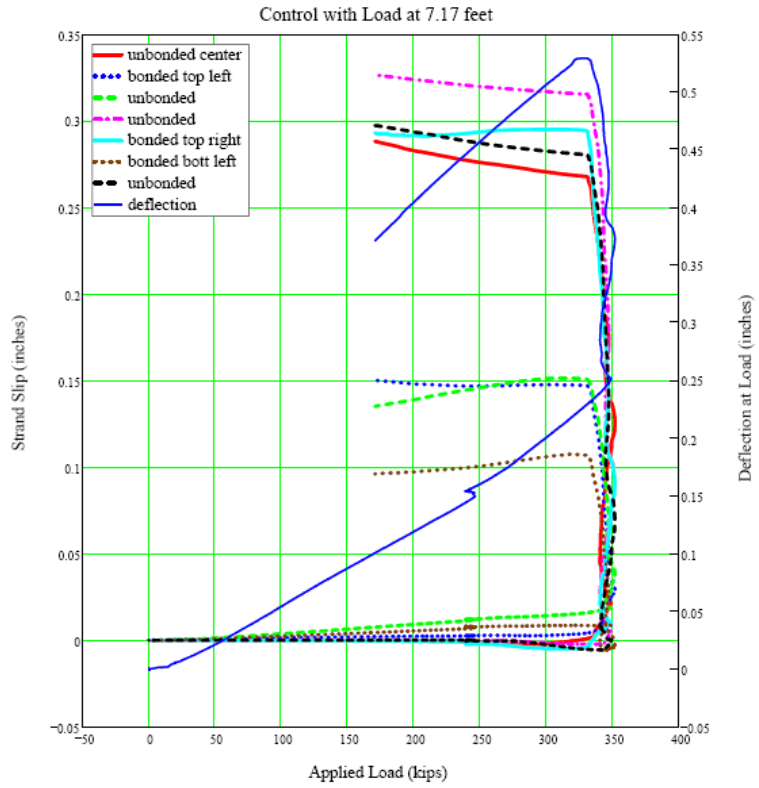
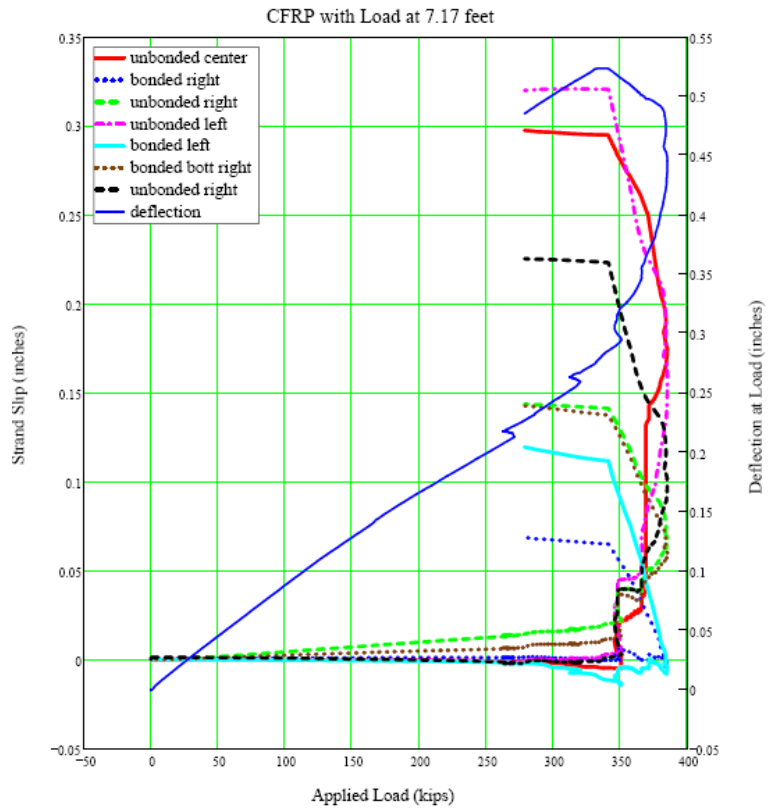
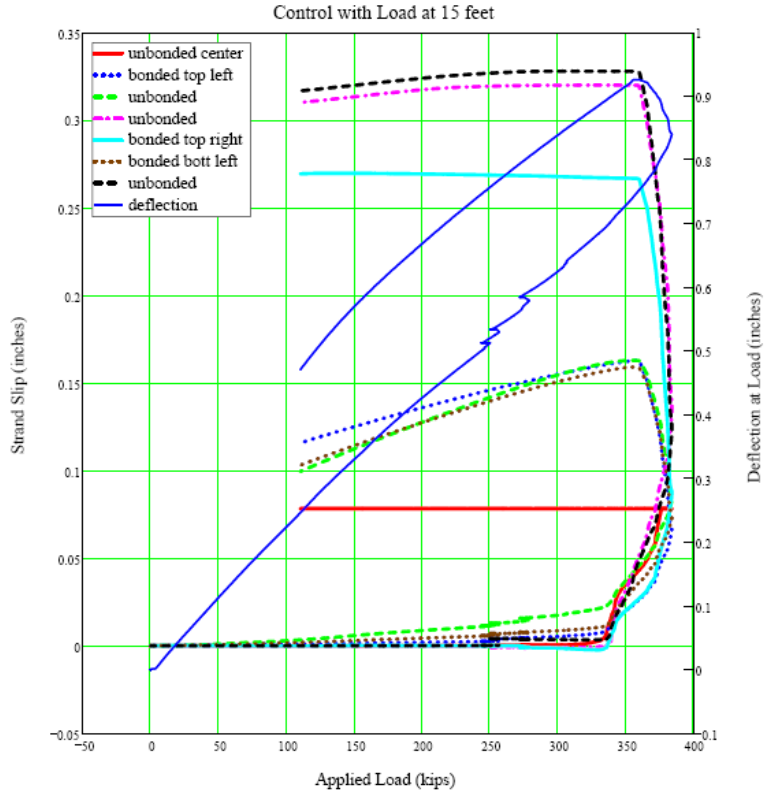
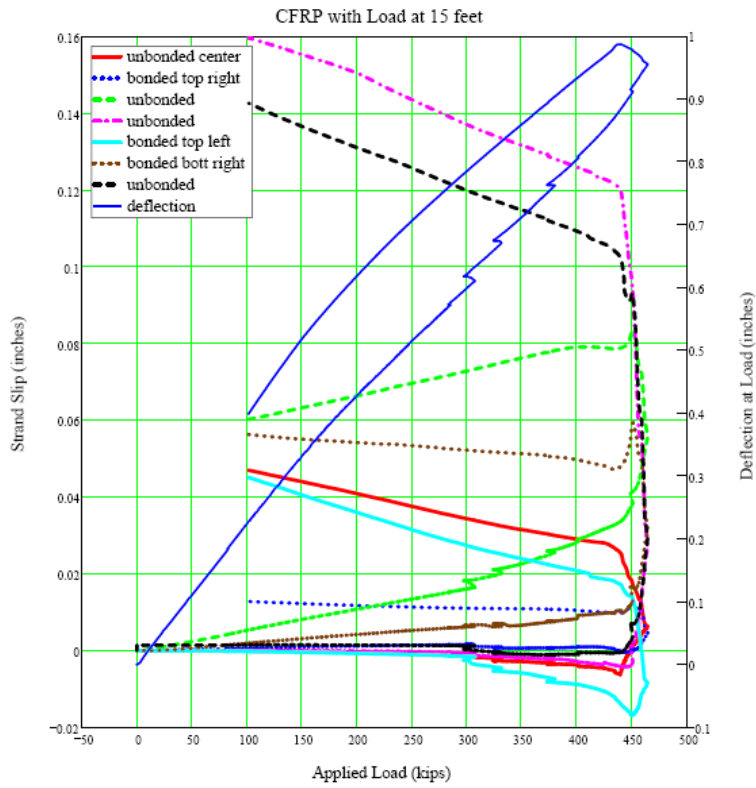
Strand slip was monitored during testing. A bracket was attached to the beam flange and displacement transducers were attached such that strand movement relative to the end of the beam could be recorded. Figures 6 through 9 provide the results from this monitoring concurrent with the deflection at the load location.

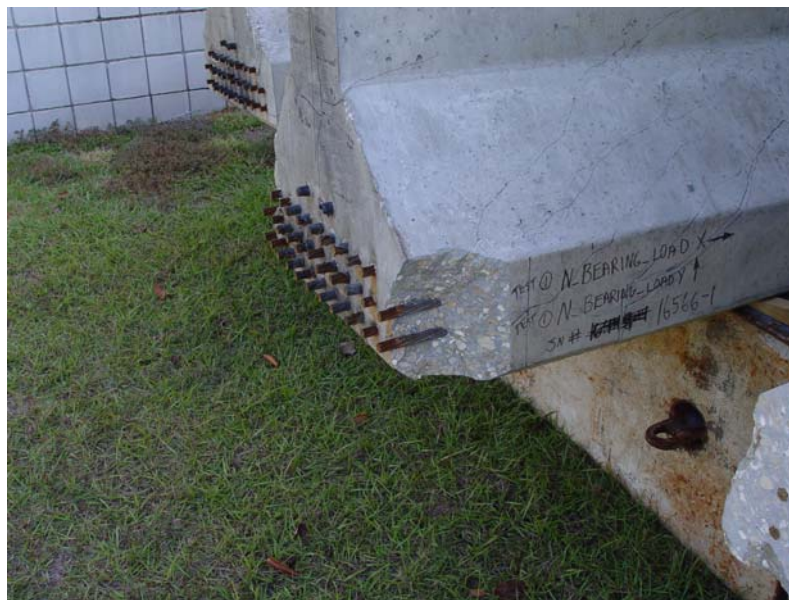
Figure 10

Prior to testing a handling mishap broke off a corner of one of the beams as shown in Figure 10.

It was decided to use this end for the 15 foot offset Control test since the anticipated failure modes meant that this damage would not adversely change the results. A review of the failure modes and Table 1 indicates that this is probably not the case. Even including this test, the coefficient of variation of the maximum reaction for the four tests is less than 8 percent.

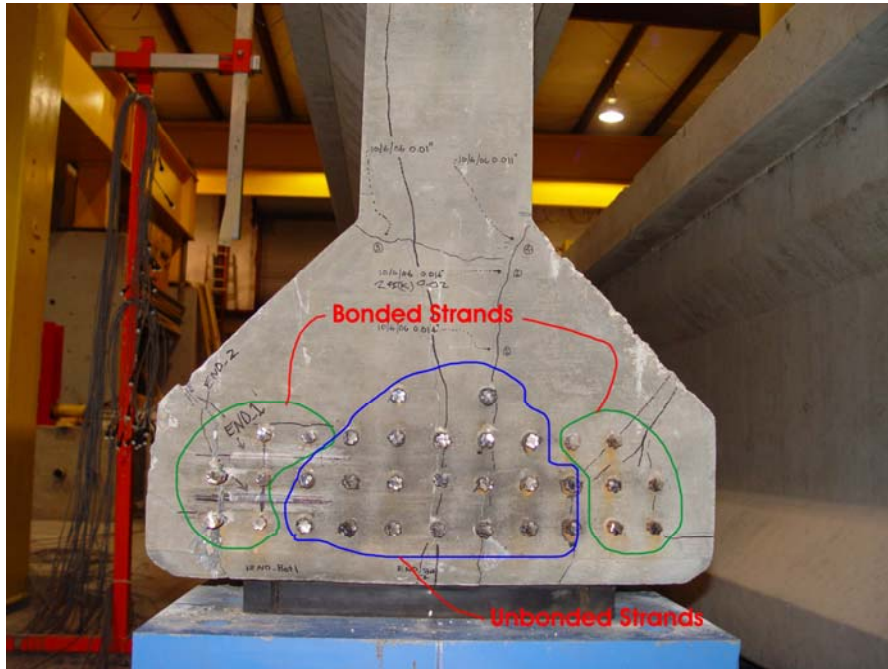
All four tests exhibited the same failure mode. Figure 11 shows the layout of the strands and the associated debonding pattern.

This pattern violates current policy by amount and distribution and is the direct reason for all of the failures. In addition, there is no confining steel around the strands contrary to current FDOT requirements.

Our testing indicates the CFRP repairs provide modest increases in the capacity from 9 to 19 percent. Due to the ship impact restraints, the repair is offset from the bearing location, diminishing its effectiveness. To eliminate this tie failure mode would require additional confinement at the bearing location, the node location shown in Figure 12. This could be accomplished in several ways but would probably require removal or modification of the ship impact restraints at the repaired beams.

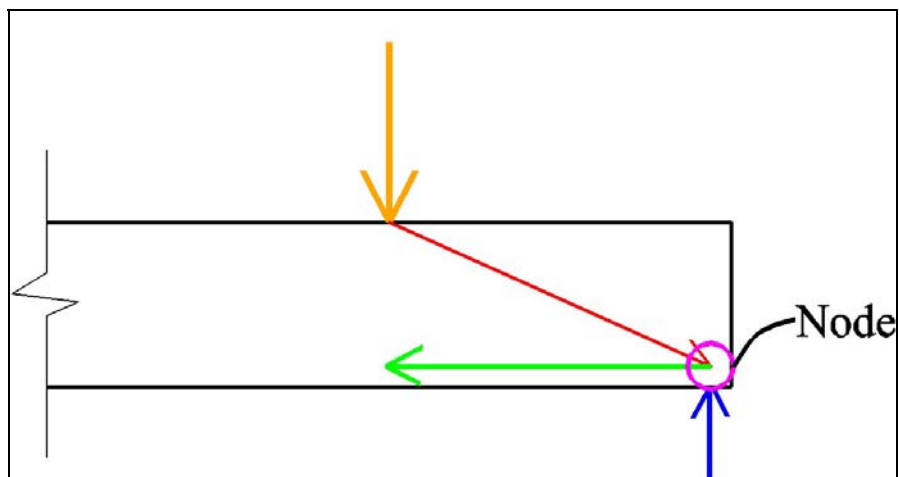
Figure 12

The forces at the end of the beam must be resolved at the node as shown in Figure 12.

This green arrow represents the tension tie, which in the Skyway beams are the bonded prestressing strands. The unbonded strands do not become integrated into the beam structurally until they are some distance along the beam and outside the node. Therefore, they cannot carry the tension tie forces. The bonded strands are located on the outside of the flange of the beam as shown in Figure 11. The local forces must flow as shown in Figure 13 to allow the compressive forces to be resolved with the tie.
