# *SHRP R06D Round 7 IAP Evaluation of 3D Radar*

## *Final Report*

Agreement No. BE291

Infrasense, Inc.

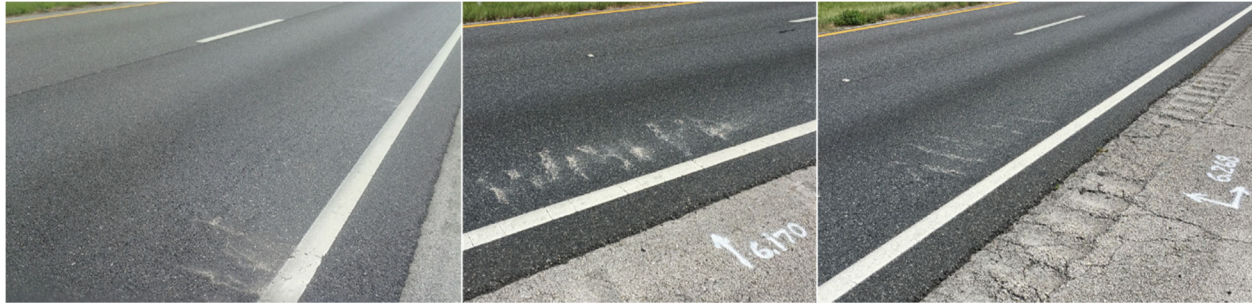
locations over a 9 miles-long segment of I-10 have been considered as evidence of unexposed subsurface damage (Figure 4). Seven core samples were acquired at these locations to better understand the source of the damage and to reveal premature pavement deficiencies (five core samples along the right side of eastbound pavement section R2; two core samples along the right side of westbound pavement section L2). Table 2 summarizes the core length, number of pieces, and bond conditions between layers of bituminous mix (BM) material. Transverse and longitudinal cracks are observed in the outside wheel path of the outside lane as it is shown in Figure 4.

Figure 4: Photographs of eastbound pavement section R2 in proximity of core #1 extraction point at MP 0.123 (left); eastbound pavement section R2 in proximity of core #3 extraction point at MP 6.170 (center), eastbound pavement section R2 in proximity of core #4 extraction point at MP 6.268 (right).

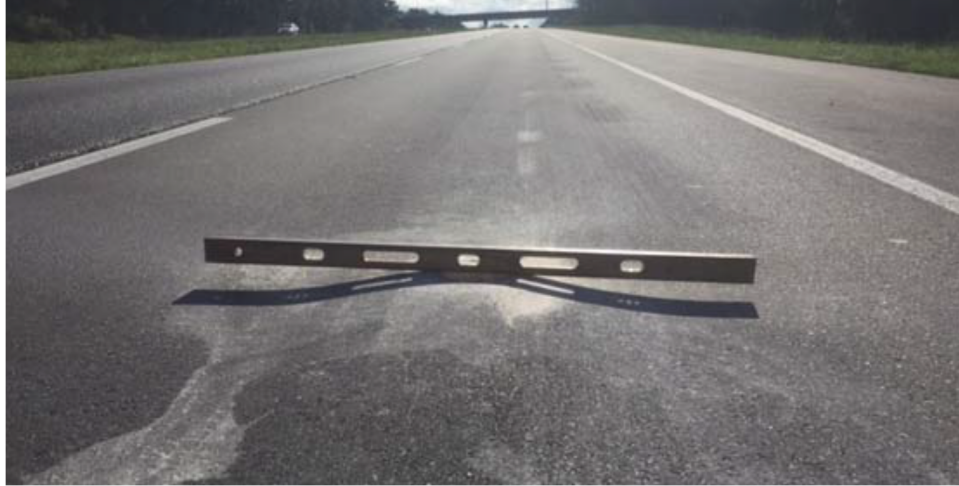
After a milling procedure was performed on July 13, 2017, the surface was discovered to have been rutted and upheaved between wheel paths more than 2.5". The upheaved area was cored in two locations resulting in the core holes filling with a clay-type white slurry of unidentified nature.

Figure 11: Observed rutting over the test section on I-10.

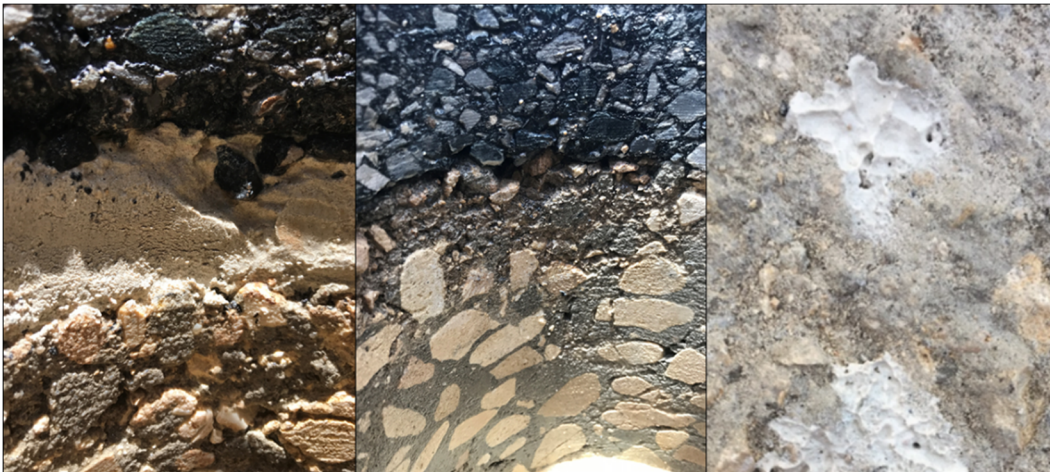
Figure 12: Examples of unidentified clay-type slurry, revealed after the milling procedure.

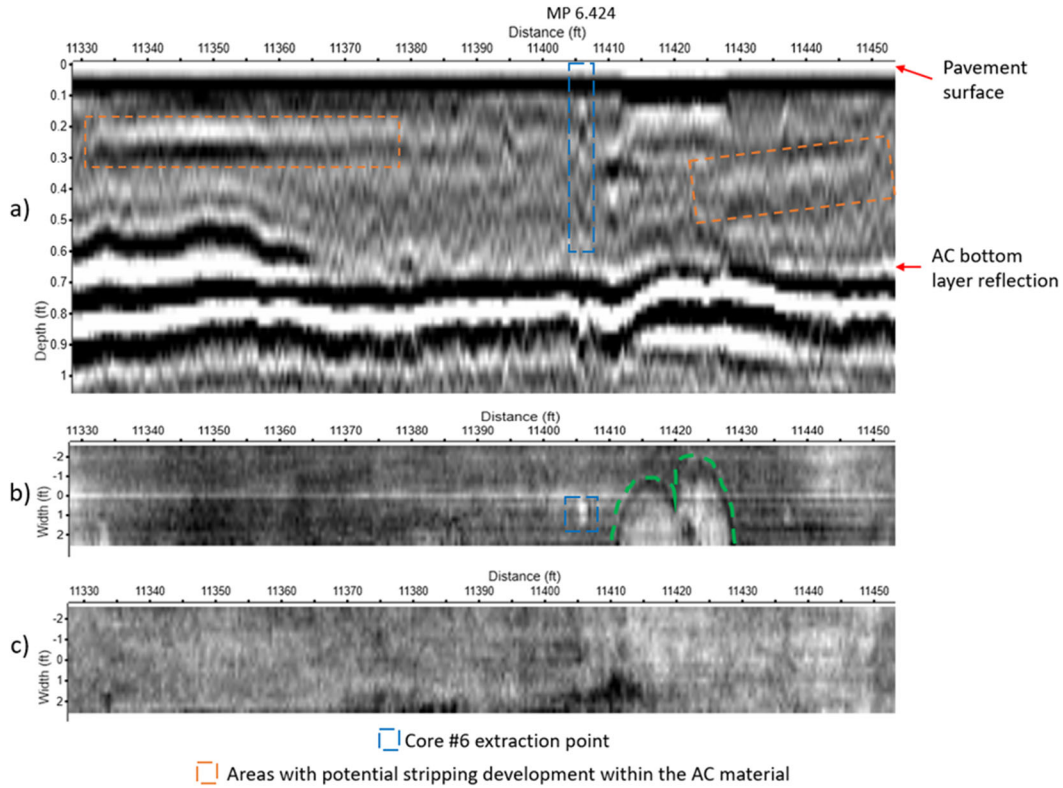
Figure 26: 3D-Radar cross-section through the core #6 extraction point (a); I-10 reflection at the depth of 1.68 inches (b); I-10 reflection at the depth of 4.51 inches (c). Green dashed line delineates the location of reported fuel damage.

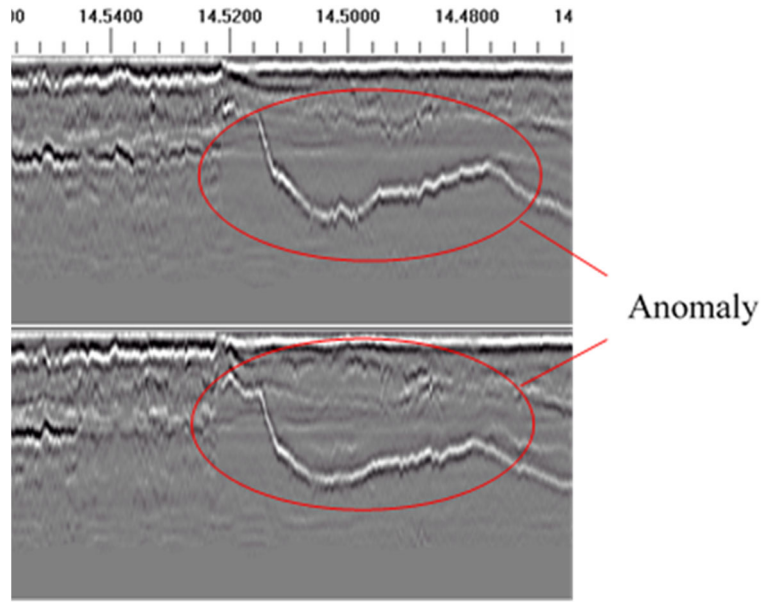
Figure 28: FDOT Air-launched GPR scan showing thickness anomaly at south end of US 26 bridge [2].

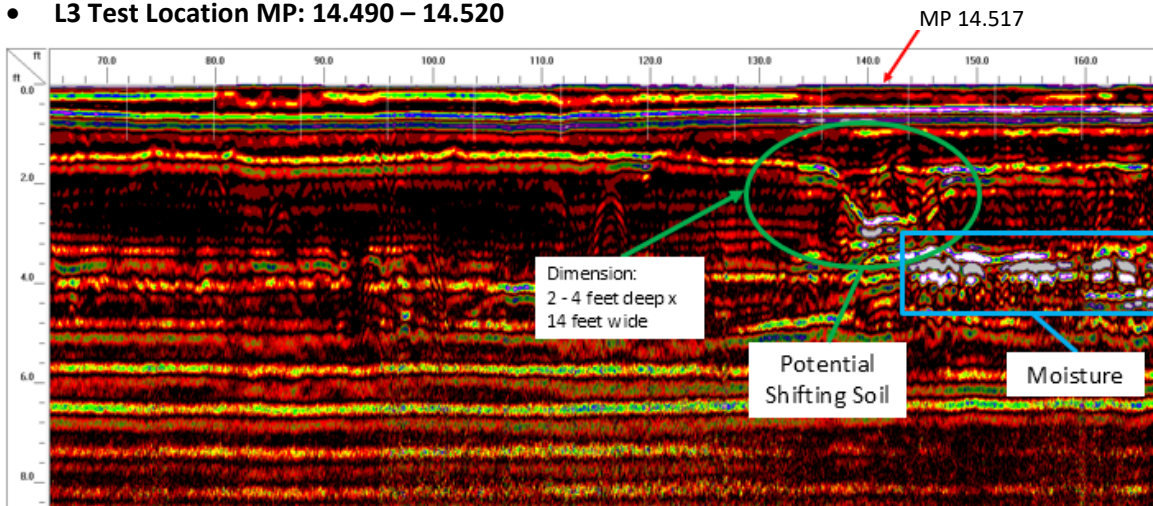
**Longitudinal run 4 identified potential shifting soil 140 feet from the starting point (near exit 387). In addition moisture is observed at a depth of 3 to 4 feet beneath the surface. Run 2 was conducted 9 feet east of the white edge line of L3. (left wheel path)**

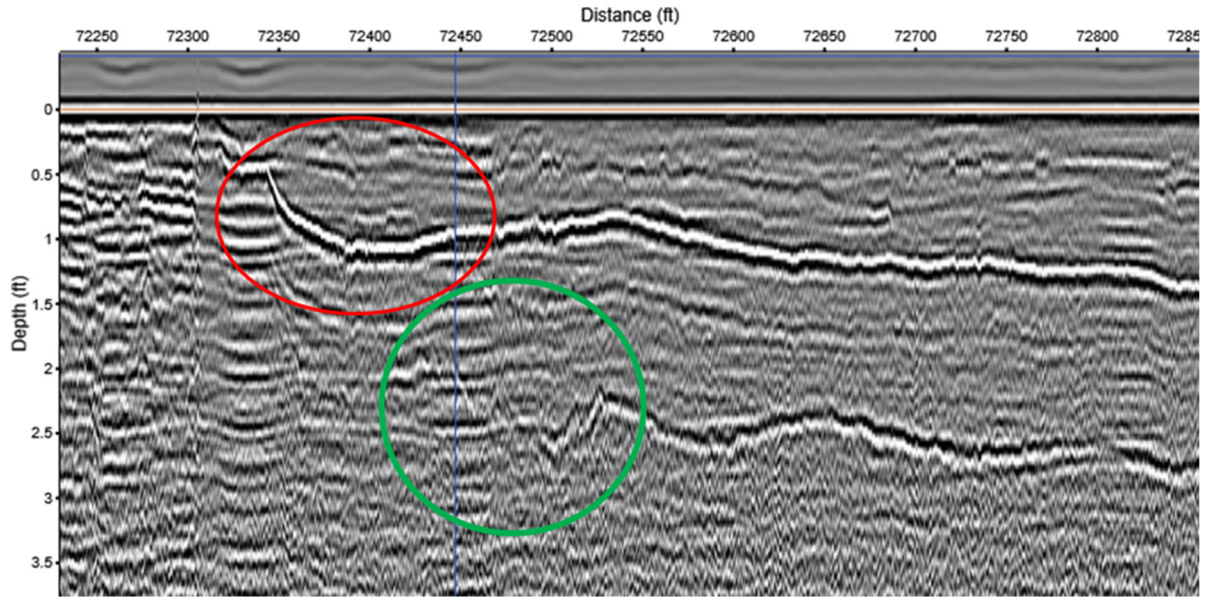
Figure 30: 3D-Radar data collected over the same location as in Figures 28 and 29. Red circled area represents the anomaly associated with potential shifting soil in Figure 28. Green circled area delineates where the evidence of potential soil shifting noted in Figure 29 can be observed on 3D-Radar data.

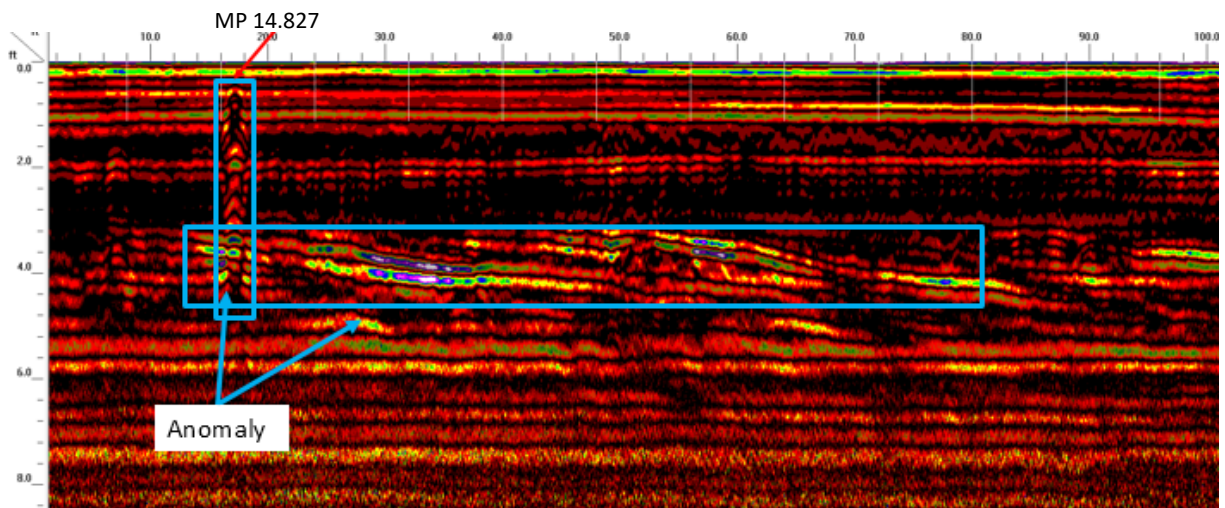
**Longitudinal run 1 identified an anomaly (highlighted in green). GPR run 1 was conducted directly over the white edge line of L3.**

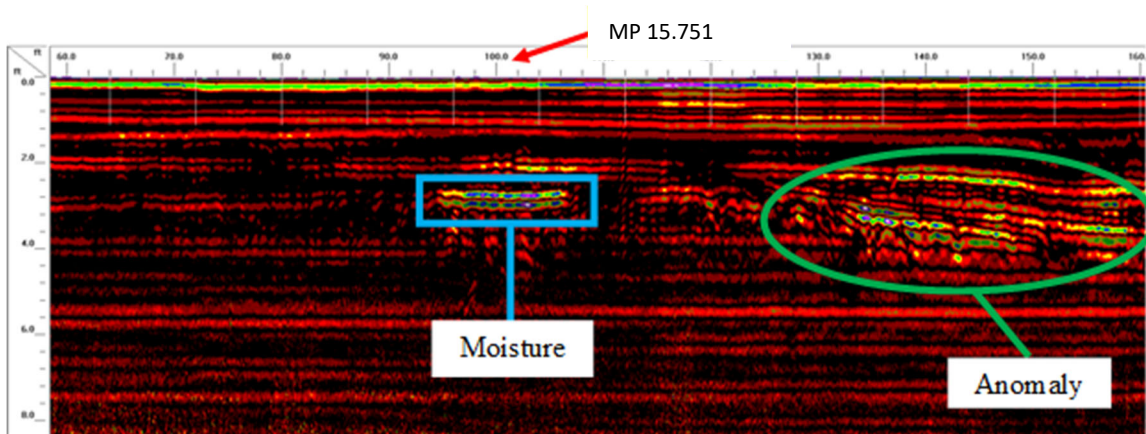
Anomaly was observed from longitudinal run 3 at approximate depths of 2 feet to 4 feet. Area of moisture was identified at approximate depth of 3 feet. Run 3 was ran 6 feet to the east of the white edge line of L3.

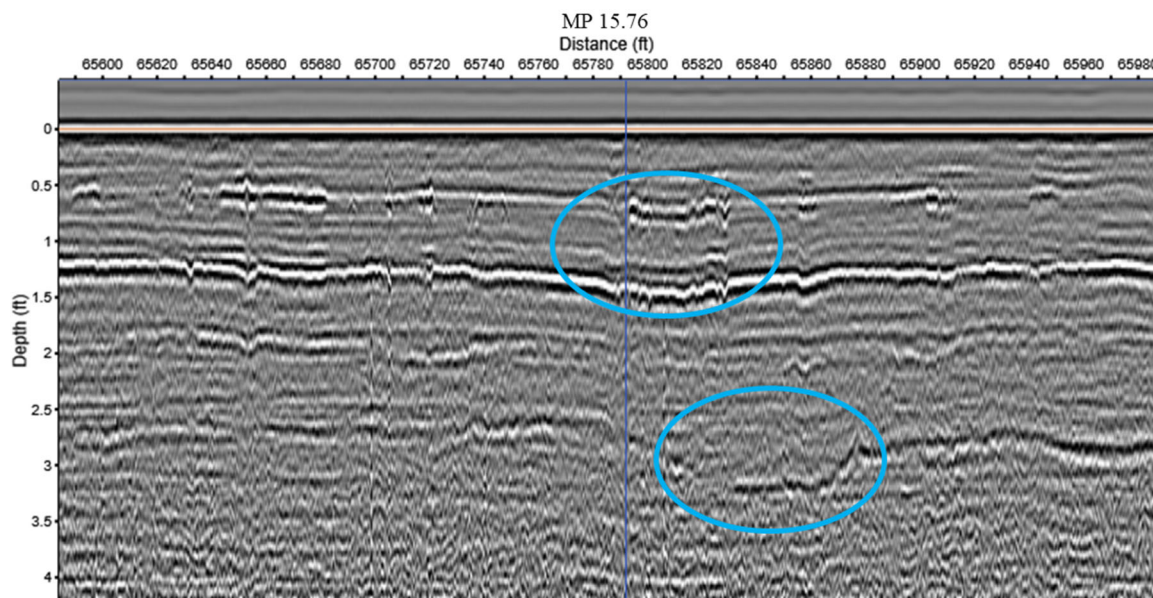
Figure 35: 3D-Radar data showing near surface anomalies which are similar to ones noted in Figure 33 along with anomaly that can be associated with deeper depression at the depth of 3 feet.

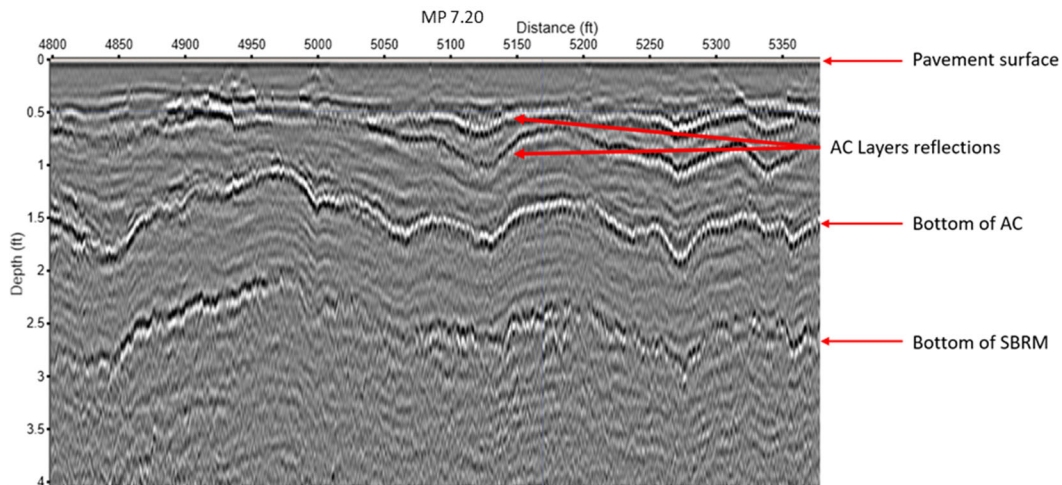
Figure 60: Example of 3D-Radar data cross-section through the area with observed signs of possible settlement development. Right side, eastbound lane.

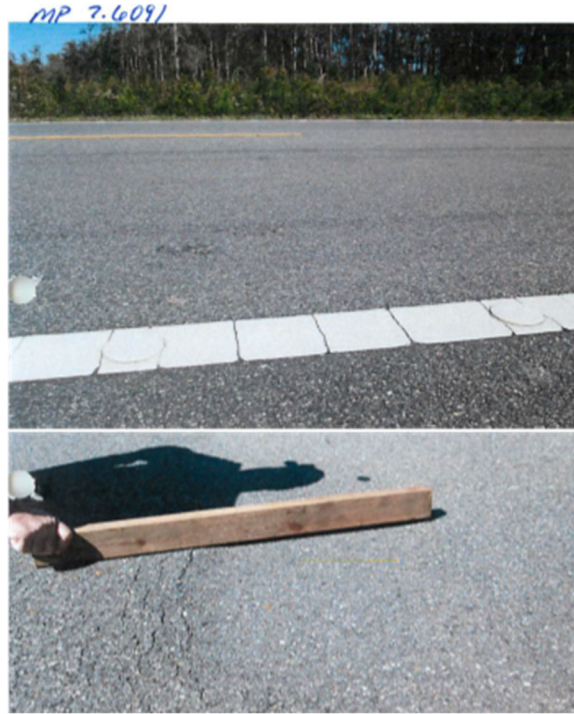
Figure 68: Photographs of pavement distress in proximity of core extraction point (MP 7.6091): a view of the lane (top) and signs of the distress on the pavement surface (bottom).

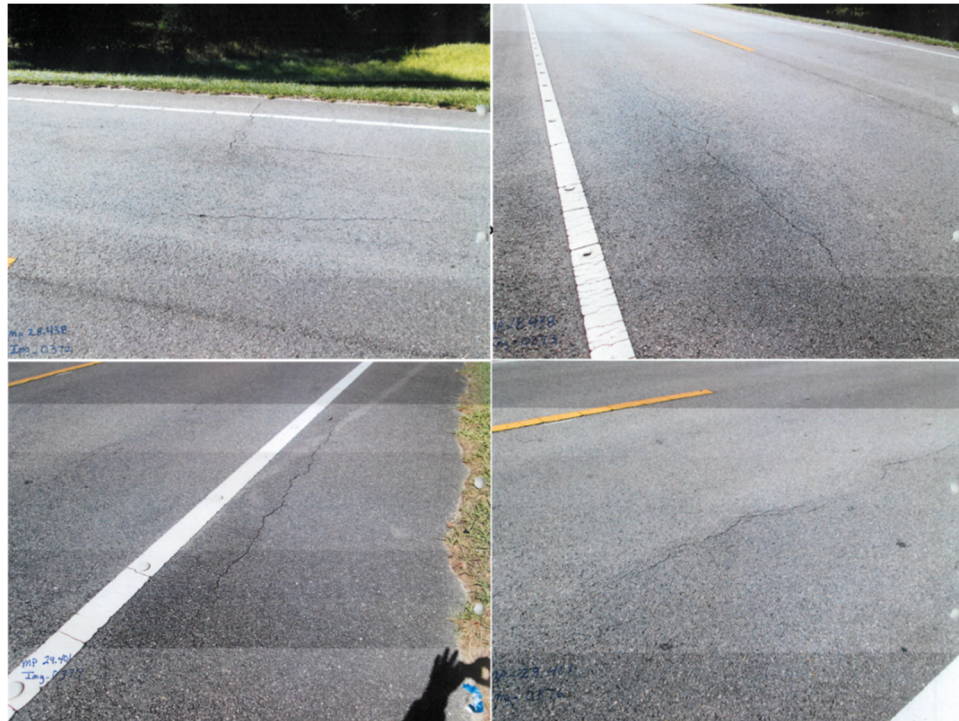
Figure 78: Photographs of pavement distress in proximity of MP 28.438 (top) and MP 29.401 (bottom).

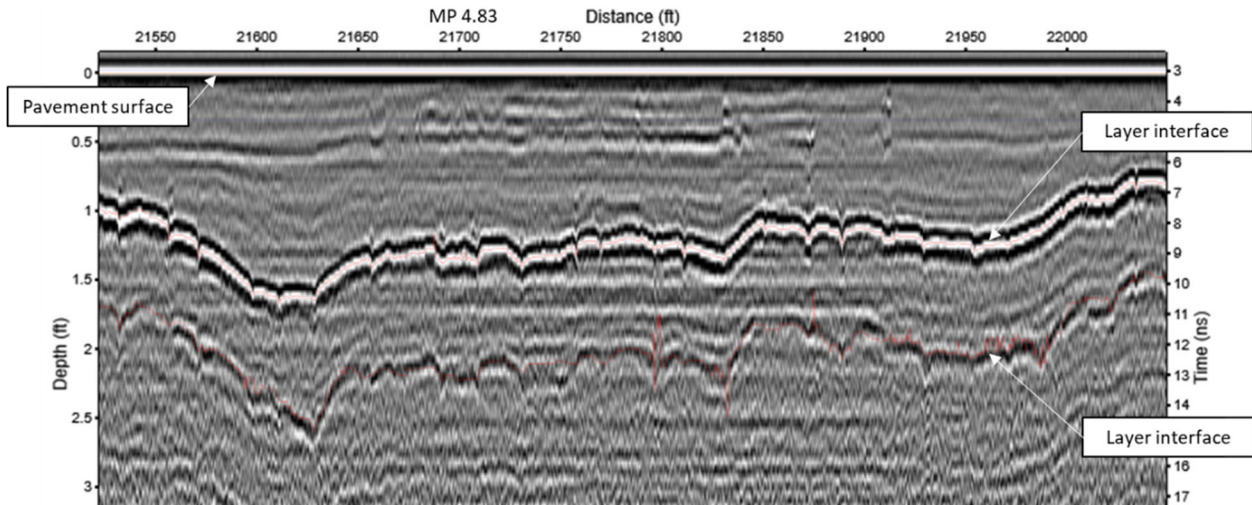
Figure 99: Vertical slice of 3D GPR data. Settlement occurs at 21, 600-foot mark.

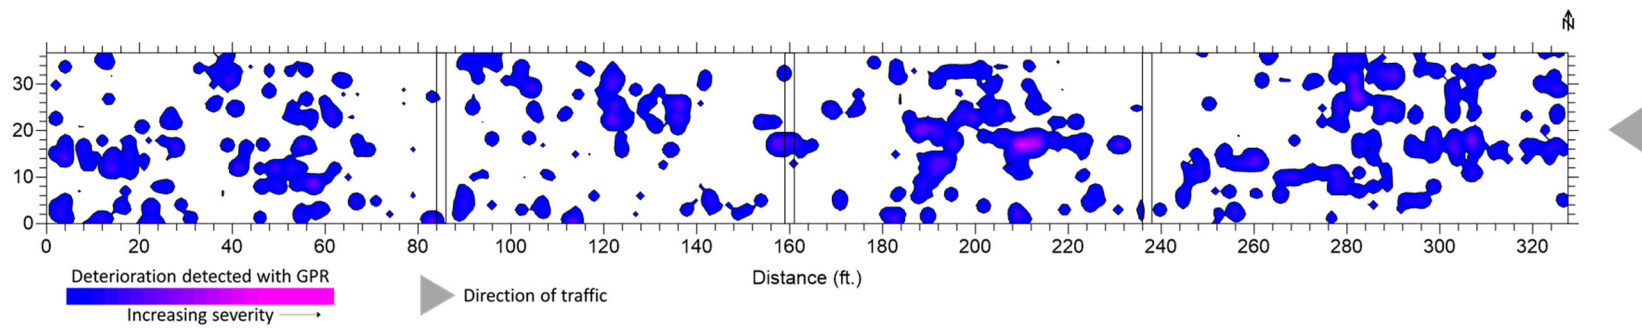
Figure 114: Concrete deterioration distribution map, generated from the results of 3D-Radar survey on westbound lane.

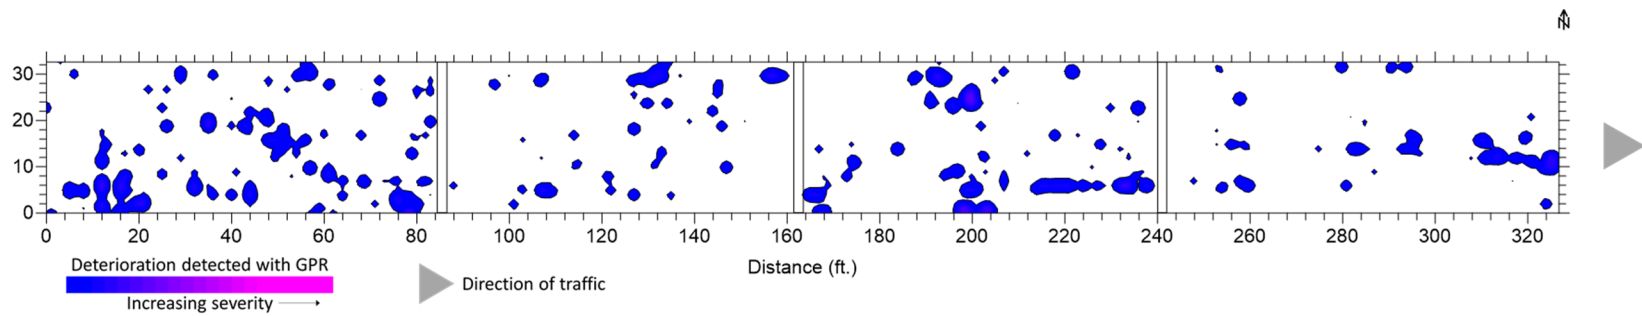
Figure 115: Concrete deterioration distribution map, generated from the results of 3D GPR survey on EB lane.
