INVESTIGATION INTO THE STRUCTURAL PERFORMANCE OF MMFX REINFORCING

Marcus H. Ansley, PE, Florida Department of Transportation

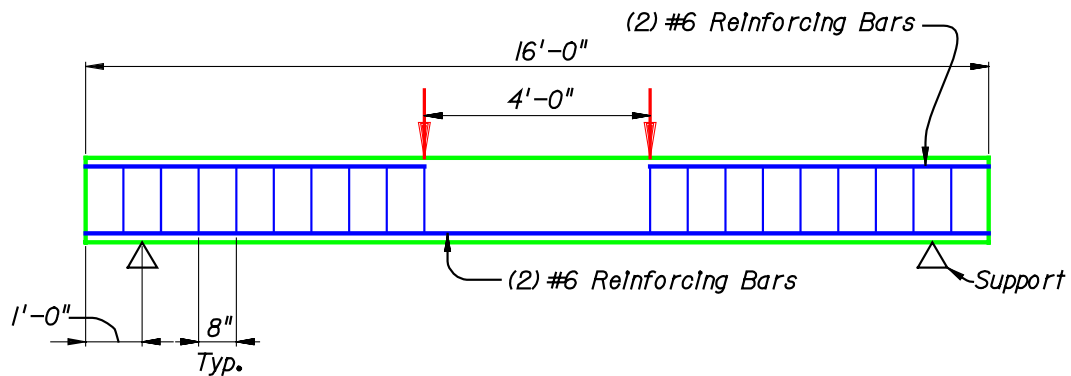
The test setup for the first three tests can be seen in Figure 1.

Fig. 1 Typical Beam Test Setup

For the first test the two number 6 bottom-reinforcing bars were the reinforcing of interest and were varied between the two material types. The second and third tests were a variation of this test with a splice provided at midspan to check bar bond and development. Test 2 used a 10-inch lap to force a bond failure and test 3 provided a Class C lap splice for the Grade 60 reinforcing of 30.5 inches. The Test 2 and 3 configurations are depicted in Figure 2. As in Test 1 the flexural steel was varied, MMFX for one beam and Grade 60 for the other

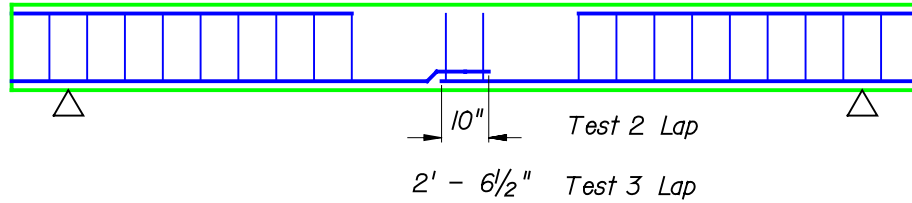
Fig. 2 Test 2 and Test 3 Bar Laps

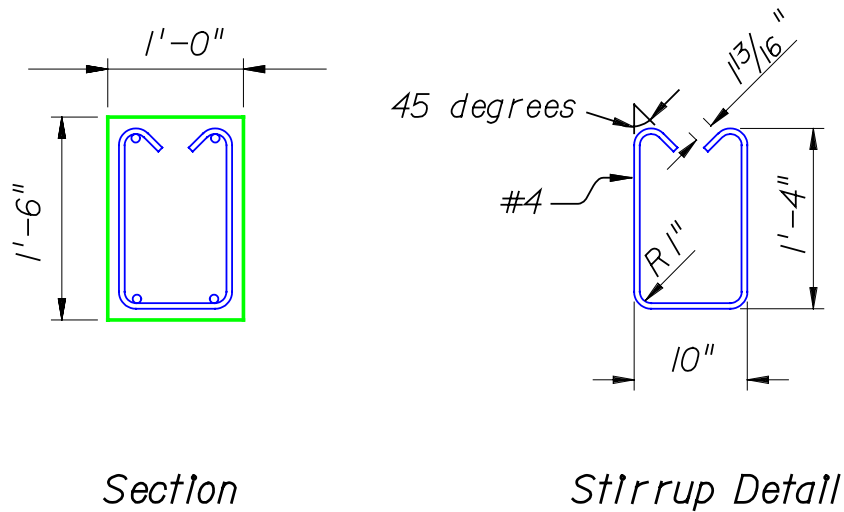
All beam tests had the same cross section properties. These are provided in Figure 3 along with the stirrup dimensions. A cover of 1 inch on the stirrups was used for all tests.

Fig. 3 Test Beam Cross-Section and Stirrup Dimensions

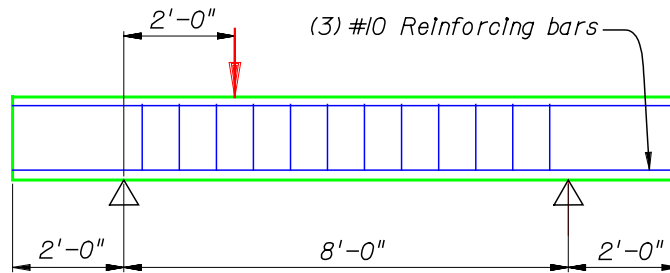
The intent of test 4 was to compare the performance of the reinforcing types when used as shear reinforcing. To insure a shear failure a different span, loading and reinforcing layout was required. The layout used for Test 4 is shown in Figure 4

Fig. 4 Test Setup for Test 4

The cross section of the beam and the configuration and spacing of the stirrups remained the same. In this case, the flexural steel (3 #10) was ASTM A615 and only the stirrup steel was varied between the specimens.

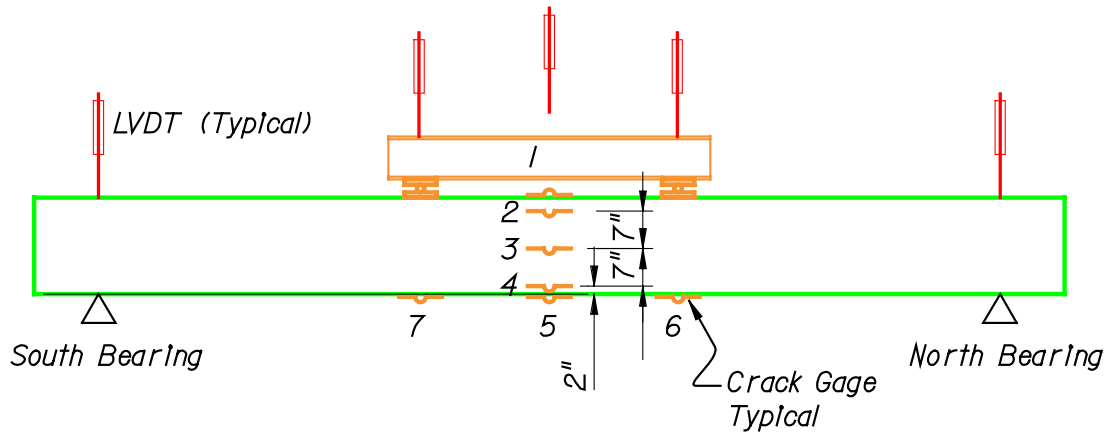
The flexural tests were instrumented with crack gages and LVDTs (displacement gages) as shown in Figure 5. A load cell was provided in line with the single actuator to measure the force being applied to the beam. The crack gages had a gage length of 200mm. As shown in Figure 5, the crack gages were numbered from 1 to 7. Two LVDTs were used at the actuator location to monitor if any transverse rotation was occurring.

Fig. 5 Location of Instrumentation

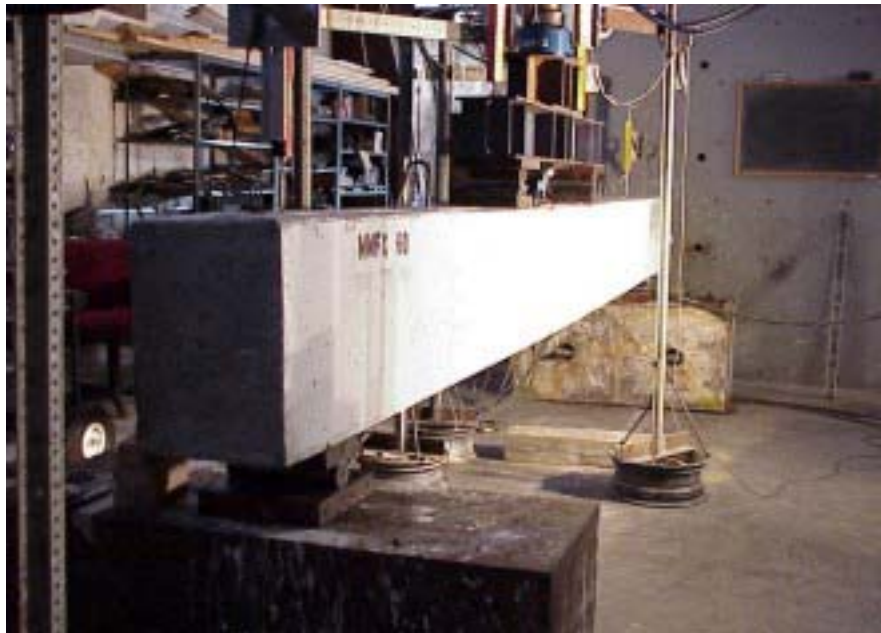
A photograph of a beam with the instrumentation undergoing testing is shown in Figure 6. This beam is the first flexural test with Grade 60 reinforcing. Pinned rollers were used for the supports.

Fig. 6 Beam During Test

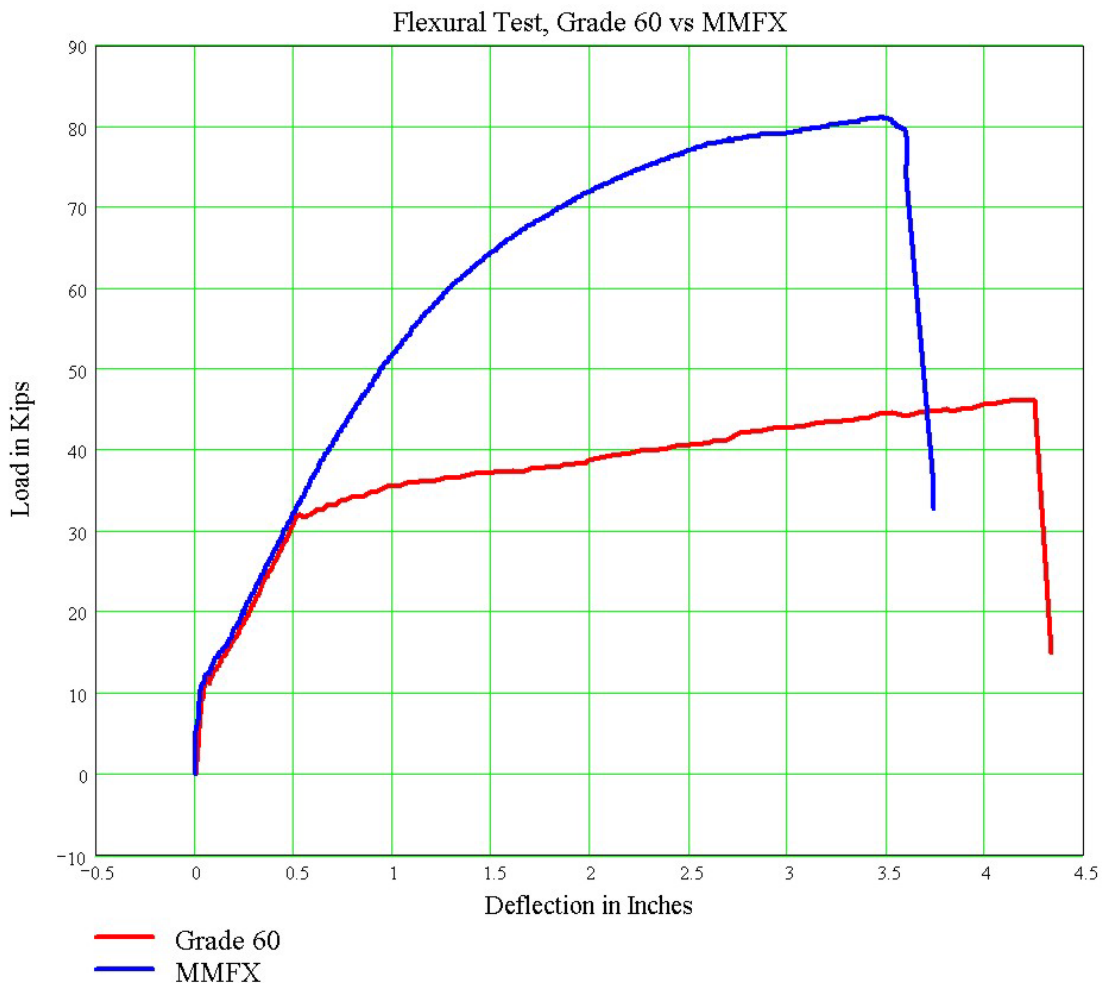
Test 1 was a comparison of pure flexural behavior between MMFX and Grade 60 reinforcing. The bottom reinforcing for both beams was two #6 bars. Figure 7 plots for both beams, the deflection at the north load location versus the applied load from the actuator. Using the south load location would change the plots very little since the difference in the deflections was on the order of 0.02 inches for most of the loading. The difference in beam behavior is due solely to the difference in the reinforcing material properties.

Fig. 7 Test 1 Results

For a general idea of the ductility, the area under the load deflection curve for the MMFX reinforced beam is around 40 percent greater than that of the one for the Grade 60 reinforcing. It can also be observed that the behavior of the two beams is very similar up to the yield loading of the Grade 60 beam at around 32 kips and both exhibit the same cracking load at around 10 kips.

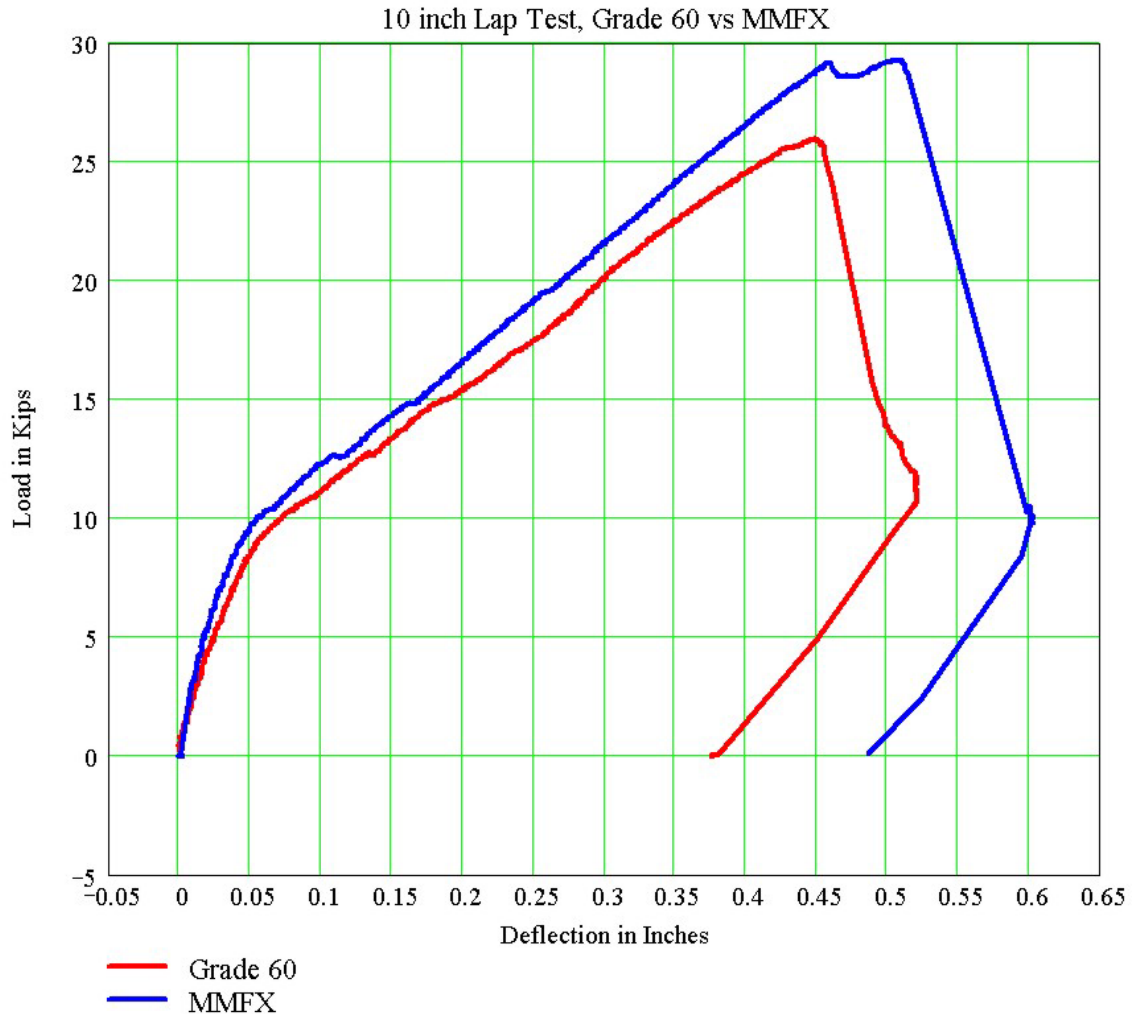
Test 2 was the same as test 1 but the flexural steel was lapped 10 inches at midspan instead of being continuous. Figure 8 provides the load deflection curve.

Fig. 8 Test 2 Results

Examining Figure 8 it is apparent that both beams failed before yielding of the reinforcing was reached. In addition, this test indicates that the bond behavior of the MMFX reinforcing is equal to or slightly better than that of the Grade 60 reinforcing.

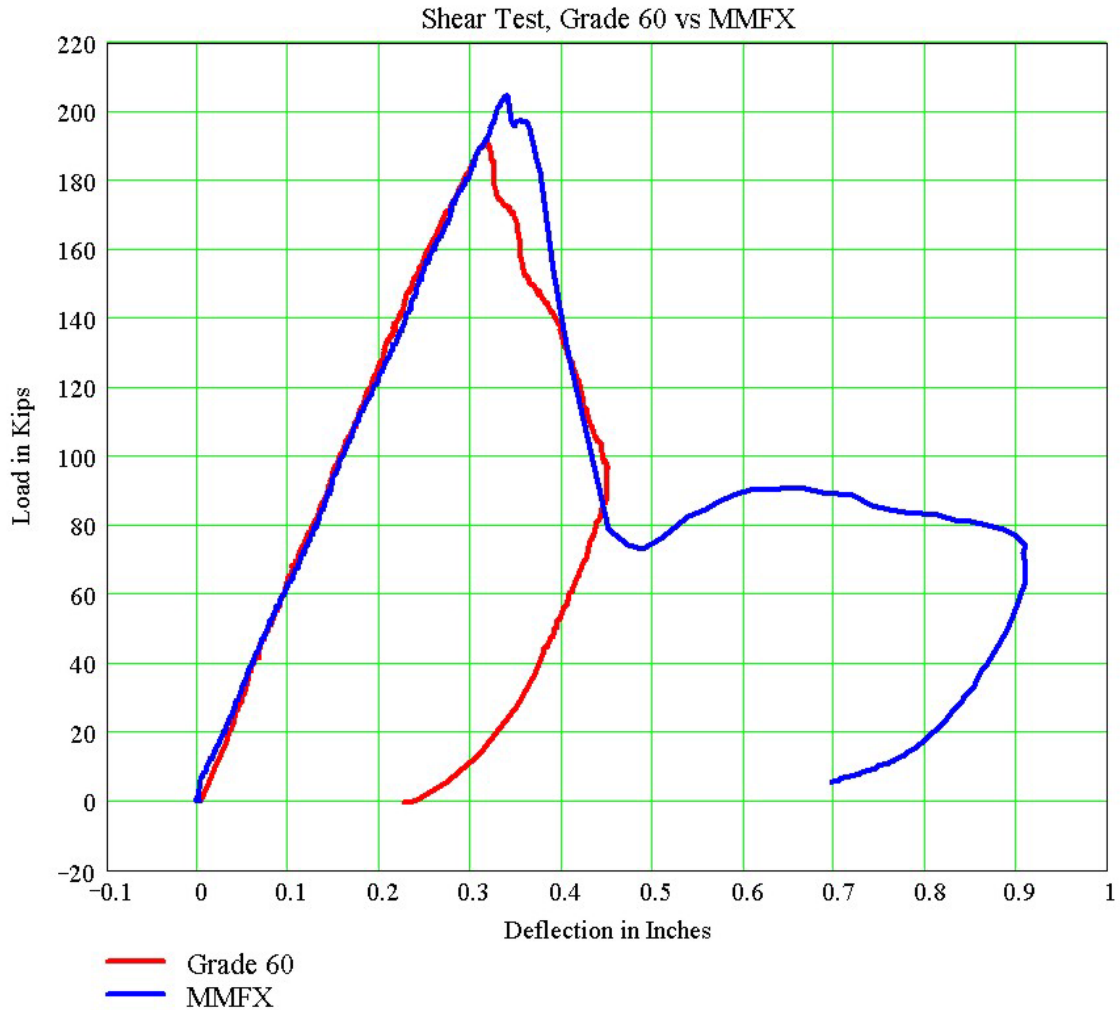
The intent of Test 4 was to compare the performance of Grade 60 and MMFX stirrups in a condition where a shear failure was expected. Figure 10 is a graph of the applied load and the deflection at midspan of the beam.

Fig. 10 Test 4 Results

In reviewing the results it is believed that the stirrups played only a minor part in the shear capacity of the section. Looking at the failure location for the MMFX section, Figure 11, and the Grade 60 section, Figure 12, it can be seen that a strut and tie model would be appropriate. The yield stress of the number 10 bars used for longitudinal reinforcing was 69 ksi. A simple truss model indicates that at a load of 231 kips the longitudinal reinforcing would reach yield. This is a little more than the 190 to the 200 plus kips where actual failure occurred for the Grade 60 and MMFX sections respectively. One possibility is that the interior bar of the three longitudinal bars was not as effective as the exterior bars.

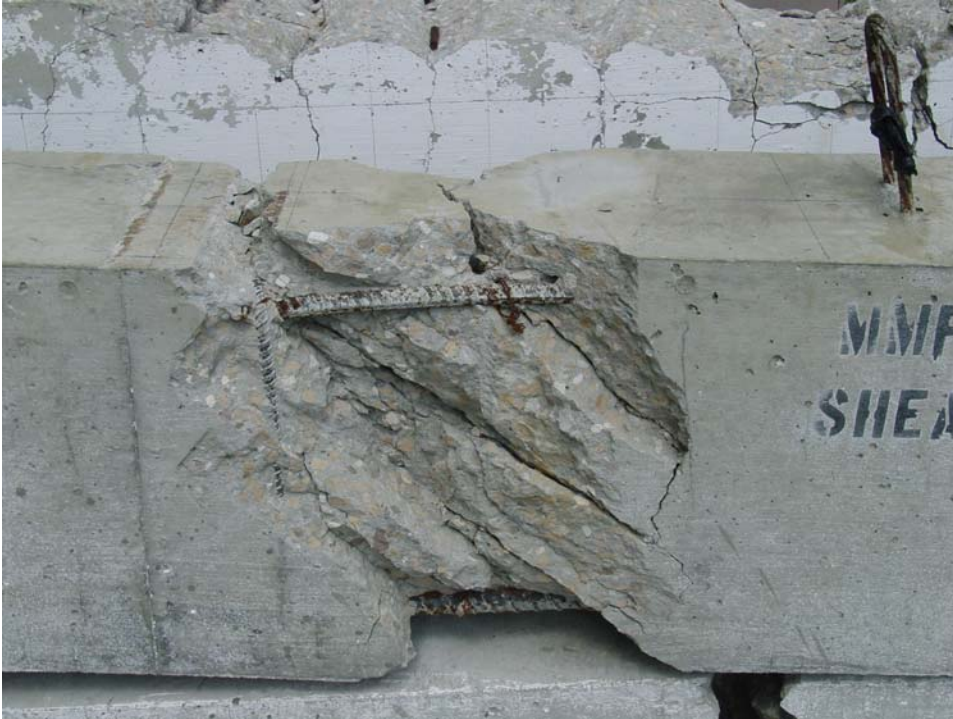
Fig. 11 MMFX Test 4 Beam

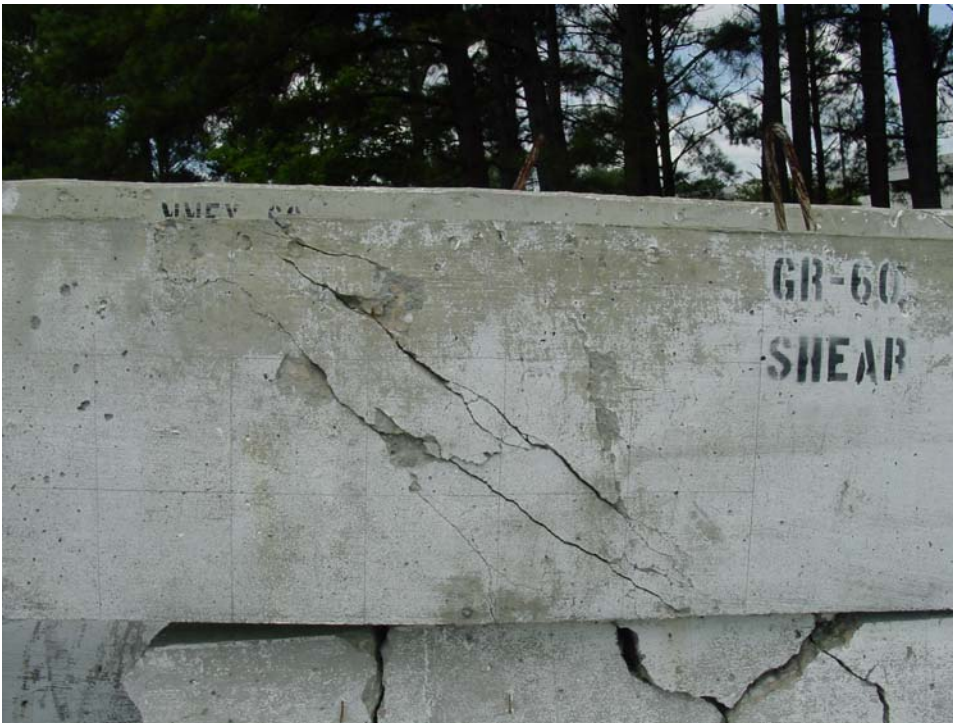
Fig. 12 Grade 60 Test 4 Beam

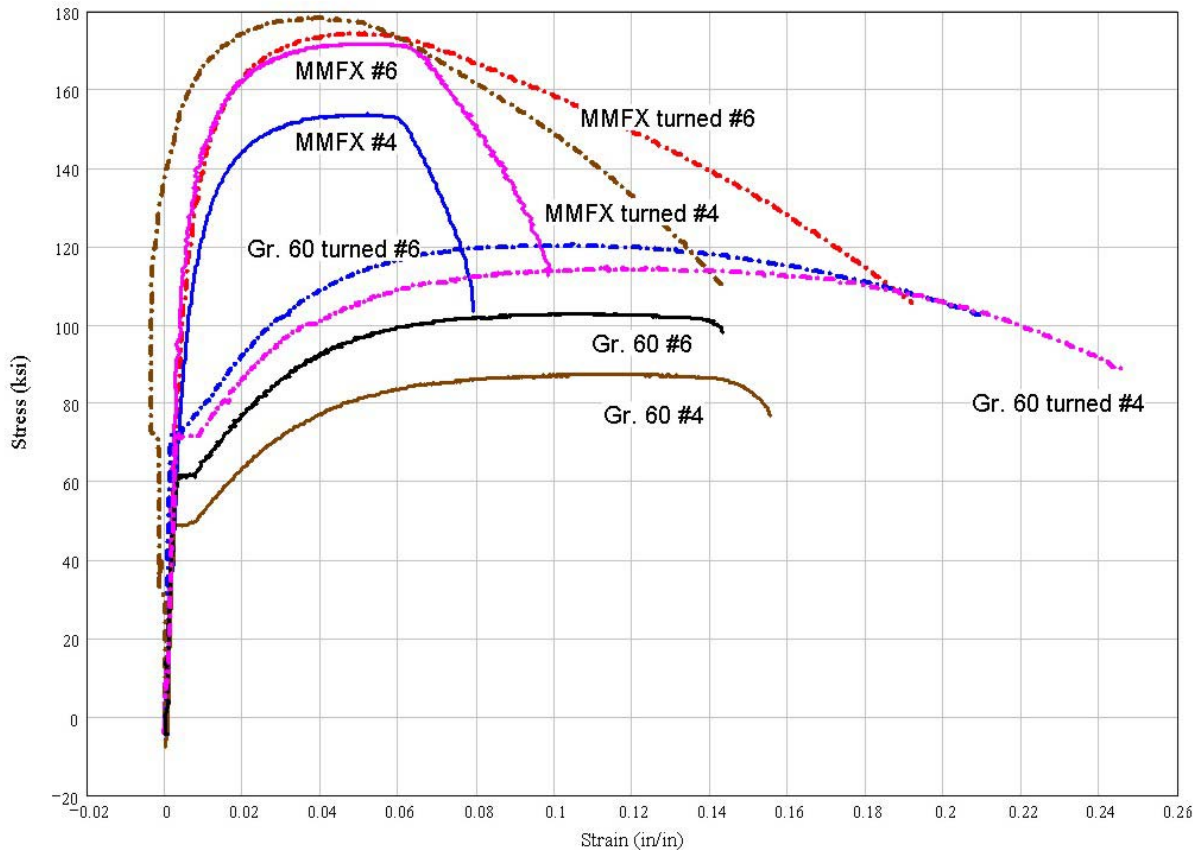
A number of tension tests were conducted on samples of the Grade 60 and MMFX reinforcing. Figure 13 contains a stress strain diagrams for several of the tests.

Fig. 13 Stress Strain

The bars labeled as turned were milled down on a lathe to remove enough material so that the bars were smooth and without ribs. These turned bars were tested with elongations measured over 2 inches. The remaining tests were on full size bars with elongations measured over 8 inches. The variation between the response of the number 6 bars and the number 4 bars in terms of strength and yield was consistent for both the MMFX and Grade 60 reinforcing. This disparity became much less when the bars were tested as coupons with the ribs removed. Also it can be seen that the MMFX bars lack a distinct yield point. The odd behavior of the MMFX turned number 4 bar is believed to be due to slippage of the knife-edges of the extensometer.

The disparity between the number 4 bars and number 6 bars when tested as whole bars versus when tested as coupons indicates that the present rib sizes may be detrimental for these smaller bars. We recently tested full size bars conforming to ASTM A955 (stainless) and noticed a similar disparity in behavior between number 5 and number 4 bars.
