Pullout Test on Barrier Reinforcing

March 2002

Submitted by: Marc Ansley

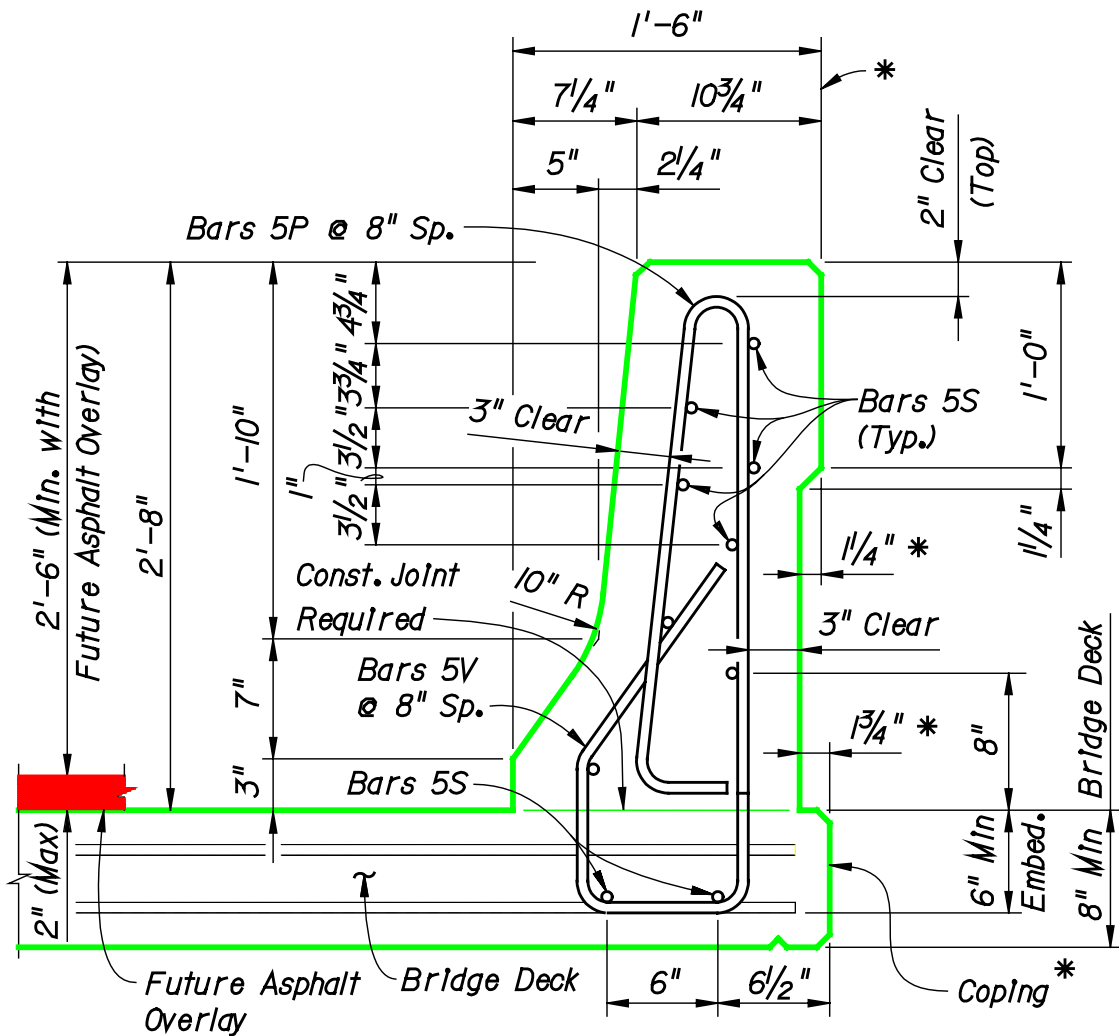
Figure 1

The bar of concern is labeled 5V in Figure 1. The test setup, shown in section in Figure 2, duplicated the reinforcing of the barrier and included as well the typical slab reinforcing. The spacing on the barrier bars in the test setup was 18 inches on center. The bar spacing for the actual barrier reinforcing is 8 inches on center as shown in Figure 1.

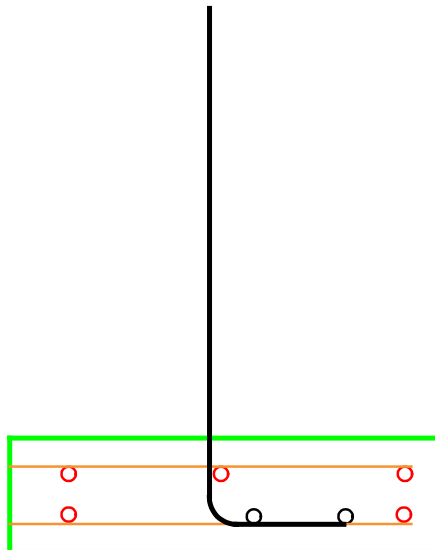
Figure 3

In addition to the bar that duplicated the 5V barrier bar (as shown in Figure 2) at the request of the Structures Design Office additional standard hook bars were added (as shown in Figure 3) between the 5V bars to allow for additional testing if testing of the 5V bars did not damage the surrounding concrete. This bar was also a number 5.

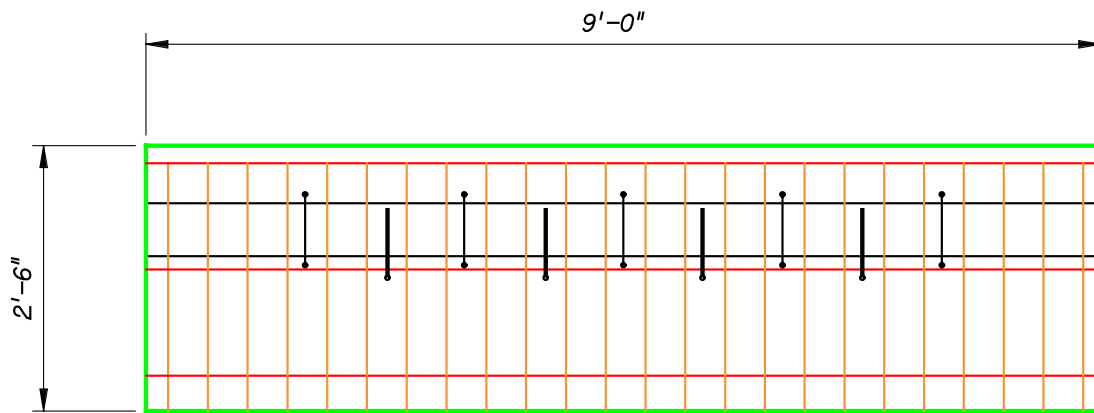
Figure 4 shows a plan view of the test setup.

As can be seen from Figure 4 five 5V bars were provided for testing and 4 standard hook bars. Figures 5 and 6 show the specimen prior to casting concrete.

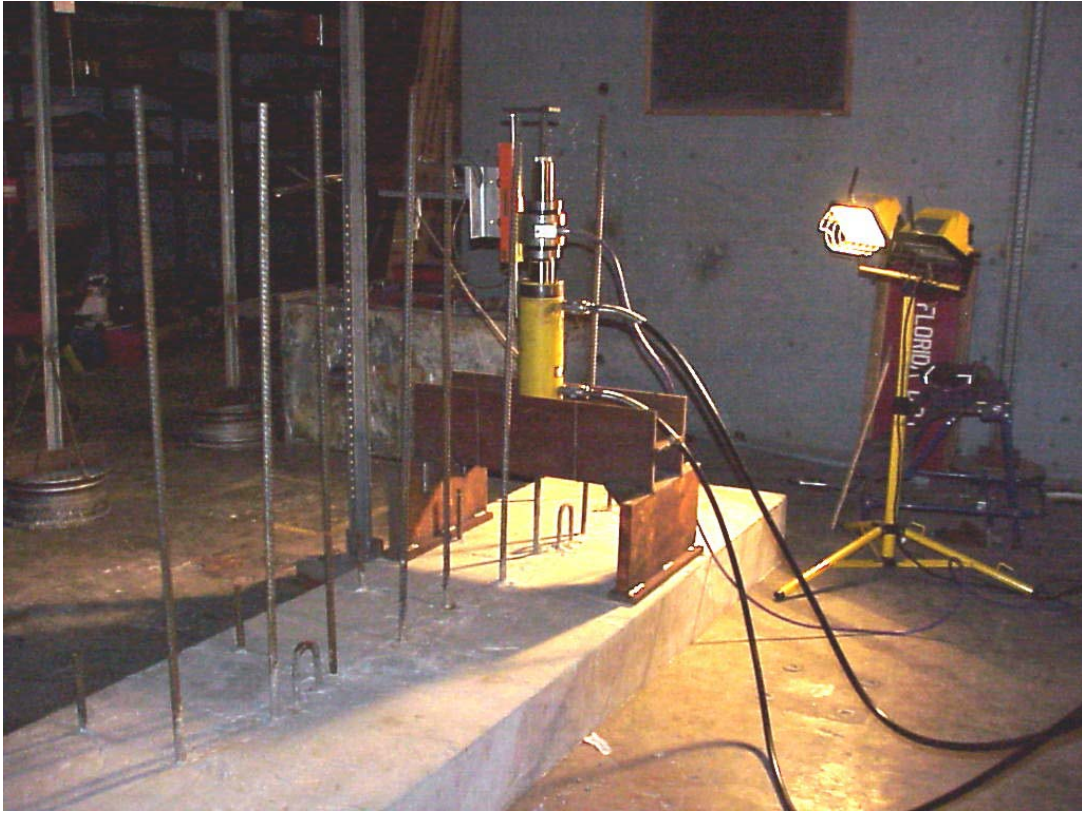
To provide for an unconfined condition the jacking load supports were placed 10 inches or more from the bar being tested. As can be seen from Figure 7 the support in the compression zone, for the barrier in bending, was placed adjacent to the projecting end of the U bar. This made the closest edge of that support $10 \frac{3}{8}$ inches from the centerline of the bar while the other support edge was $12 \frac{1}{8}$ inches from the center. The device was equipped with an inline load cell and deflection was measured at the end of the bar. The load cell and the deflection gage can be seen in Figure 7.

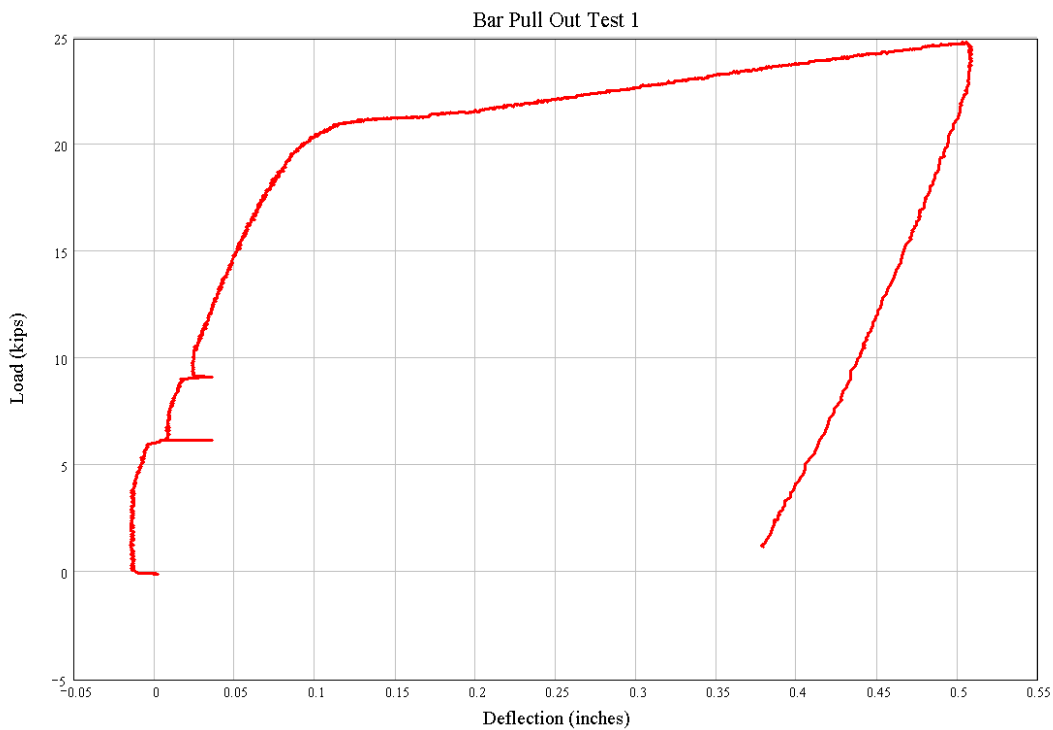
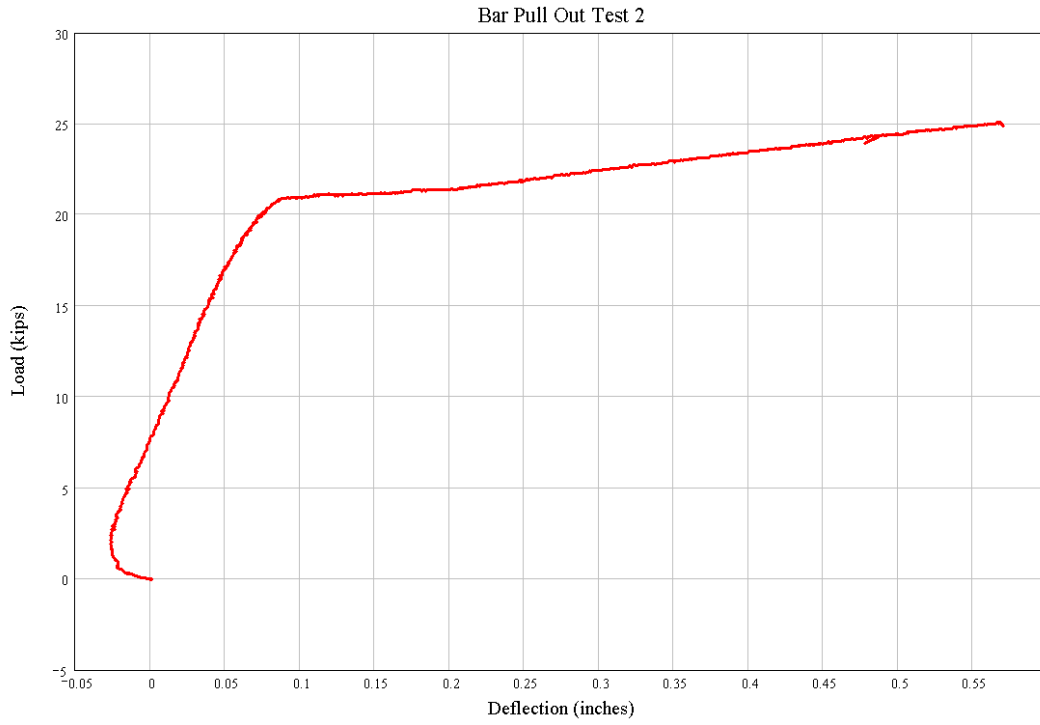
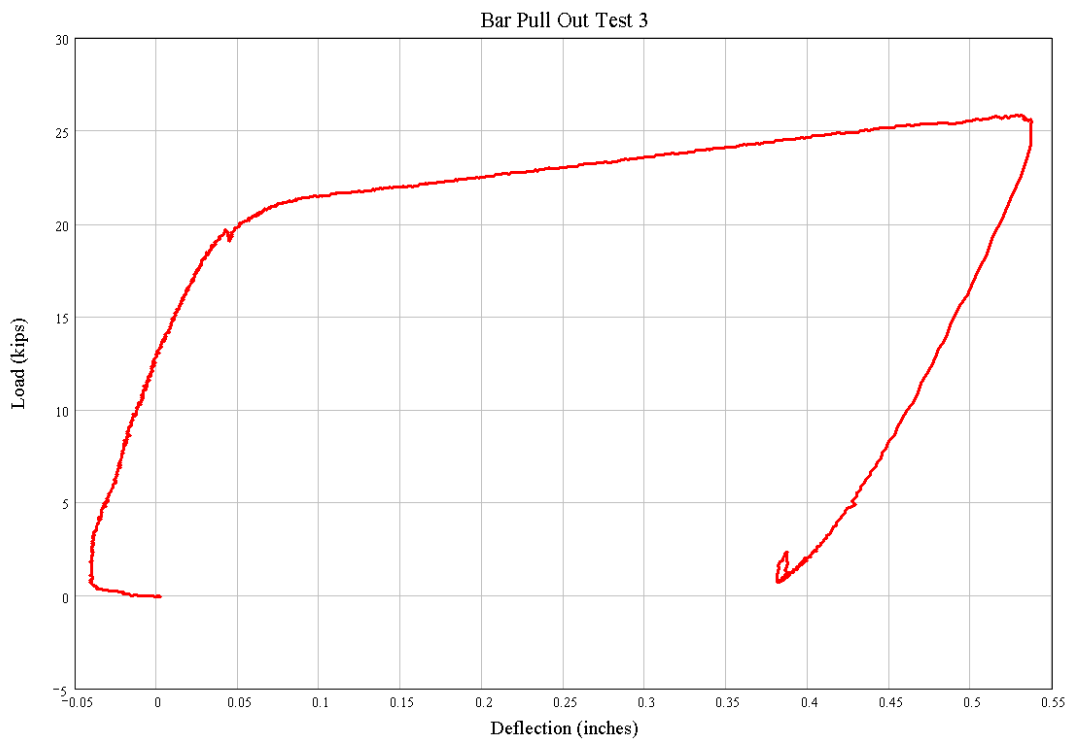
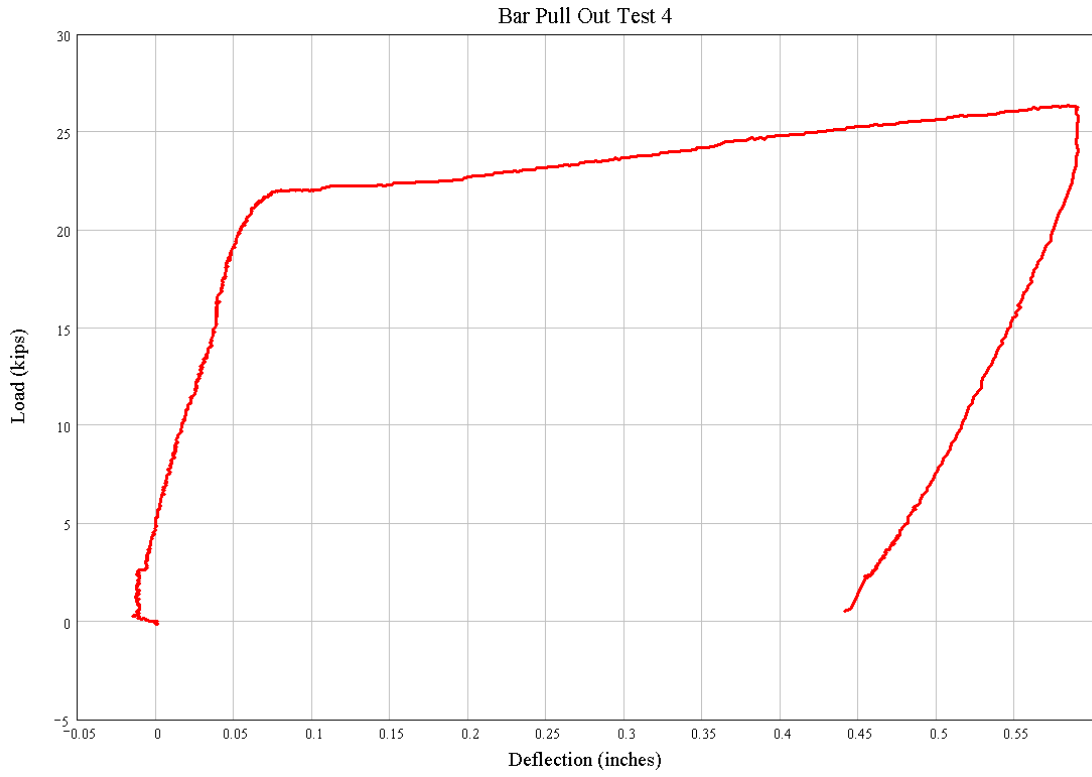
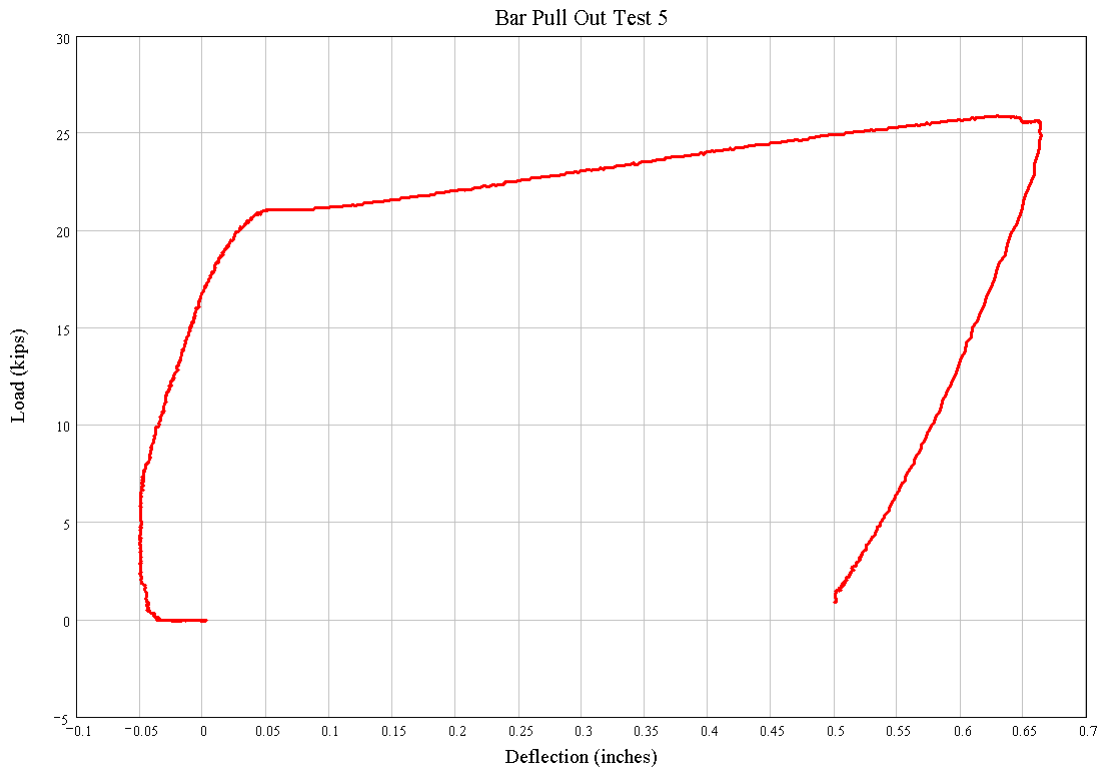
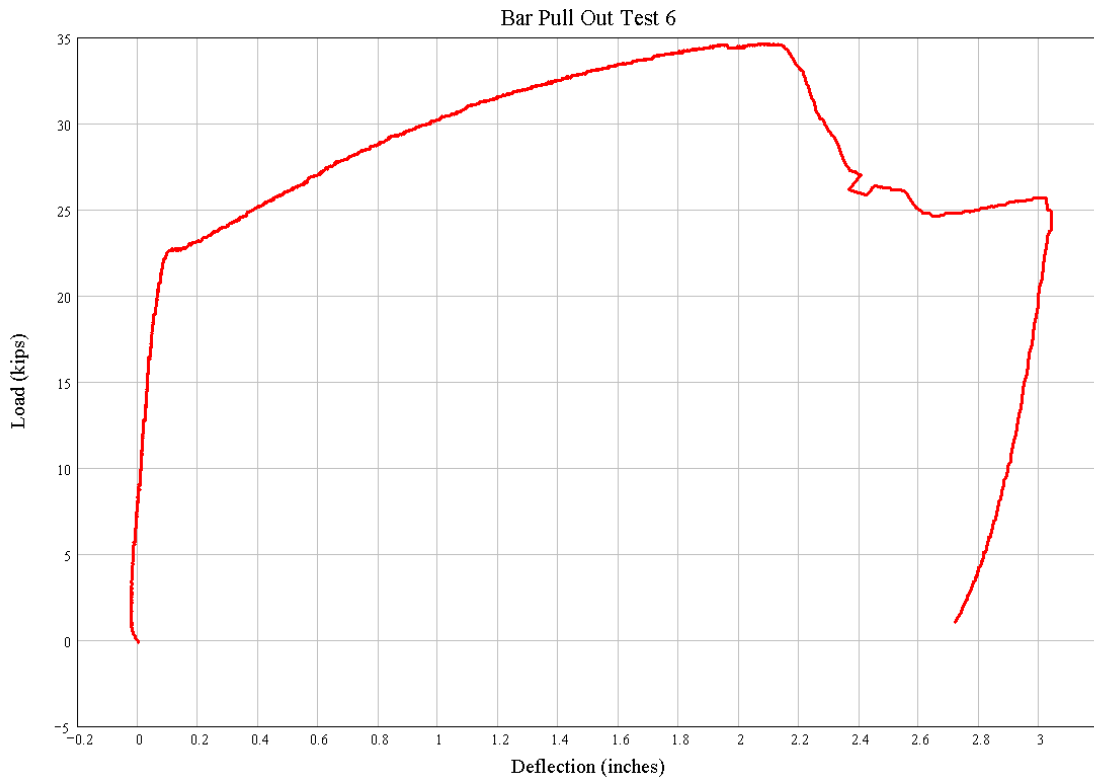
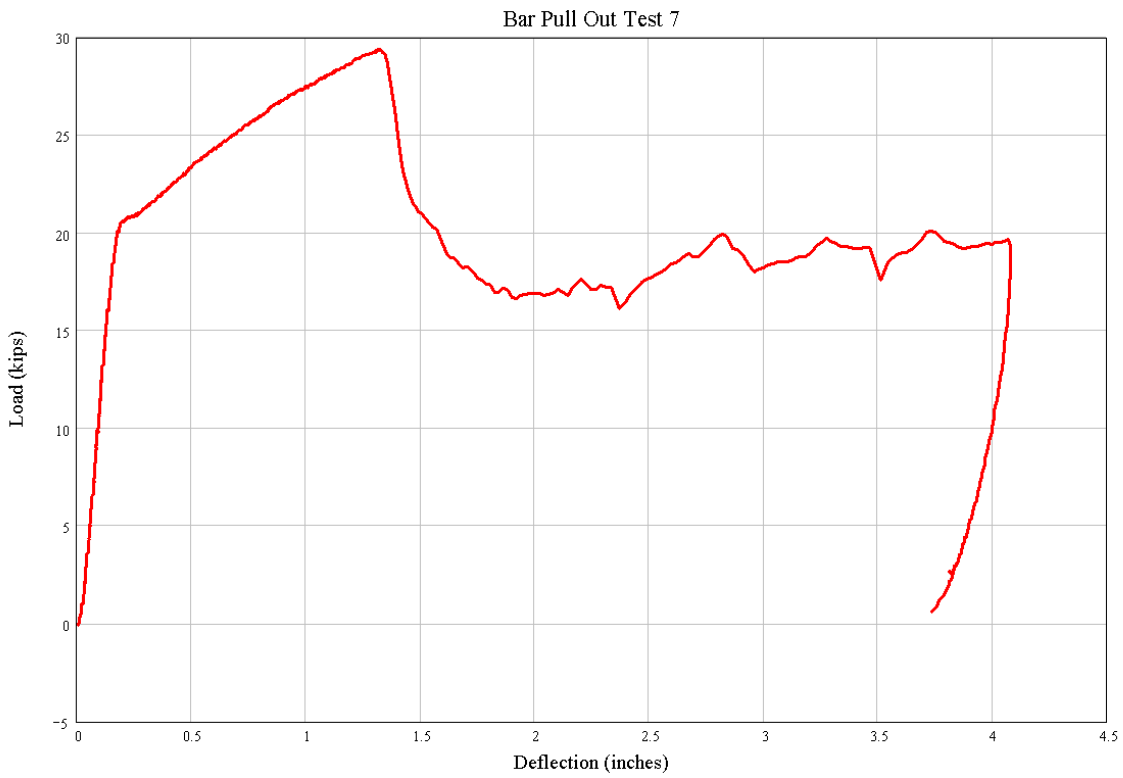
Load and deflection data was gathered for each test. The results of which are presented in Figures 8 through 14.

Tests 1 through 5 were halted before failure of either the bar or the concrete, although some concrete cracking had initiated. The nominal yield force for 60 ksi #5 bars is 18.6 kips and 125% of that value is 23.25 kips. It was decided that if the bars reached a value exceeding 23.25 kips they had demonstrated sufficient capacity for their intended use. Tests 6 and 7 were loaded until the capacity of the system was exceeded. In both of these cases the bars did not fail; the concrete in a radius of approximately 10 inches around the bar delaminated. Table 2 provides a summary of the results. (Yield loads were determined by visual inspection of the load deflection graphs)

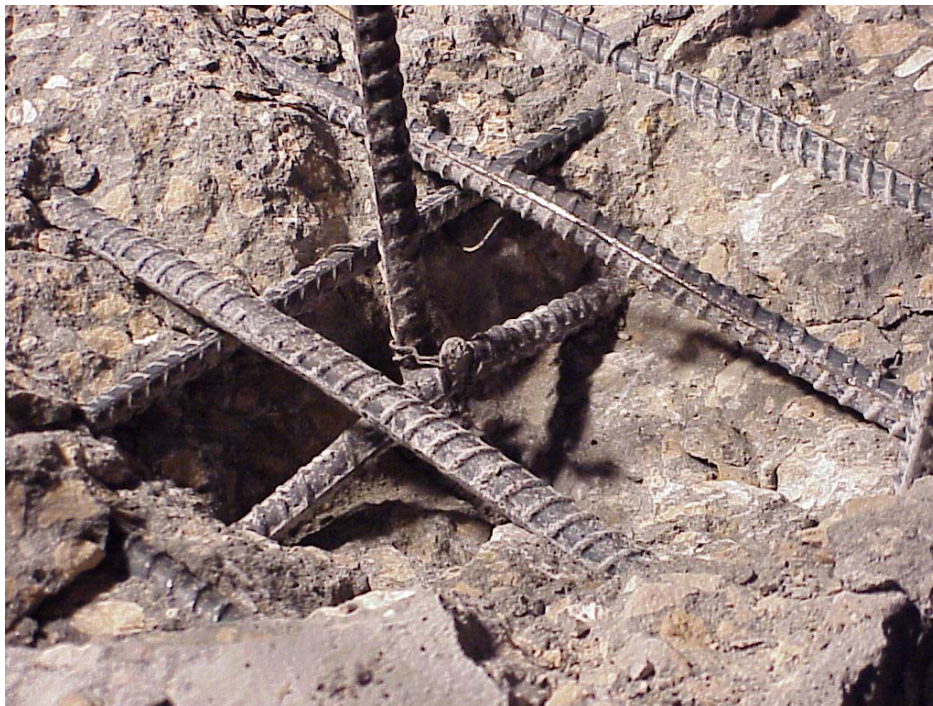
Figure 15

In examining the failure for test 6 it was apparent that the longitudinal reinforcing bar placed inside the hook at the bottom played a significant role in its capacity. This can be seen in Figure 15.

The present barrier-reinforcing configuration, based on the results of these tests, is completely developed. From an examination of the two tests to failure (Tests 6 and 7), it is apparent that the greatest contributor to the additional capacity, beyond what would be expected, is the longitudinal bar the reinforcing was hooked around. For both tests these longitudinal bars at the hook are the focal point of the concrete failure. It can be speculated that this condition causes these bars to act more like a headed anchor than a hook. Other possible contributors were the top transverse bars, adjacent to the test specimens, which were bowed up from resisting the concrete delamination. It can also be surmised that for the extent they were tested (only two) the standard hooked bars perform as well as the barrier bars with the smaller radius hooks. Their performance also lends credence to the importance of the longitudinal bars at the hook location since the standard hooked bars lacked the complete U shape. The U shape of the barrier bars from examination of the tests did little to contribute to the additional capacity.
