Load Test on Sure-Lock Square Pile Splice

April 24, 2002

Submitted by: Marc Ansley

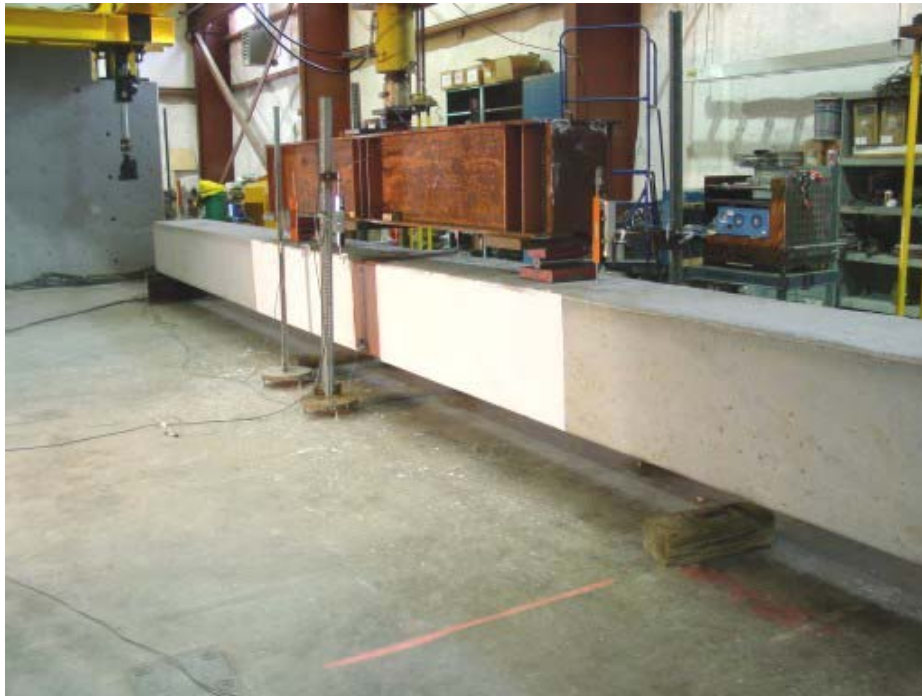
Figure 2

A single actuator provided the two point loads through the use of a steel beam as can be seen in Figure 2. The steel distribution beam was composed of two W 21x68 sections connected together.

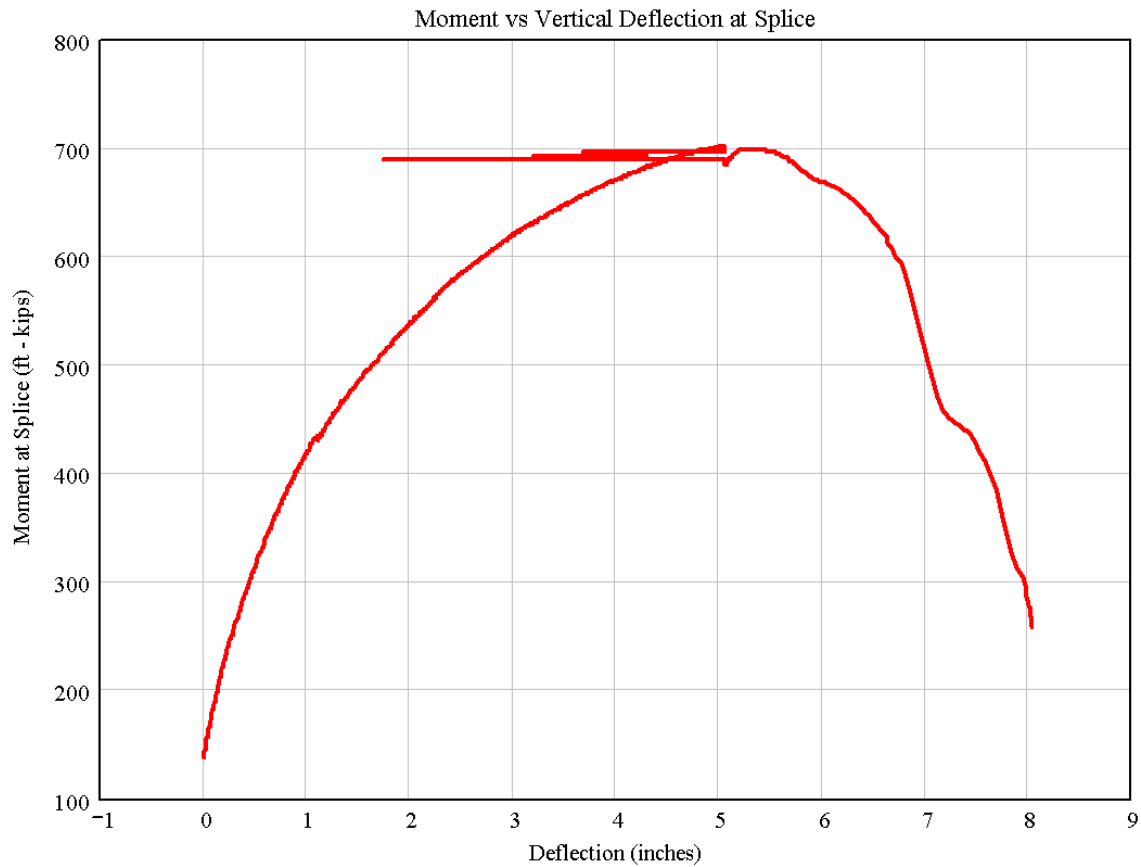
Two static tests were conducted. Shown in Figures 5 and 6 are the resulting graphs depicting deflection at the splice versus the corresponding moment. The discontinuity near the peak in Figure 5 is because the displacement gages had to be reset since the range was exceeded. This problem was corrected in the second test. Note that in both graphs the moment at 0 inches of deflection is 138.775 foot-kips.

Test Number	Peak Moment Capacity (foot-kips)
1	701.3
2	688.7

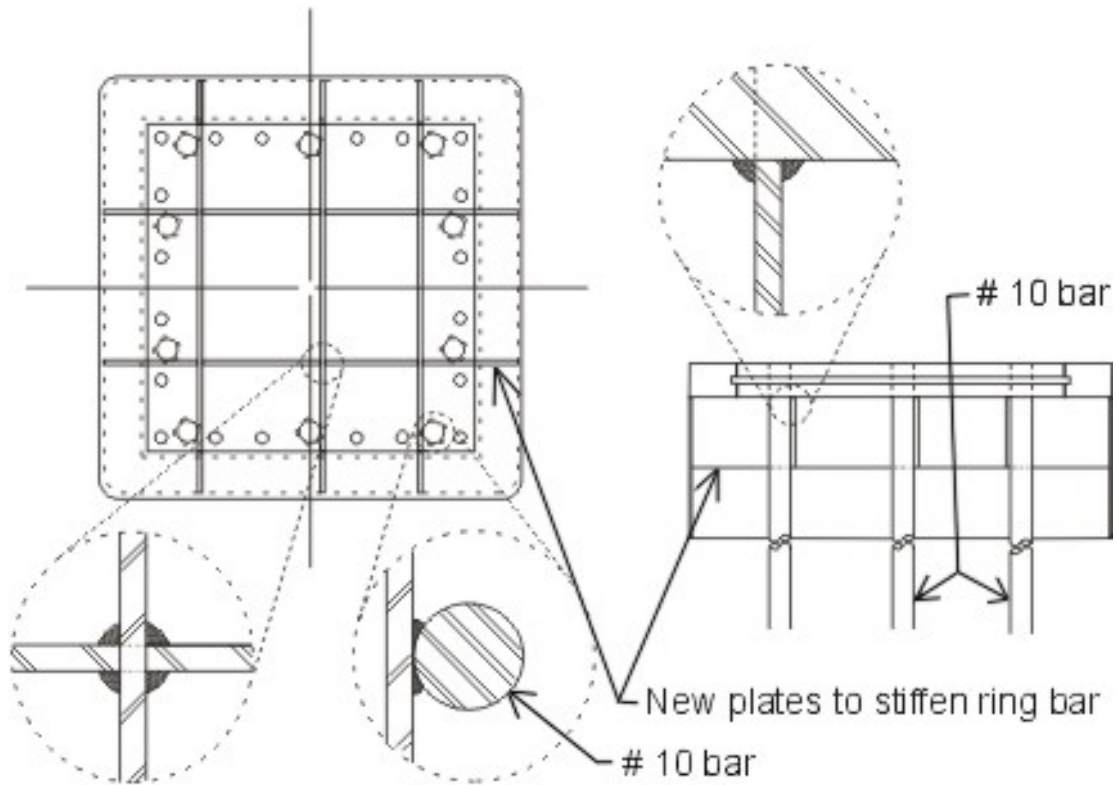
In Figure 12 a grid of plates is added to the splice to torsionally stiffen the ring bar and provide a means of connecting straight reinforcing. In Figure 13, a plate is added behind the ring bar that would also improve its torsional capacity and allow the use of straight reinforcing.

The Sure-Lock[®] splice demonstrated a capacity in excess of 600 foot-kips. The average moment capacity for the two tests is 695 foot-kips. Even though it easily met the Department's minimum strength requirements, it is believed the capacity of the splice could be significantly enhanced with a few modifications to the female half. Shown in Figures 12 and 13 are two different suggestions on how the splice might be modified.
