Test Report for NMB Splice System  
- For Sound Barrier Wall Foundation Connection -

By: Will Potter  
6/15/07

Proposed Testing of NMB Splice System – For Sound Barrier Wall Foundation Connection

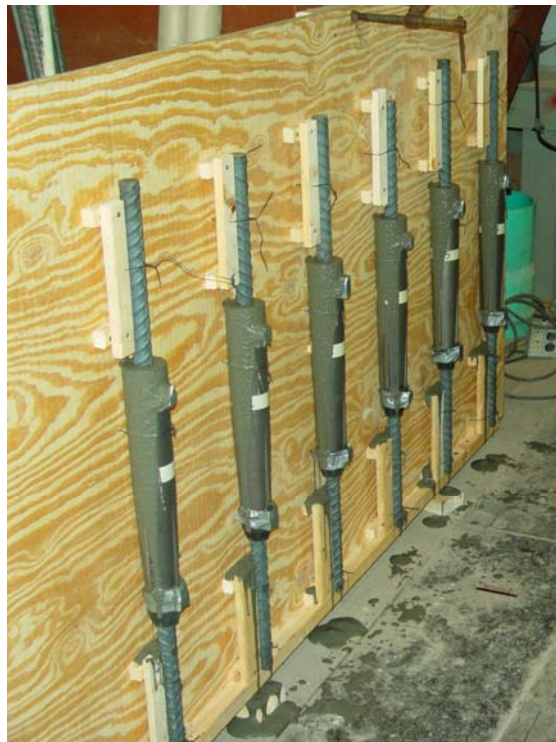
**Figure 1:** NMB Splice Sleeve setup

Six 9U-X NMB Splice Sleeves were constructed, grouted, and then subjected to a tensile test. The specimens were assembled and grouted in accordance to the proposed testing scheme (see attachment). The grout was mixed as per specifications with 1 gallon of water to 1 bag of SS Mortar. The reinforcing bar was a number 9, Grade 60. The assembling and casting setup is shown in figure 1. The specimens are labeled numerically 1 to 6. Specimens 1 to 3 represent the poor grout scenario, in that they were not rodded. Specimens 4 to 6 correspond to the proper grouting technique, with specimen 6 being agitated further by moving the reinforcing bar.

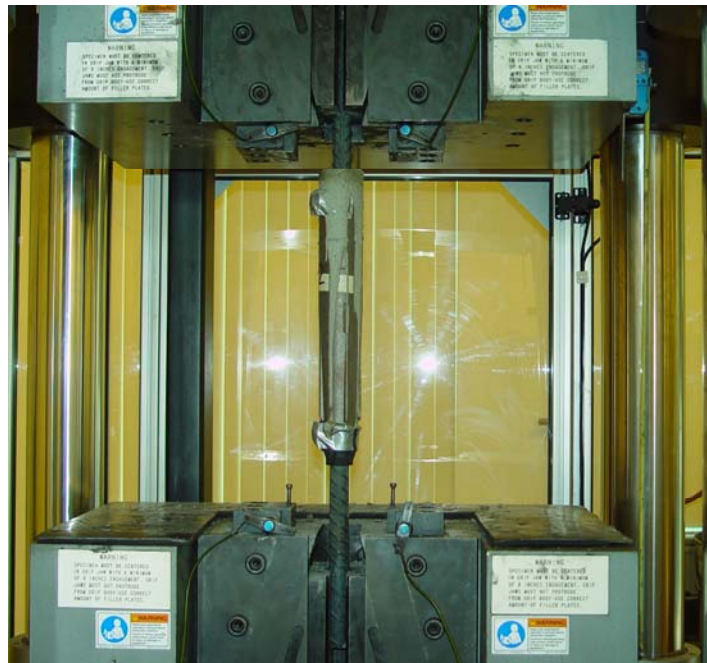
**Figure 2:** Test Setup

A tension test was performed on the six specimens 12 days after casting at the State Materials Office in Gainesville, FL. The test was conducted based on ASTM A615. The setup is shown in figure 2. The objective of testing was to acquire the load at which

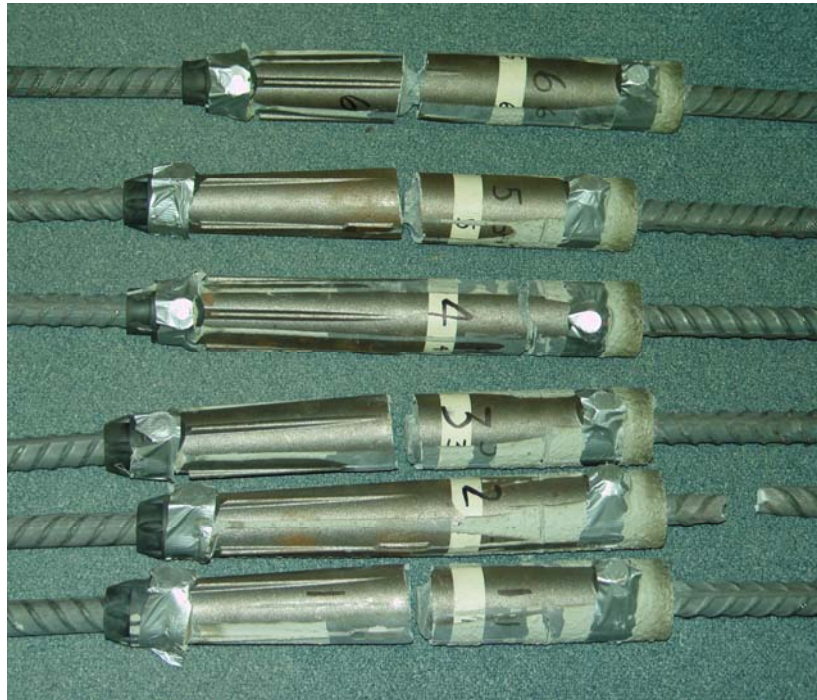
**Figure 3:** Failed Test Specimens

The results in table 1 depict consistency based on the small variance in ultimate load. With the type of failures that occurred, a comparison of the grout installation cannot be established, due to the fact that the grout was not the controlling factor. It is shown that five of the specimens failed within the splice sleeve with one specimen failing within the reinforcing bar. It is also observed that specimen 4 failed in the upper region of the device (bar insertion end) as opposed to mid-depth as the other four. A plausible explanation for the devices failing rather than the reinforcing bar is that the clear distance between the top of the device and the grips of the testing machine was small,

approximately 4 to 5 inches. This short distance prevented the reinforcing bar from failing, except in specimen 2. It is believed that if this clear distance was increased the bar would have a better opportunity to fail. The reason for the failure in specimen 4 is not yet determined. The failed specimens can be seen in figure 3.
