Initial Report on Testing of Beams Removed from I-75 Bridge over Main 'A' Canal

February 1, 2007
Marc Ansley

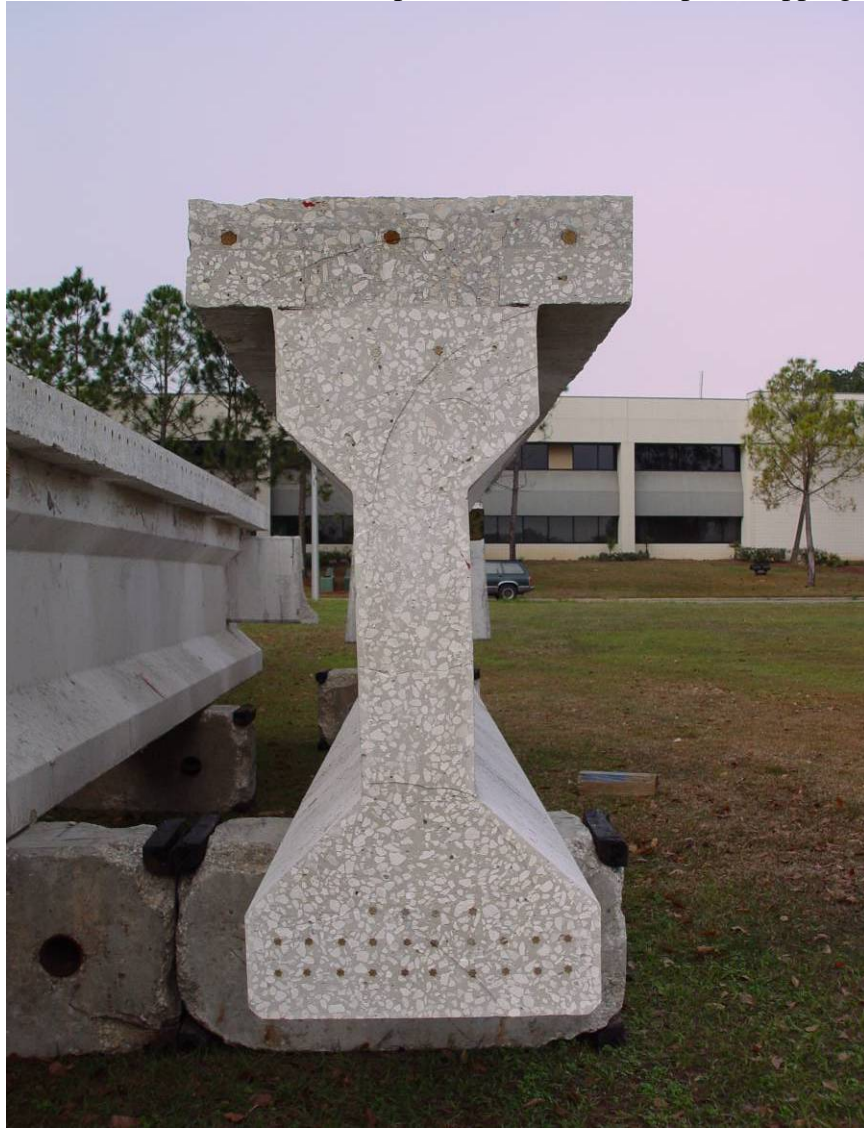
Four AASHTO Type III beams from the I-75 over Main “A” Canal Bridge in Sarasota County were saw cut from the bridge and delivered to the Structures Research Center in Tallahassee. A portion of the composite slab, 28 inches wide, was included with the beams. Contrary to the original plans, the slabs were not cast-in-place but composed of precast deck panels with a cast-in-place topping. Figure 1 shows the cross section of the beam with the interface between the deck panels and the cast-in-place topping.

The deck panels are transversely keyed with a stepped thickness that alternates between 2.5 and 4.5 inches. Figure 2 shows removal of one of the beams from the bridge.

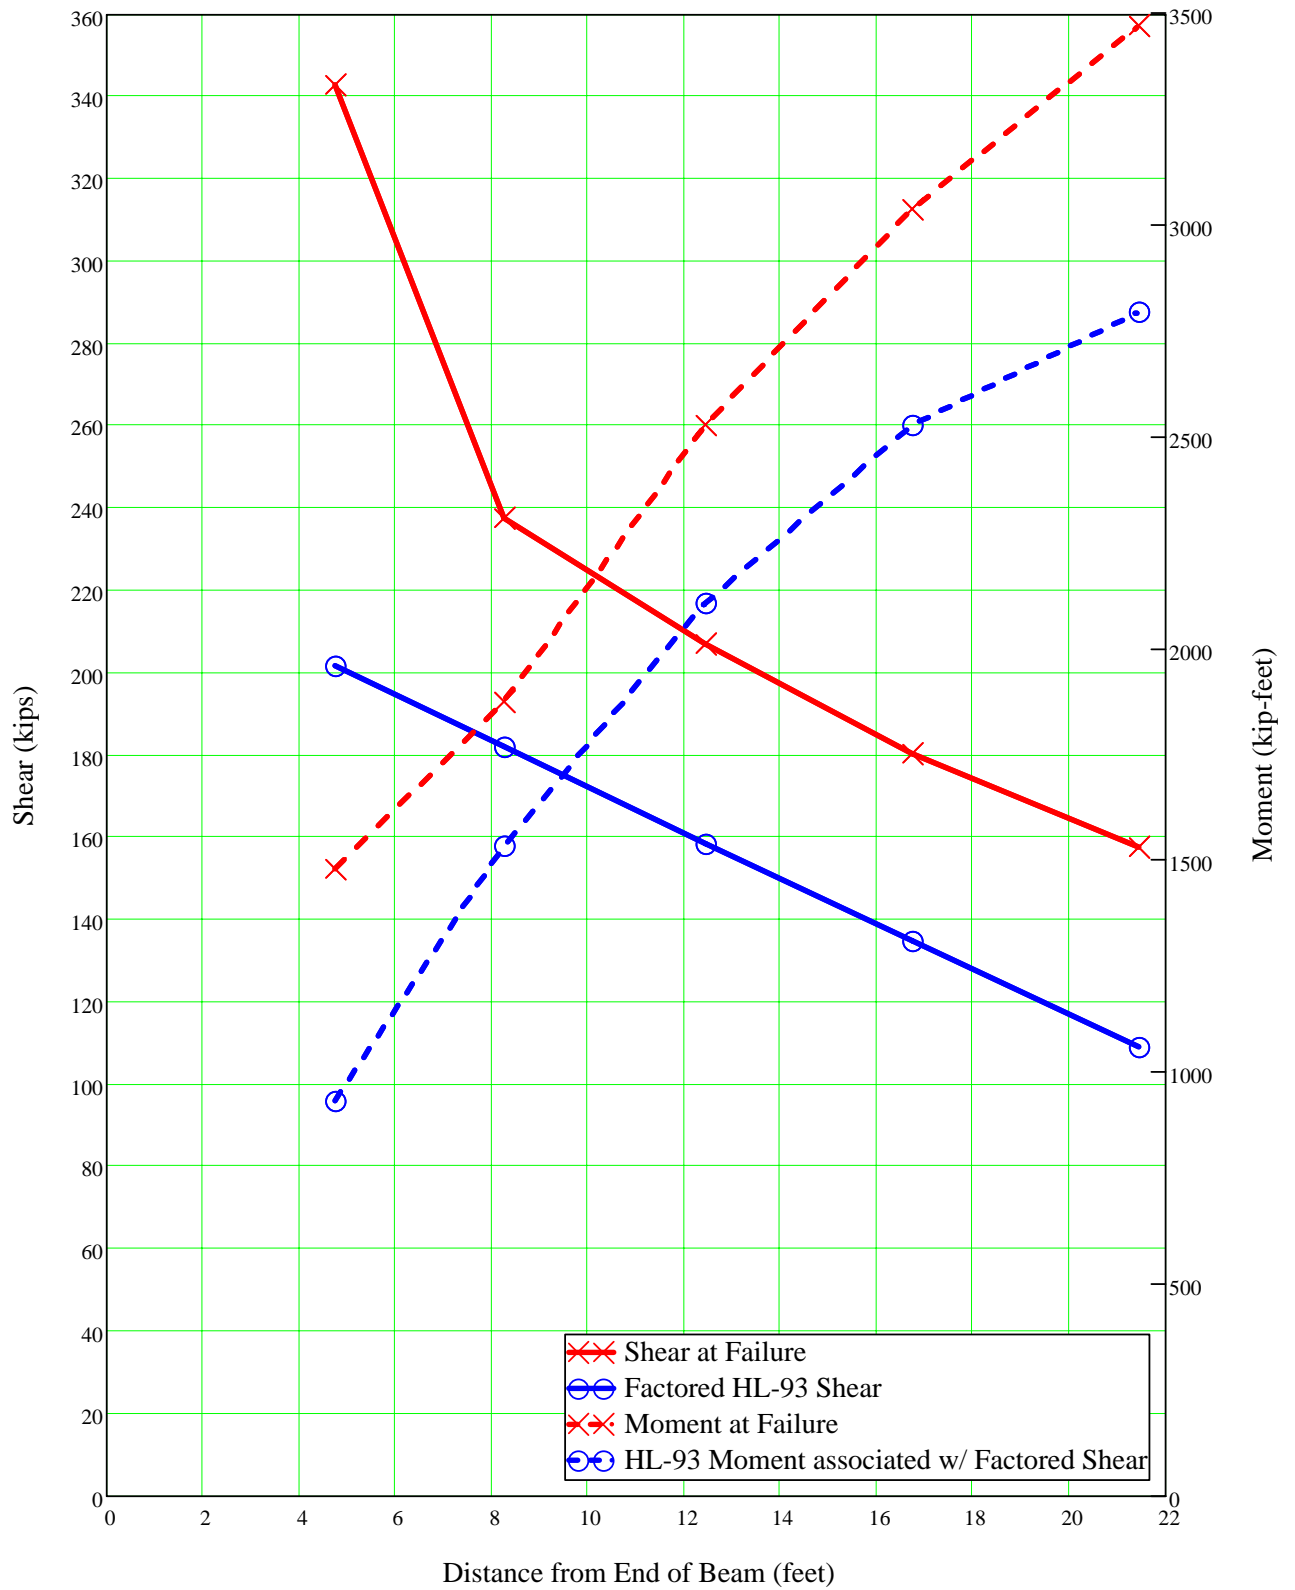
Figure 9 summarizes the results of the testing along with Table 2. For comparison, the calculated HL-93 factored design loads for the original bridge are shown on the same figure. It should be noted that not only do the tested shear capacities exceed the HL-93 loads at all locations but also that the concurrent failure moments are greater than the design moments associated with the factored shears. The shear capacity of the 8 foot offset test exceeded the factored HL-93 shear by 27%. This was the smallest percentage increase observed.

It is speculated, that the improved performance, in terms of the obvious data trend, for the 4 foot offset test, could be due to the confinement provided by the load restricting strand slip. This is subject to further study but the result is consistent with previous tests, which demonstrate improved performance for loads located within 2 beam depths of the support. The reported shear and moment values in Table 2 are those at the section located at the load and include the additional forces due to the beam weight.

Location from End of Beam (feet)	Shear at Failure (kips)	Moment at Failure (ft-kips)
4.75	342.9	1478.5
8.29	237.5	1873.8
12.46	206.7	2528.1
16.75	180.1	3038.2
21.46	157.6	3474.0
