Aluminum Picket Weld Test

Written By: Will Potter, E.I.

Overview:

An aluminum picket weld test was requested by the Department in order to obtain the strength of the aluminum 5356 filler wire and the 4043 filler wire on the picket connection of index 860 of the FDOT's *Design Standards*. The objective was to test whether the 4043 filler wire has sufficient strength to withstand the design live load and compare it with the current 5356 filler wire. The FDOT's *Design Standards* lists a design live load of 200 lbs concentrated over 1 square foot. According to the dimensions of the picket railing this would conservatively equate to 100 lbf distributed along 12 inches of the picket length.

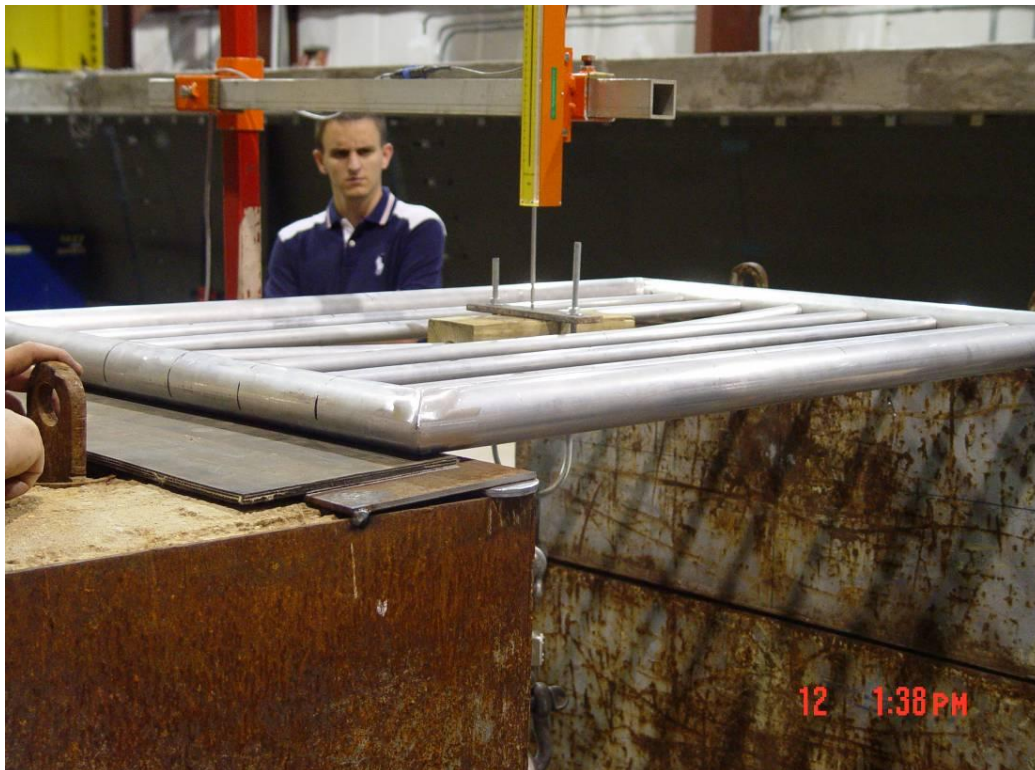
Figure 1: Panel and Test Layout

To perform the tests, two aluminum railing panels were built according to the *Design Standards*, one welded with 5356 filler wire and the other with 4043 filler wire. The picket connections were welded with a 3/16" fillet weld; however, further observations show that it is more of a penetration weld on two sides due to the lack of coping and beta limitation. The panels were constructed with a Type B connection, which allows one end to be non-welded. Each panel contains six 3/4" NPS Schedule 40 pickets. Each rail (outer tube) is a 2" NPS Schedule 40 pipe. All pipes were aluminum alloy 6061 – T6. The test setup consisted of placing 12" timber block centered on the length of the picket and applying a point load in the center of the block with a hydraulic actuator. The load and center displacement were recorded with a data acquisition system. The panel and test layout is shown in Figures 1 and 2.

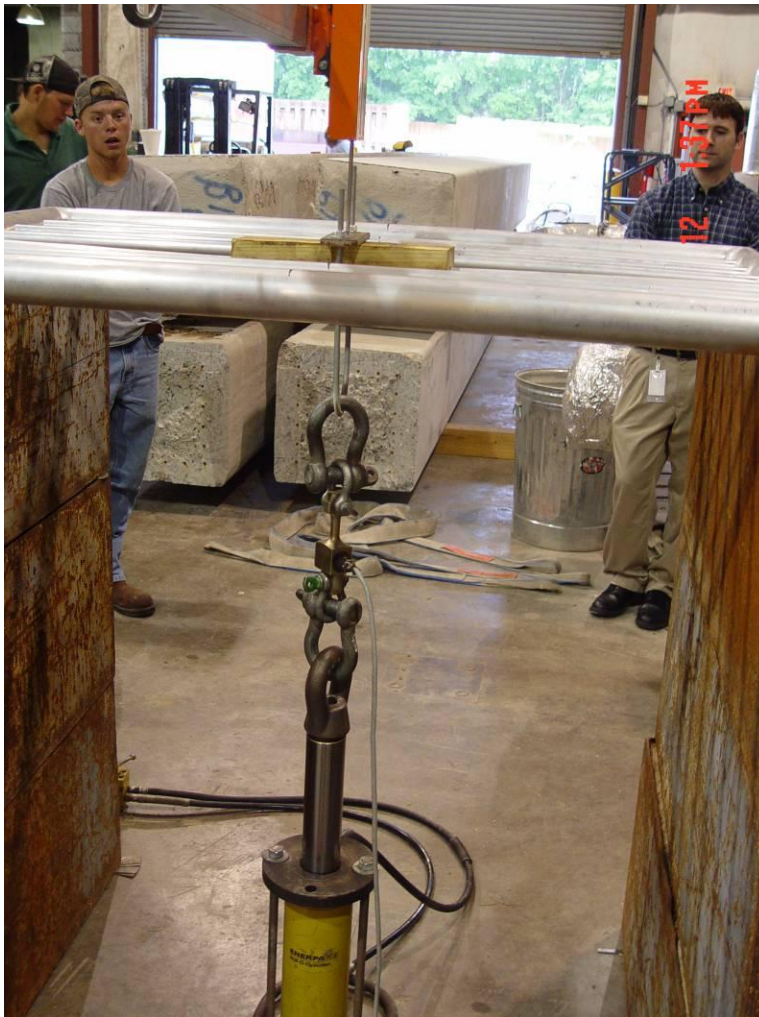
Figure 2: Panel and Test Layout

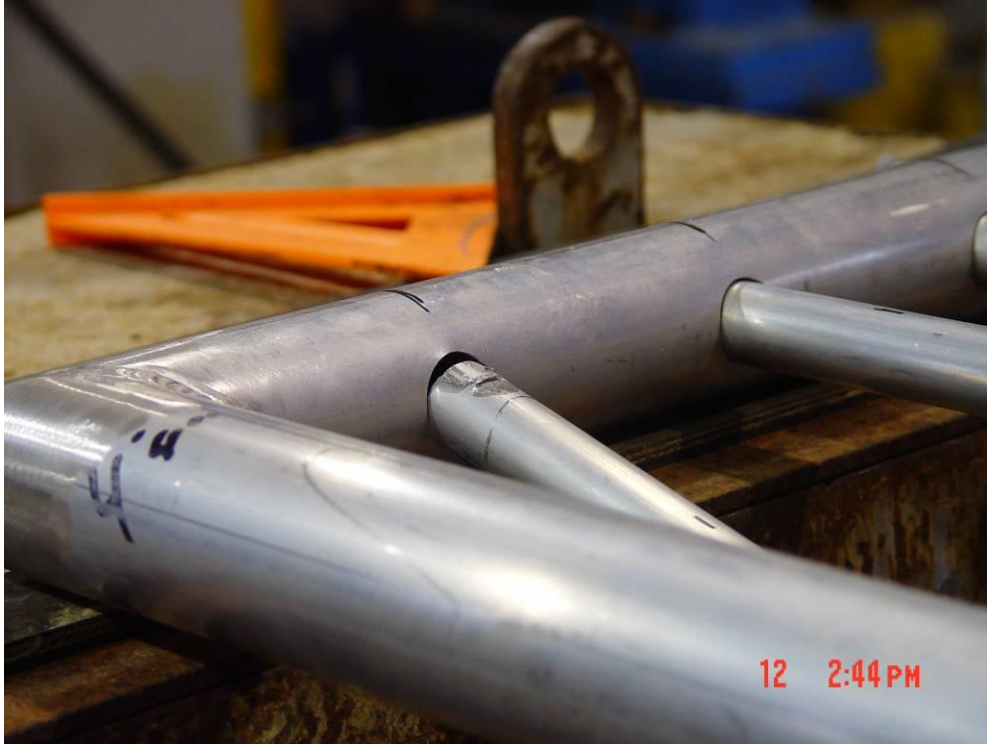
Figure 4: Slipping of Non-welded End

The results of the tests revealed that the response of the picket to the applied load varies slightly with the type of weld metal used. Of the 11 tests that were performed, five on the 4043 filler wire and 6 on the 5356 filler wire, only two instances occurred where the base of the weld metal fractured. The fractures were on the pickets that had 4043 filler weld, shown in Figure 3. The other tests were halted based on a drop in load due to the non-welded end slipping out of the rail as shown in Figure 4. The test data given in Table 1 provides the maximum attained load with the failure type. Figures 5 and 6 plots the load versus displacement for all tests. The test data indicates that the maximum load values are disparate on the tests when the picket slips, which is due to the inside roughness of each pipe socket being inconsistent.

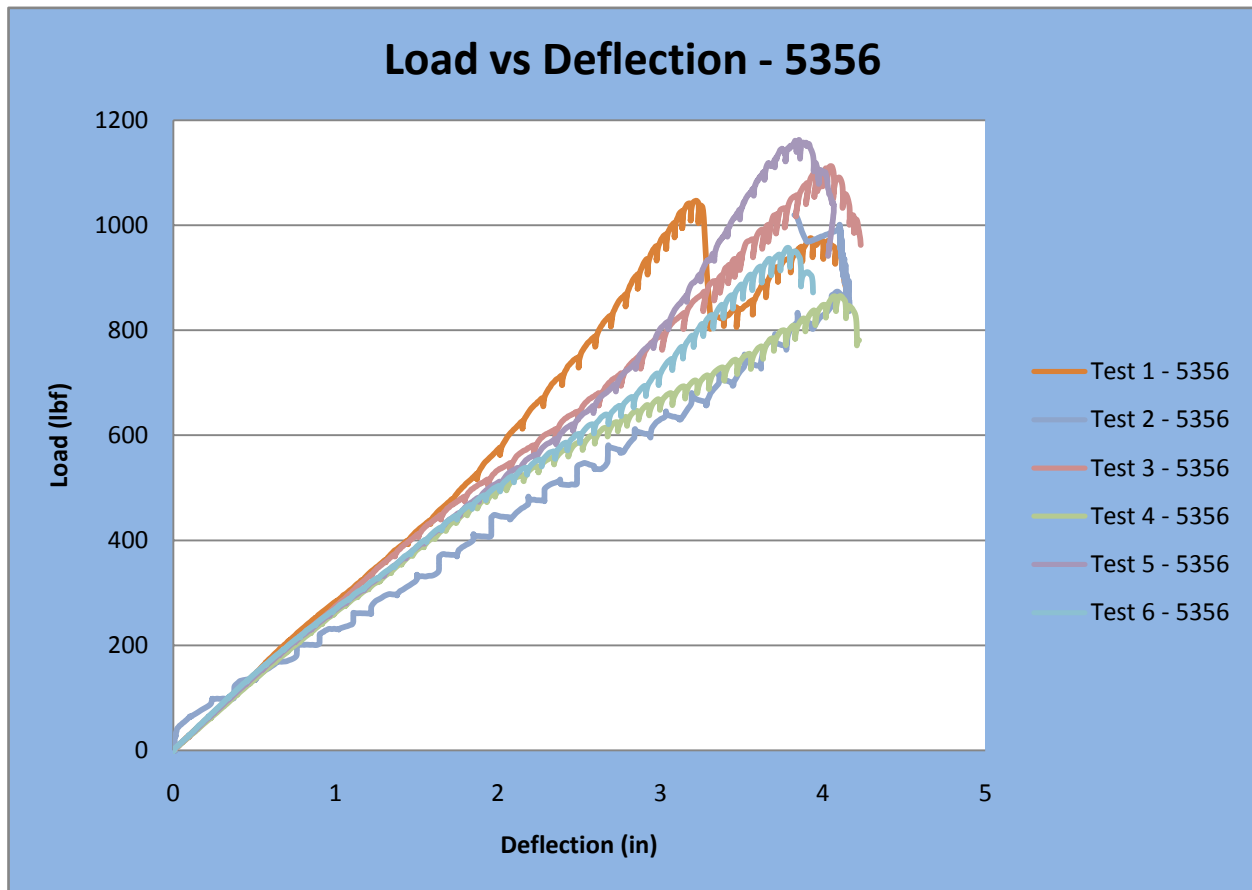
Figure 6: Load vs Displacement – 5356 filler wire

The maximum loads, 986 lbs and 980 lbs, for the 4043 weld metal occurred on the pickets with the fractured weld. The 5356 weld metal had more strength exceeding these values by 6% or more on three separate tests before slipping. The load versus displacement graphs on both types of welds suggest that the pickets yielded between 400 and 600 lbs. Some of the pickets, once yielded, began to slip and eventually developed membrane action before the load drop (Test 2 and 4 – 4043 and Test 3,5, and 6 – 5356). Three tests also demonstrated membrane action immediately after yield with very little slip (Test 1 and 3 – 4043 and Test 1 – 5356). Membrane action occurs once a large amount of deflection has taken place and the picket end is locked in the rail socket, thus allowing the applied load to be resisted axially by the member. Once the load is large enough the weld metal fractures as in the two 4043 welds or slip occurs.
