Investigation of the Double-Composite Box Girder Failure Criteria

FDOT Structures Research Center

January 11, 2010

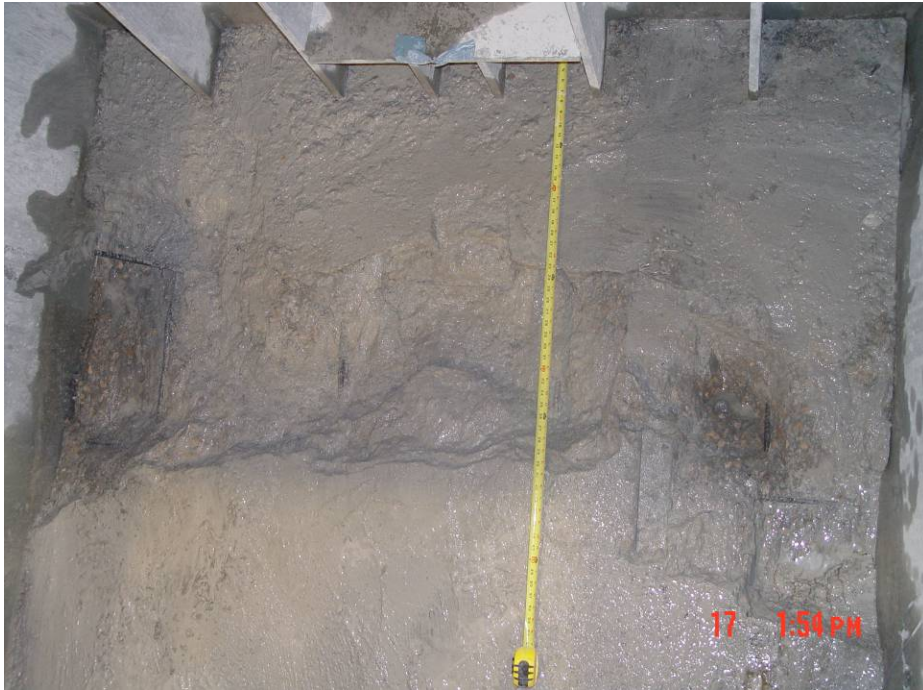
Figure 6: Concrete Failure

At the time in the test when the load was being held, at 394 kips, the concrete capacity was exceeded, resulting in a sudden brittle failure. The concrete cylinder strength was 700 psi at the time of testing. The concrete failure is visible in the top portion of the bottom slab, see Figures 26 and 27. This region has little confinement with the exposed face and shear studs only extending 4 inches into the 27 inch slab, at a spacing of 23 inches. Two strain gages, G109 and 11, located on the top of the bottom slab at 4'-10" from the diaphragm on the hold down side revealed that the concrete in the bottom slab was under distress during the load hold. Figure 28 is a plot of load versus micro-strain, using the average of gages G109 and 11, and depicts increasing strain while the load was held constant at 394 kips. By averaging the strain gages along the depth of the box at 4'-10" from the diaphragm on the hold down side and using linear extrapolation the approximate strain level at 11 inches from the diaphragm was 2148 micro-strain in the bottom fiber of the bottom slab and 1513 micro-strain in the top fiber of the bottom slab in compression. The average measured strain gradient along the depth of the box, at failure, is shown in Figure 29. This data includes the average for gages in the top flange, web and bottom slab. The stress-strain curves for three cylinders of the bottom slab concrete are given in Figure 10. The

The failure mechanism for the given setup was a sudden brittle concrete failure that occurred after elastic buckling of the steel bottom flange at low load levels. The bottom flange buckling could potentially be resolved by using a tighter spacing of studs closer to the support which would reduce the buckling length. This also could provide additional confinement to the concrete. A higher capacity could be obtained; however, this would still entail a sudden concrete failure if the entire section is required to achieve plasticity. For designs of this type the bottom concrete slab and bottom steel flange are composite requiring that the strain levels in the materials match. The concept of achieving the full plastic moment capacity is not possible due to the concrete bottom slab's inability to withstand strains equal to the yield strain of the steel bottom flange. In this particular case, the bottom steel flange yielded at 2750 micro-strain. The concrete failed at approximately 2230 micro-strain in compression. The double-composite design should be limited in design, in negative moment regions, to achieving full plasticity in the top flange only.

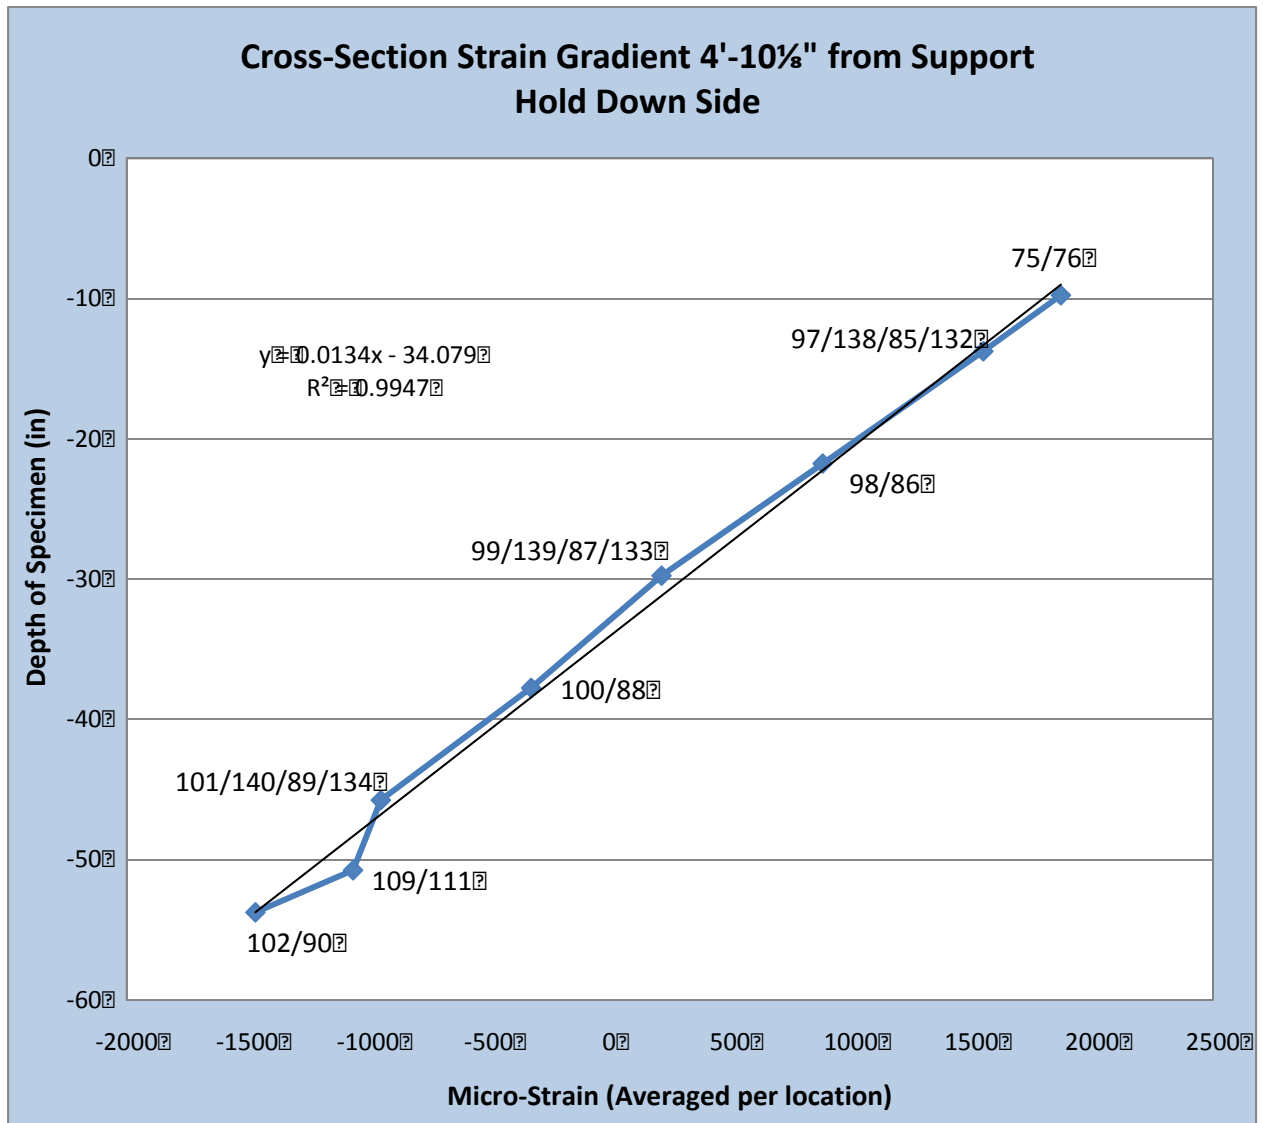
Figure 9: Strain Gradient at 4'-10 1/8" from Support – Hold Down Side

average maximum failure strain for the three cylinders is 2230 micro-strain. The situation for the Double Composite is similar to a cylinder test in that due to the position of the neutral axis there is a small strain gradient across the depth of the bottom slab, however, the cylinders were tested at the ASTM prescribed load rate, as opposed to a held load in the double composite test. Concrete fails at lower stresses under sustained load.
