Testing of Trelleborg Structural Plastics

Written by: David Wagner
Reviewed by: Jerry Hocking, P.E.

Introduction:

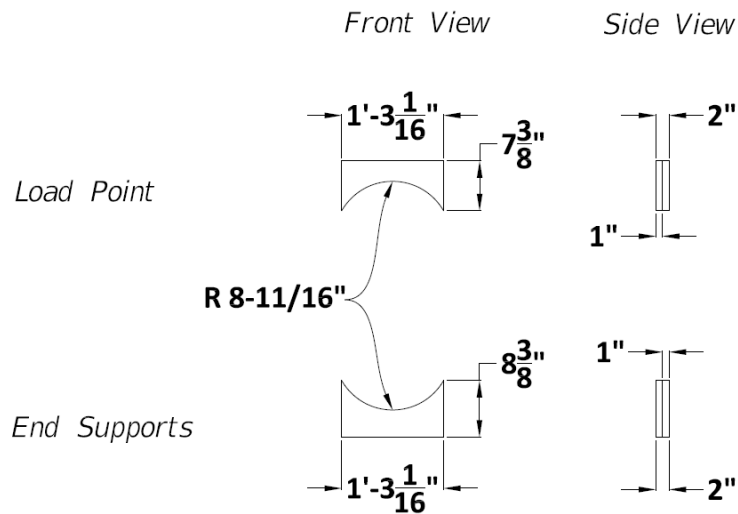
Figure 3: End Supports for CP Test Setup

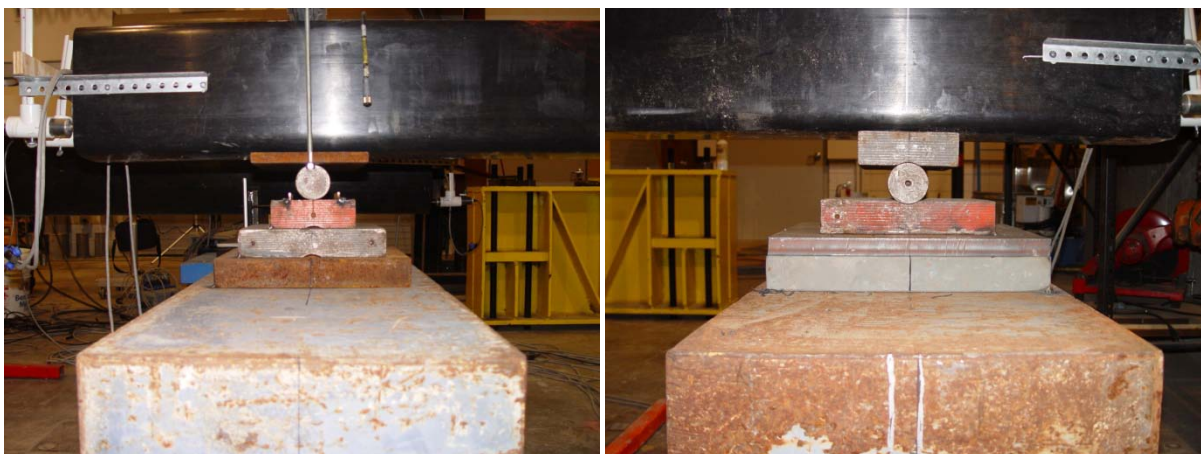
Figure 5: North Roller Support (left) and South Rocker Support (Right) for SCL Test Setup

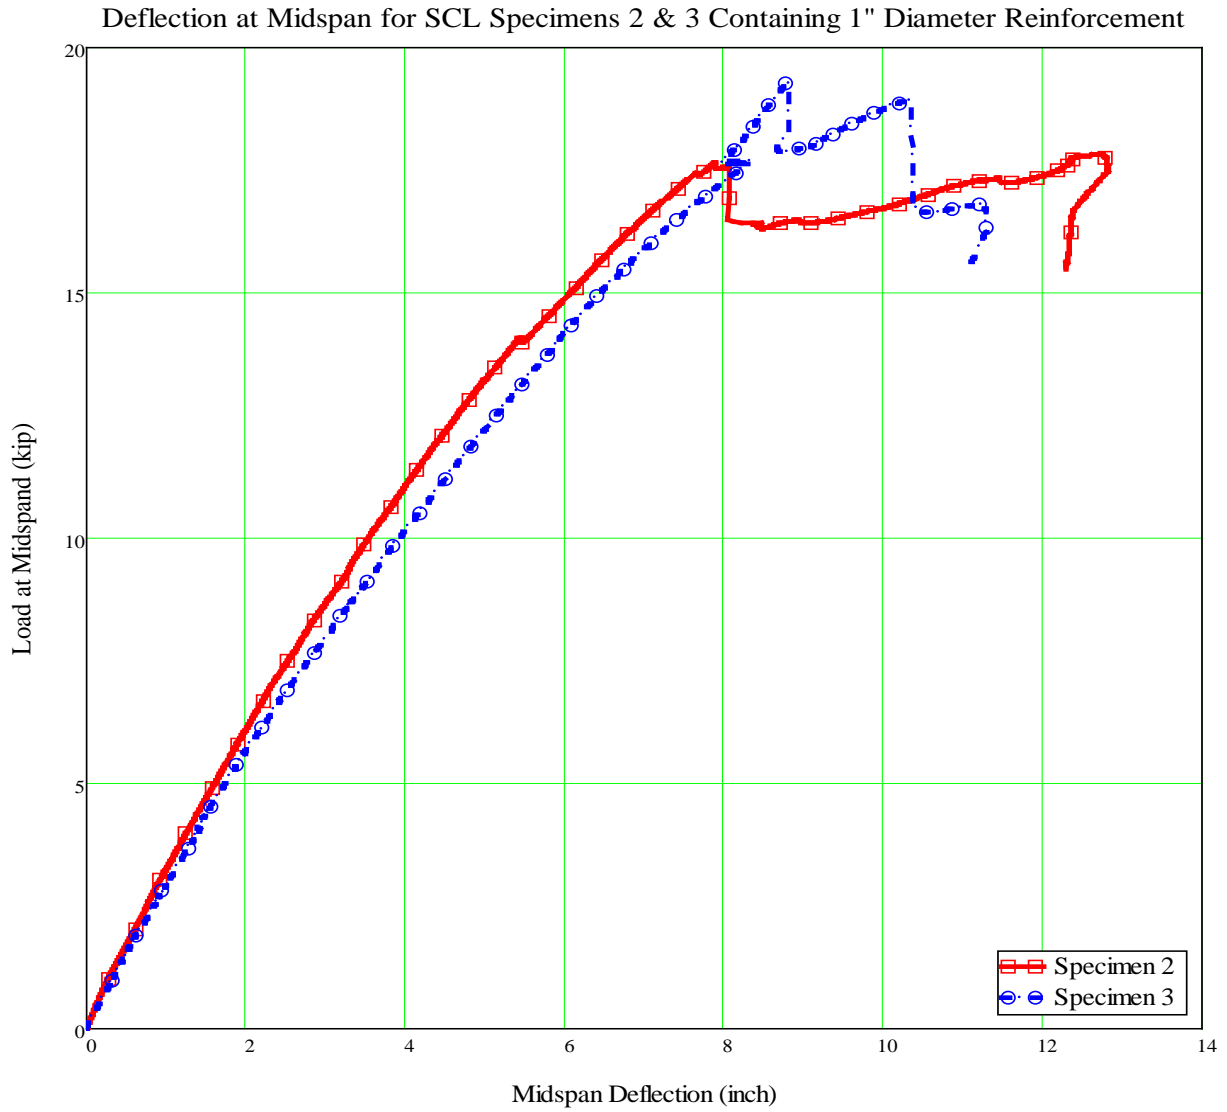
Figure 6: Deflection Curves for SCL Specimens with 1" Diameter Fiberglass Reinforcement

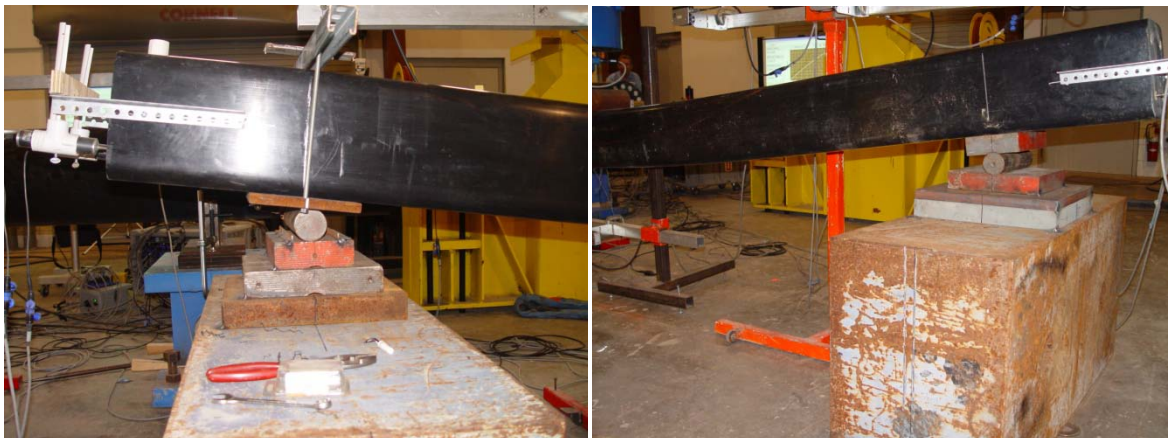
Figure 7: North Roller Support and South Rocker Support during Testing

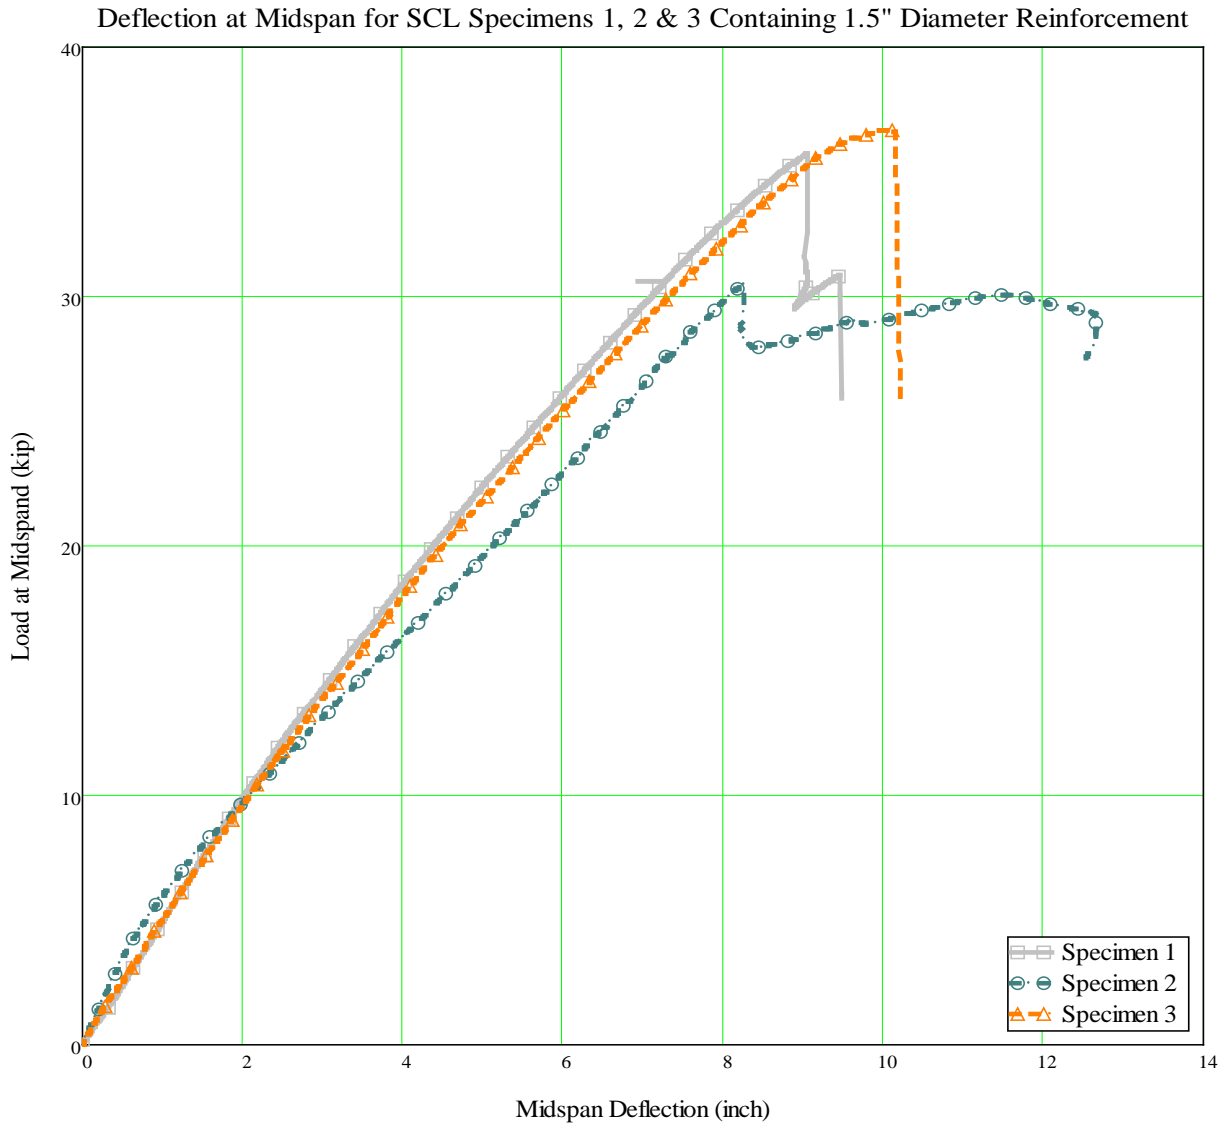
Figure 8: Deflection Curves for SCL Specimens with 1.5” Diameter Fiberglass Reinforcement

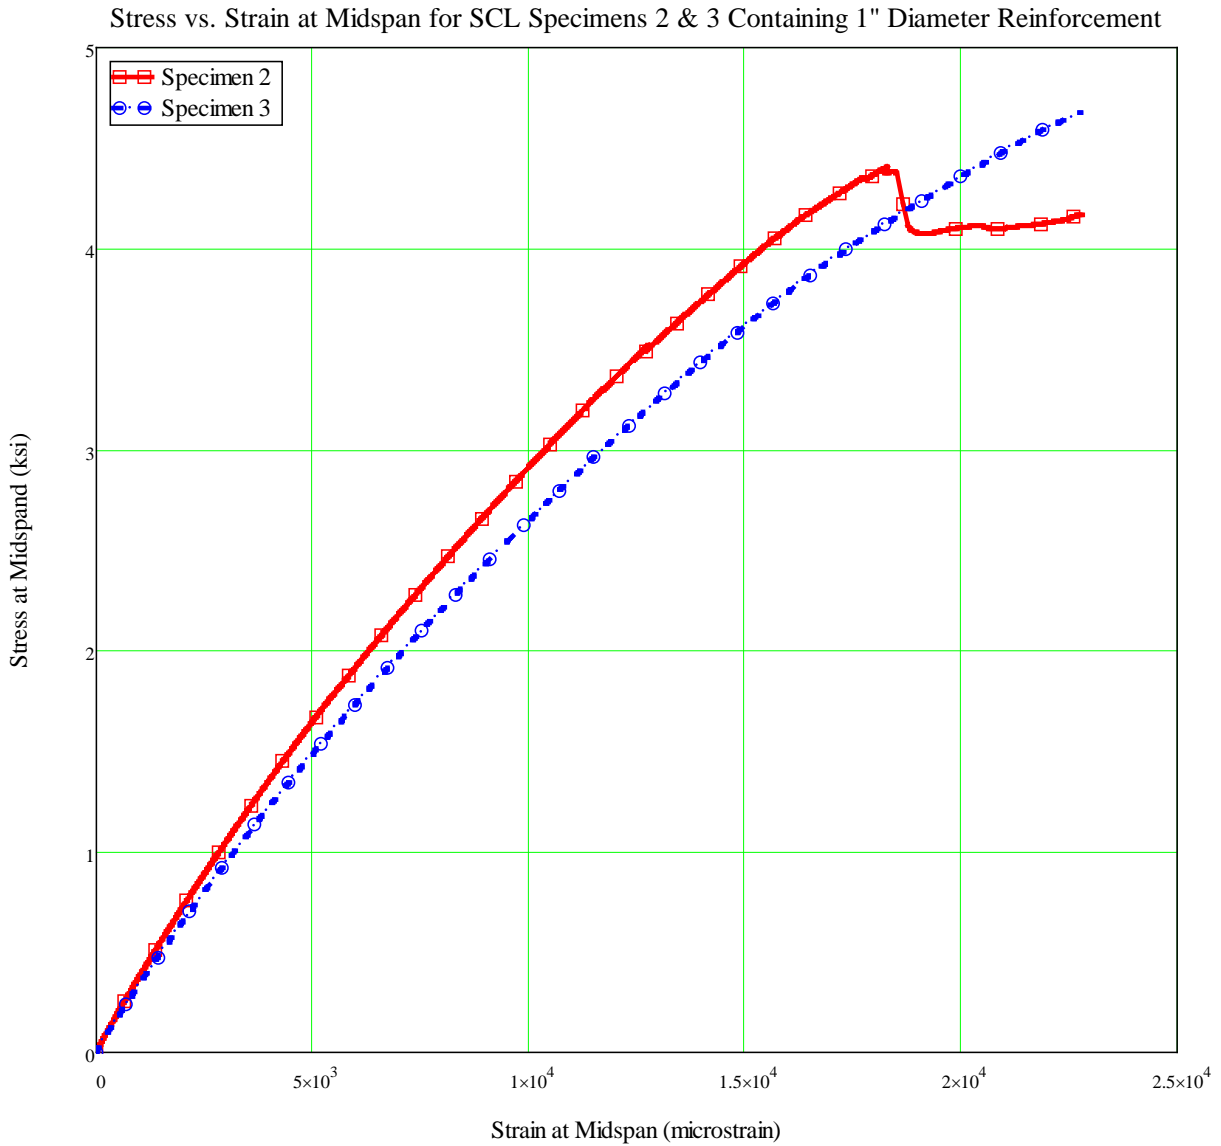
Figure 10: Strain Curves for SCL Specimens with 1" Diameter Fiberglass Reinforcement

The data sets collected are accurate but there are a couple issues worth noting with a few of the graphs and photos presented above. The stress vs. strain plots in Figures 10 & 12 are not truly complete. The highest strain the data acquisition system was set to read the strain gauges was just above 22,800 microstrain. This is why the graphs in Figures 10 & 12 all terminate at the same point in relation to the x-axis. This was not an issue with the CP specimens because they did not reach that high a level of strain before failure. The absence of a full set of strain data for the SCL specimens is thought to be inconsequential seeing as strain data far beyond 1% strain were recorded and displayed and the stress at 1% strain was used to calculate the modulus of elasticity per ASTM D6109. Also of note is the failure depicted in Figure 13. It should be known that the specimen shown in Figure 13 which is a SCL specimen with 1.5” diameter reinforcing was the only specimen to experience rupture failure. Even though all other specimens experienced breaking or slipping of the fiberglass reinforcement they all rebounded mostly to their original state with only a couple inches of permanent deflection at midspan and a surface dimple where the load was applied. Table 3 lists the averaged structural properties for each specimen type.

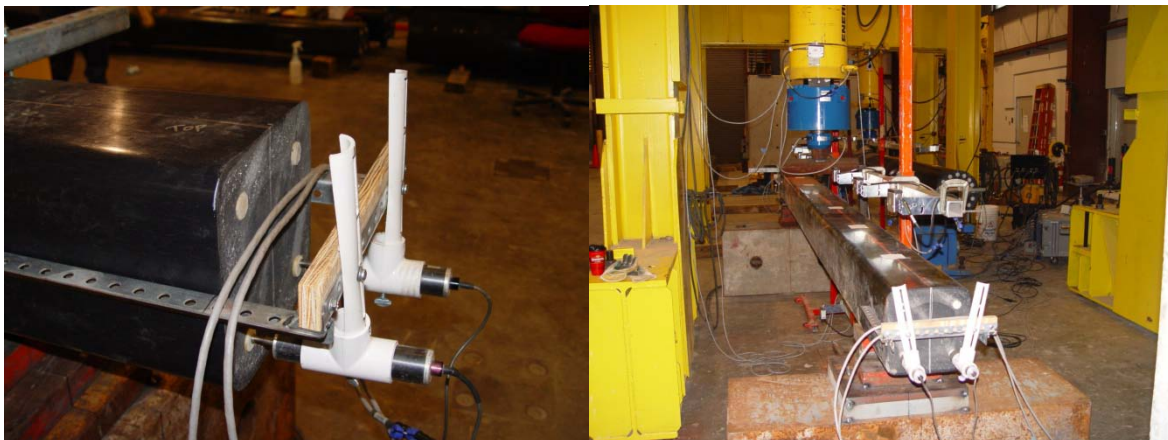
Figure 11: Deflection Gauge Setup for Detecting Slip of Reinforcement for SCL Specimens

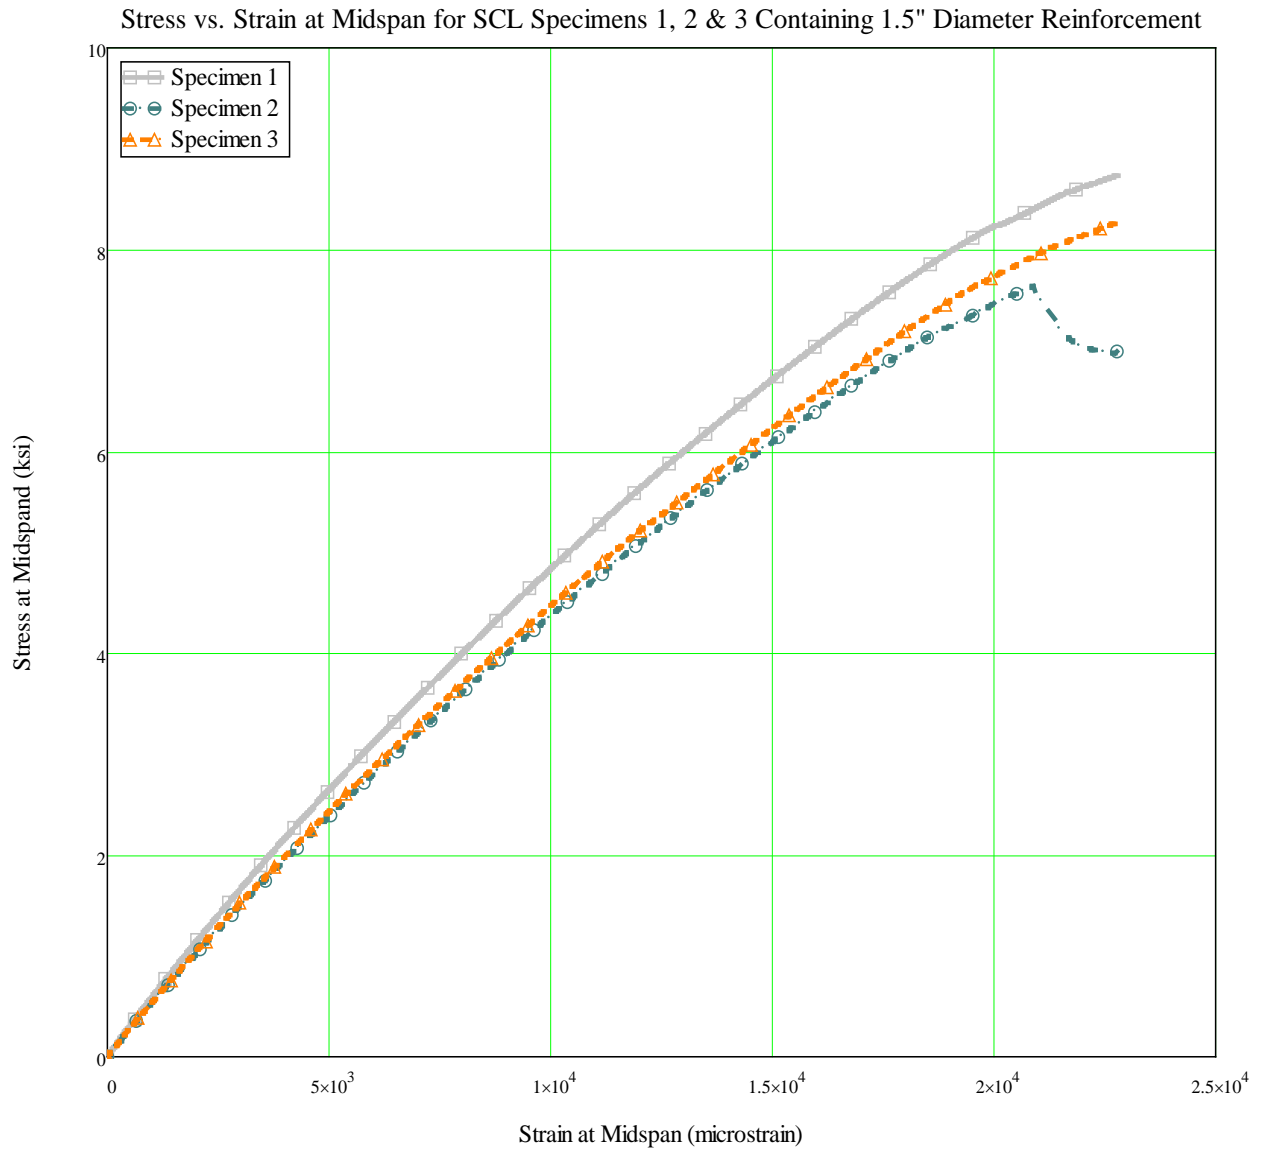
Figure 12: Strain Curves for SCL Specimens with 1.5" Diameter Fiberglass Reinforcement

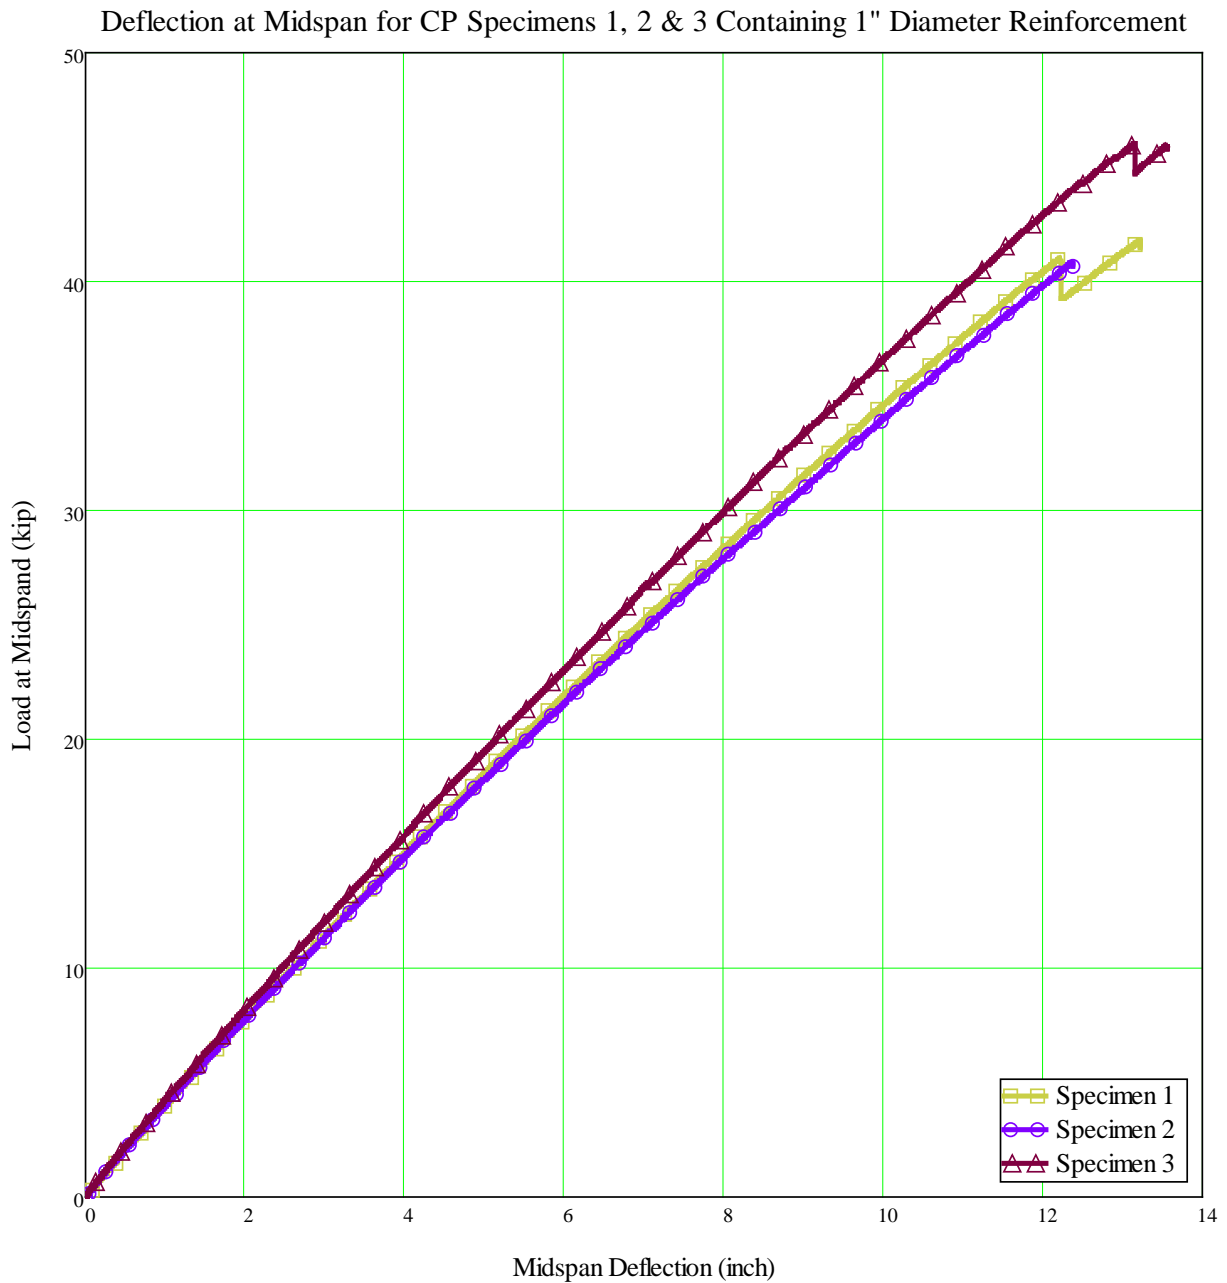
Figure 14: Deflection Curves for CP Specimens with 1" Diameter Fiberglass Reinforcement

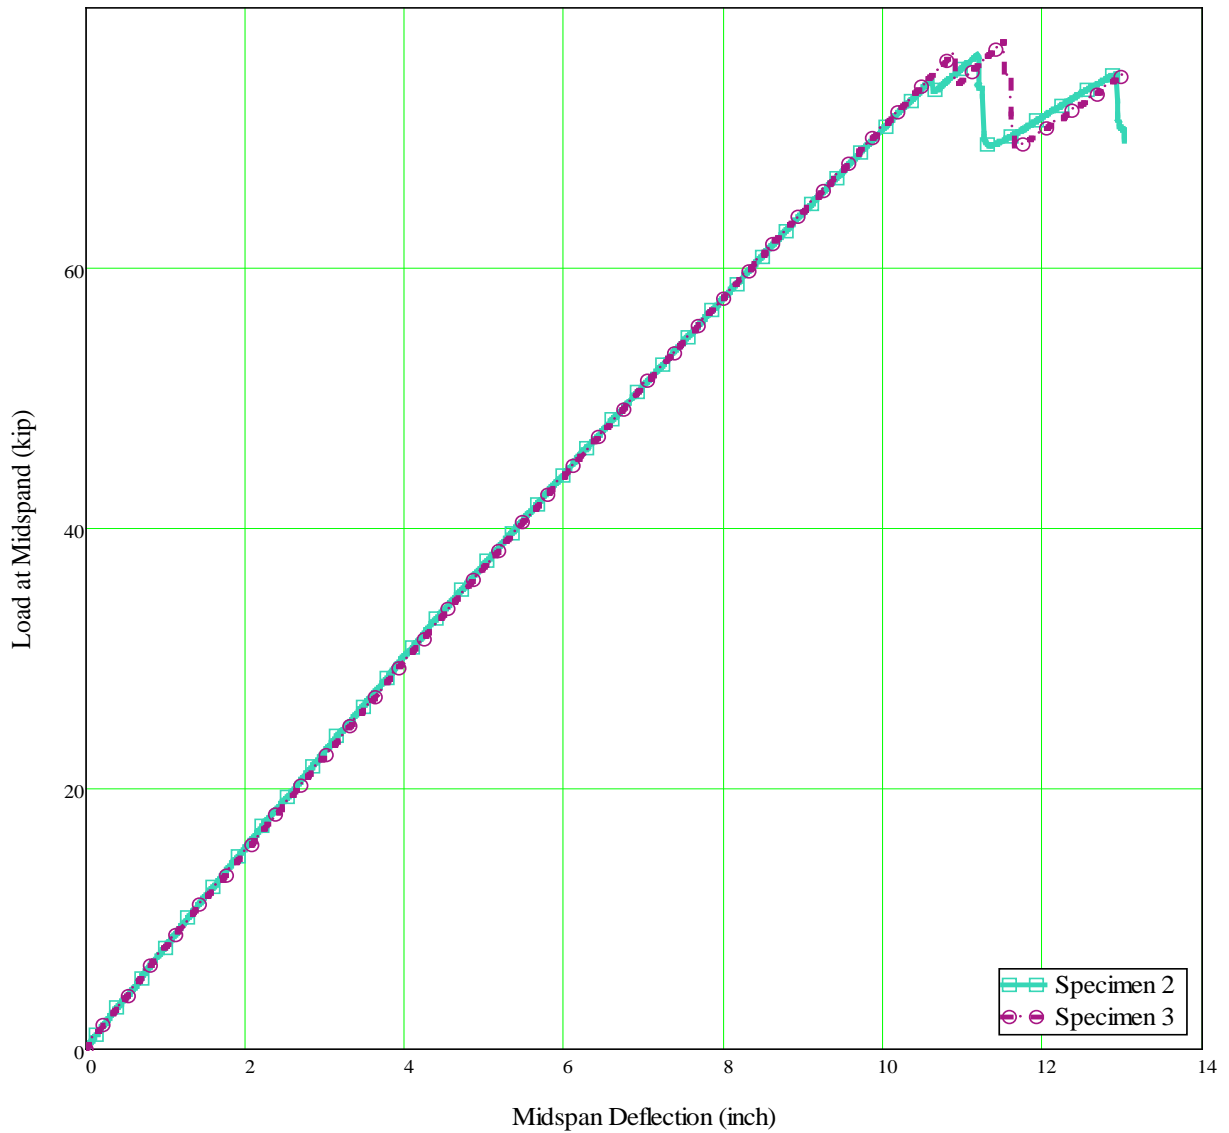
Deflection at Midspan for CP Specimens 2 & 3 Containing 1.5" Diameter Reinforcement

Figure 15: Deflection Curves for CP Specimens with 1.5" Diameter Fiberglass Reinforcement

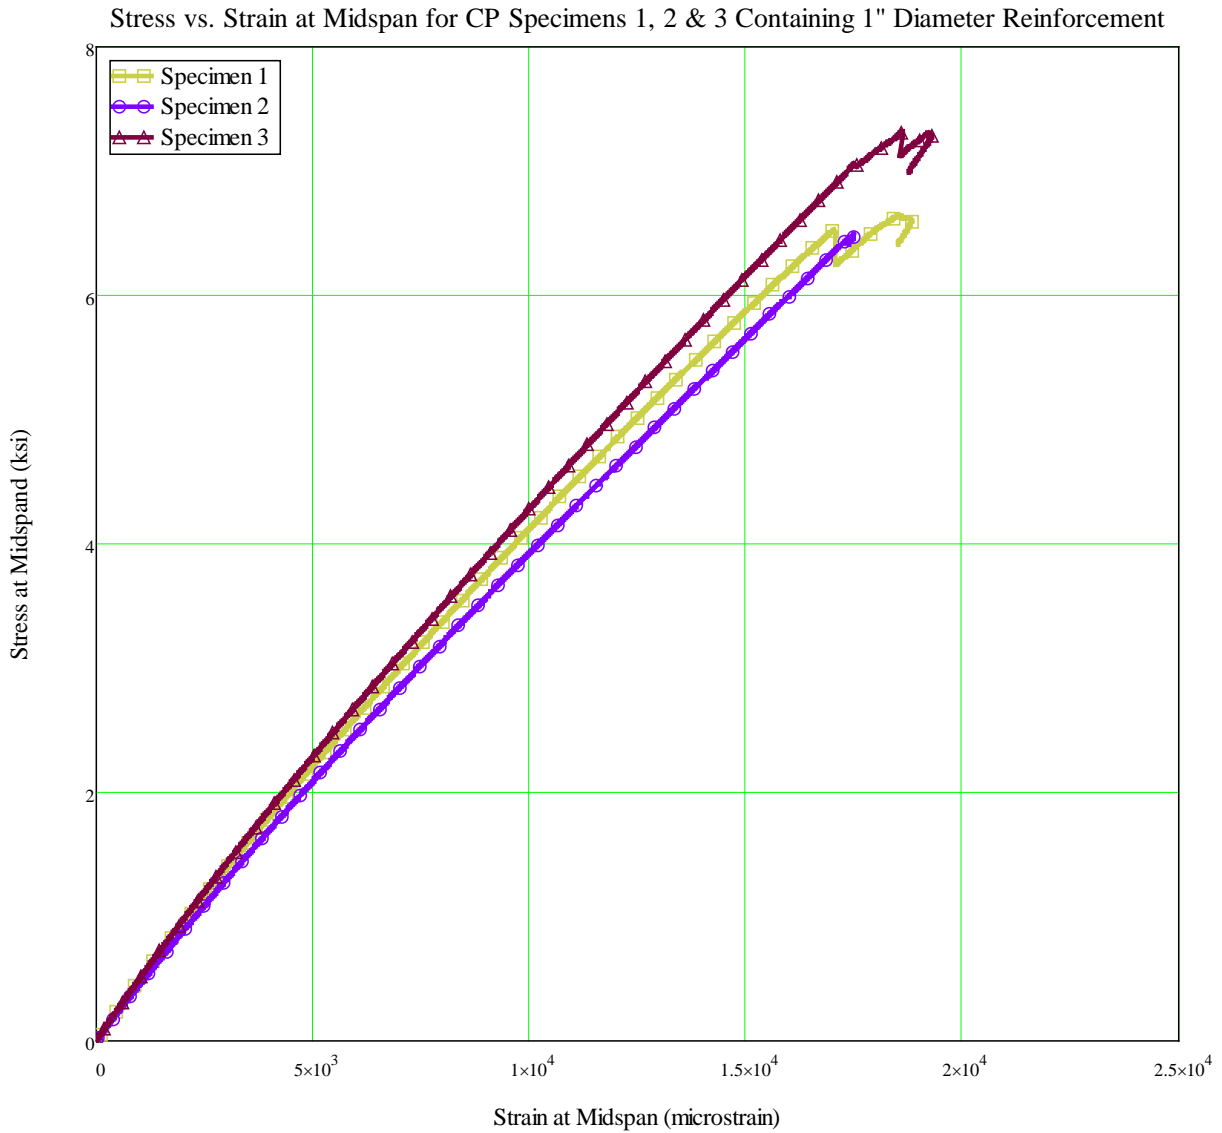
Figure 17: Strain Curves for CP Specimens with 1" Diameter Fiberglass Reinforcement

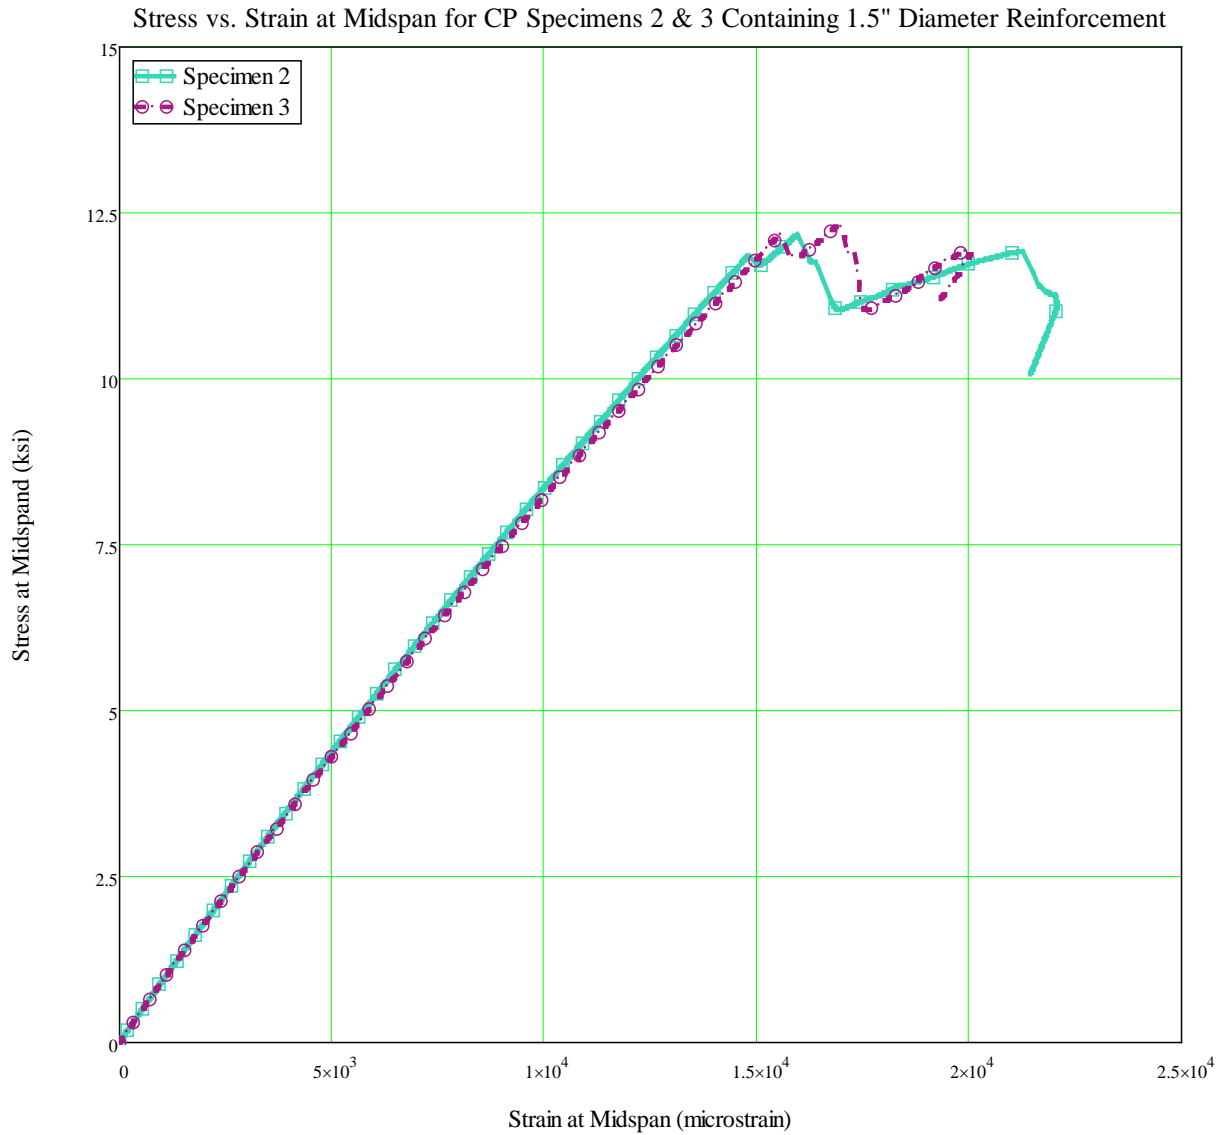
Figure 19: Strain Curves for CP Specimens with 1.5" Diameter Fiberglass Reinforcement

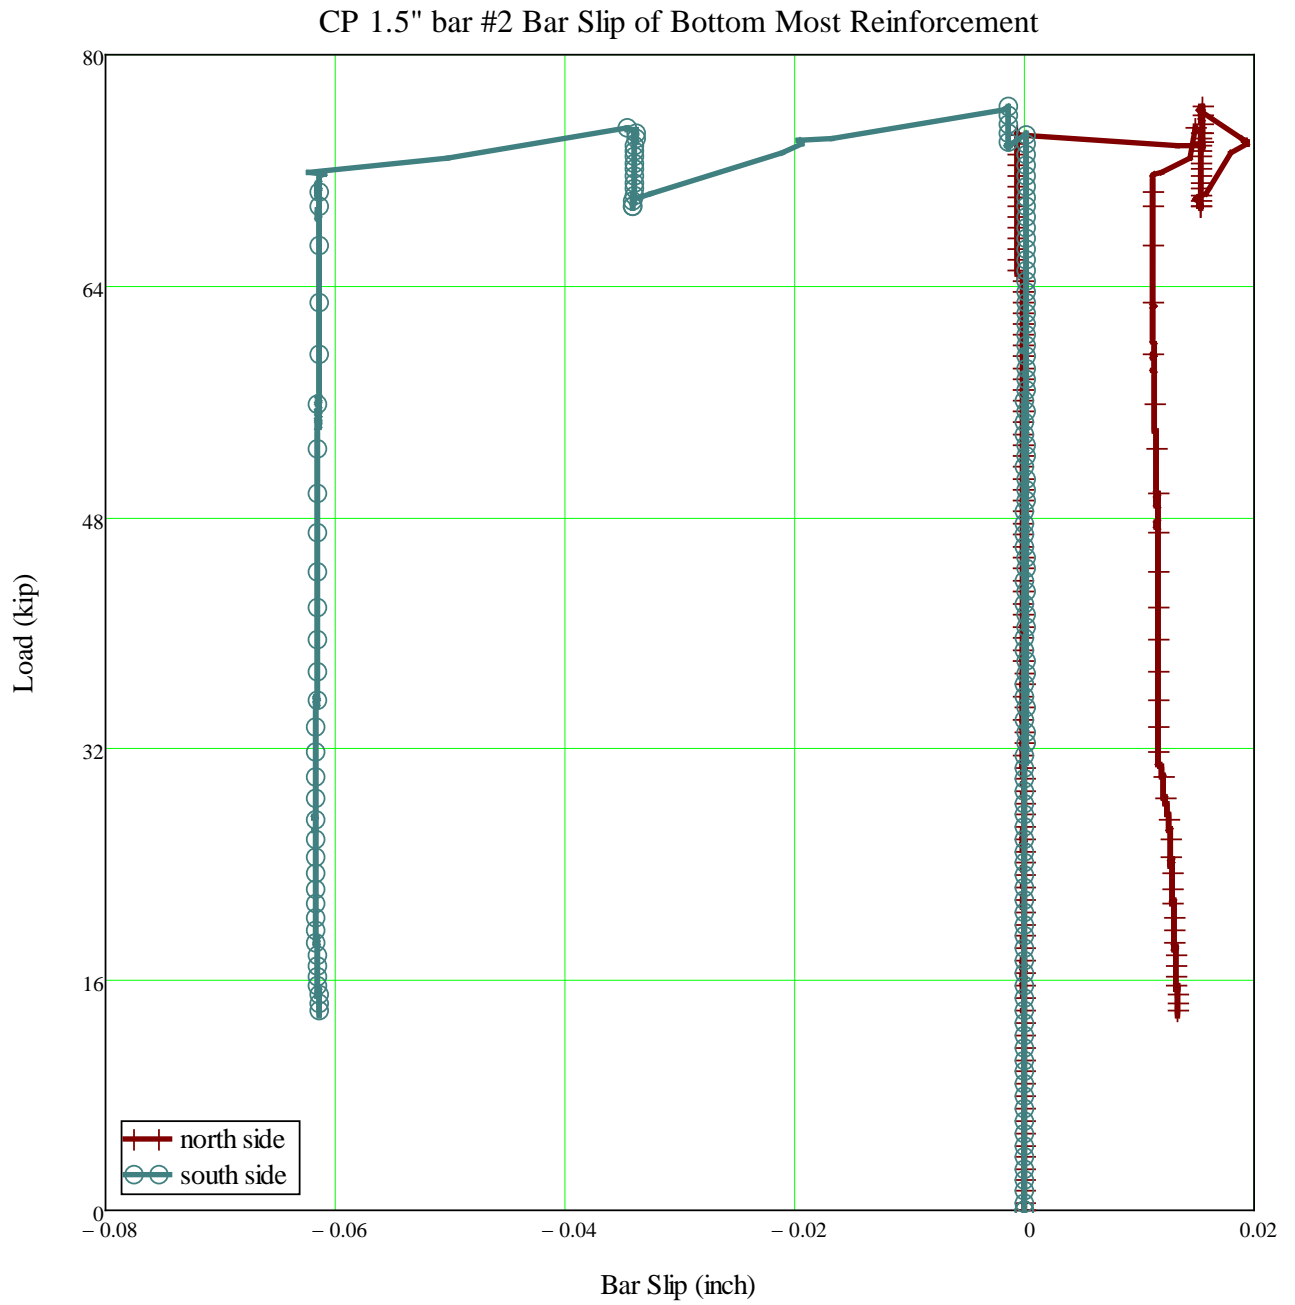
Figure 21: Slip of Reinforcement during CP_1.5-2 Testing

During testing popping and cracking sounds could be heard. These sounds are believed to be slipping or breaking of the fiberglass reinforcing bars. Review of the data shows that notable (though small) movements of the reinforcement coincide with failure of the member. Figures 21 & 22 are plots for bar slip of a couple of the more obvious examples. A negative value on the “Bar Slip” axis marks the reinforcement is moving inside of the member, away from the deflection gauge and a positive value that the bar is moving outside the member. Table 4 gives stress and strain values for when the first sizeable bar movement occurred for the specimens we have a full set of strain data for.

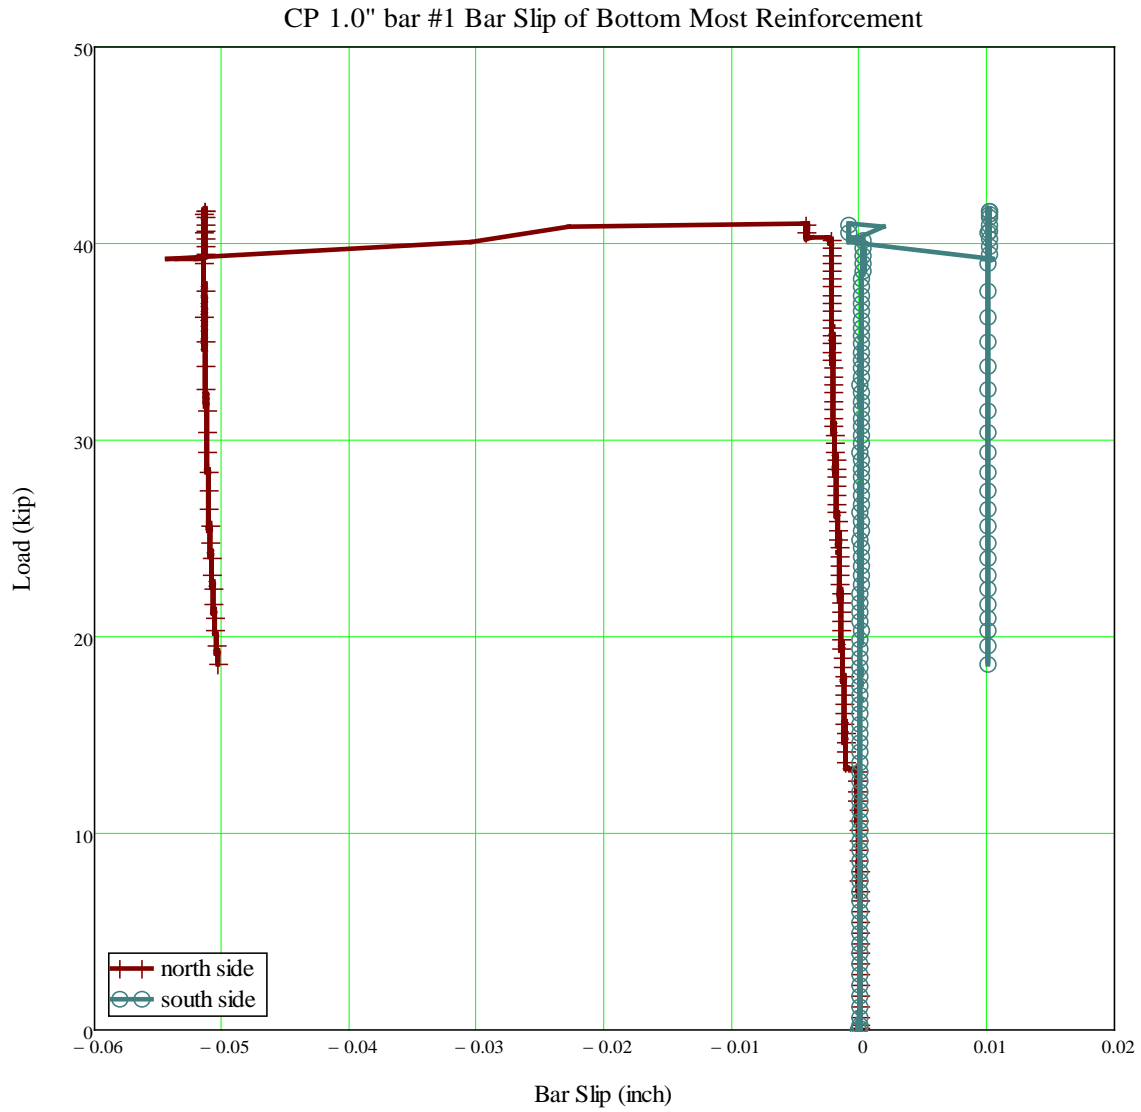
Figure 22: Slip of Reinforcement during CP_1.0-1 Testing

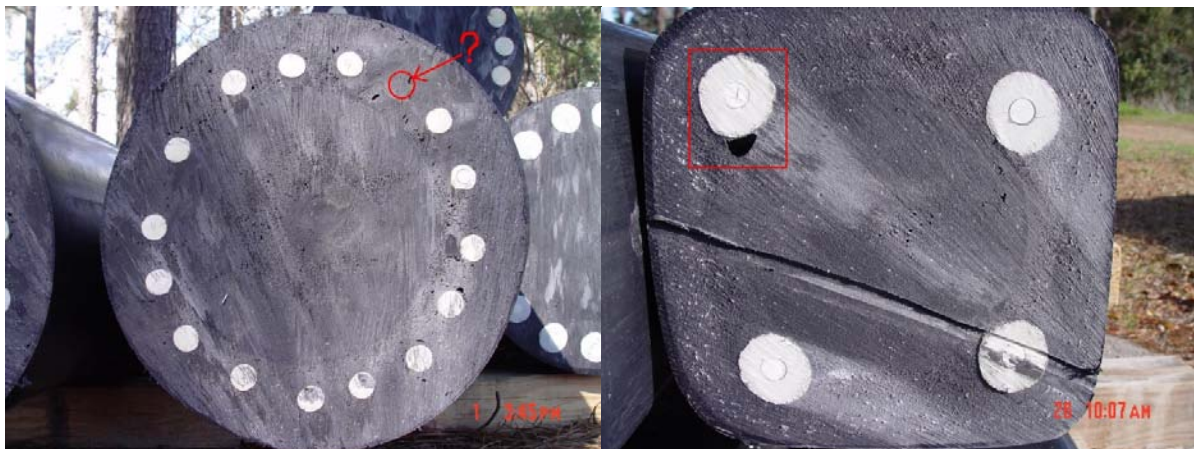
Figure 23: Possible Issues a Structural Plastic Member May be Rejected for

A final note is that a careful field inspection of the materials provided by the manufacturer should be done to make sure all structural plastics are: 1) free of large voids especially along the edge of the reinforcement 2) not cracked or split, 3) have no voids or cracks in fiberglass reinforcement, 4) the reinforcing bars are properly spaced and 5) the required minimum number of reinforcing bars are present. Figure 23 shows a couple examples of what to look for that were found on two of the specimens provided by Trelleborg. There appears to be a reinforcing bar missing in the CP specimen of the left picture of Figure 23. All sixteen reinforcing bars were present on one side of the specimen but not on the other leaving the consumer to wonder where along the span the missing bar stopped. Perhaps a specification should be written to require that the vendor drill out the end of the pile at the location of a “missing” bar to show that the bar is within a certain distance from the end of the pile. In the right picture of Figure 23 a large void is seen right alongside a 1.5” diameter reinforcing bar. If this is a frequent occurrence the strength of the bond between the reinforcing bars and the plastic member may become a concern.
