Assessment of Highway-Railroad Grade Crossing Strategies, Countermeasures, and Technologies to Improve Traffic Safety and Mobility in Florida

Final Report

Project Number: BED25-977-08

USF Center for Urban Transportation Research

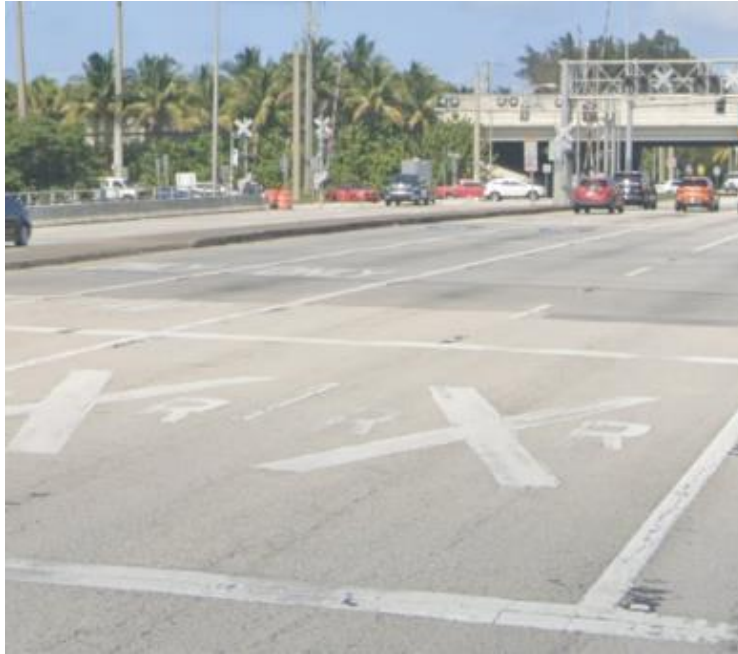
As shown in Figure 2-2, pavement markings provide advance indications and aim to prevent confusion so that the number of improper turns can be effectively diminished at HRGC tracks. Pavement markings aim to: (a) convey to drivers where to place their vehicles, (b) inform drivers about upcoming situations, and (c) specify where passing is allowed (4).

Figure 2-2. Pavement Marking Upstream of a Railroad Crossing
(Source: Google Maps)

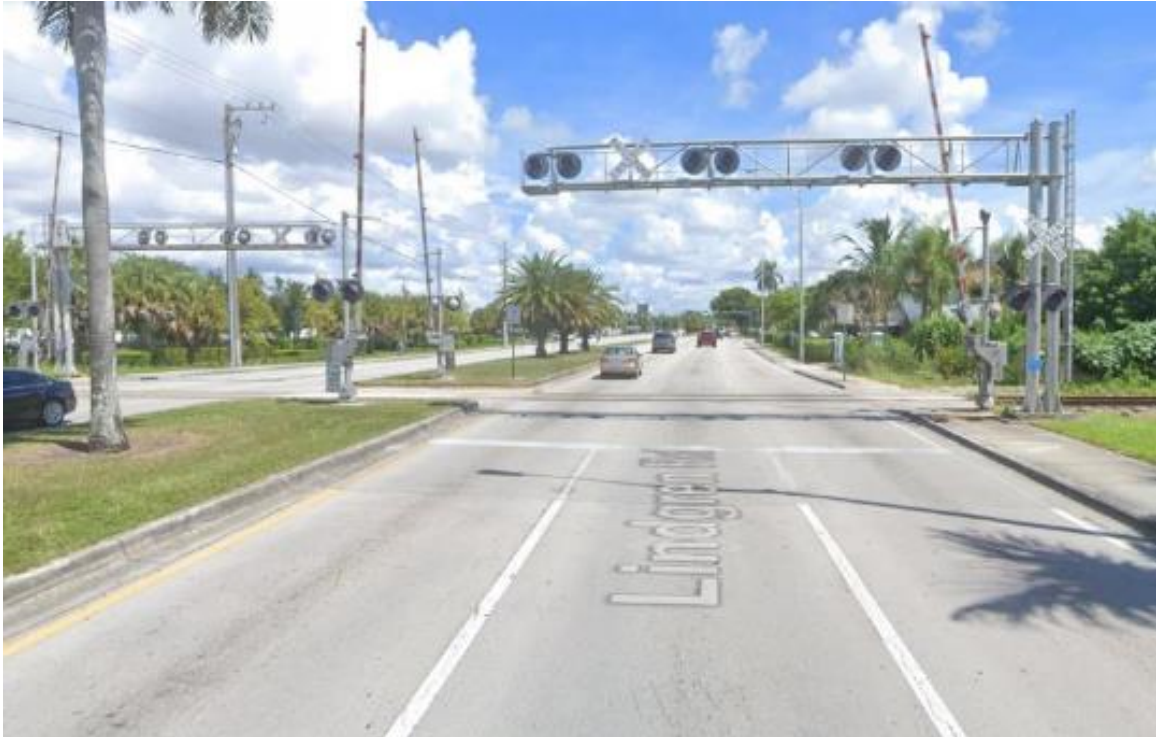
Active grade crossings constitute active warning and control devices, including bells, flashing lights, and gates (12). Active traffic control systems inform road users of the approach or presence of trains at grade crossings. These systems include four-quadrant gate systems, automatic gates, flashing-light signals, actuated blank-out, variable message signs, and traffic control signals. An example of an active HRGC with flashing-light signals and a four-quadrant gate is shown in Figure 2-4.

Figure 2-4. An Active Quadrant Gate
(Source: Google Maps)

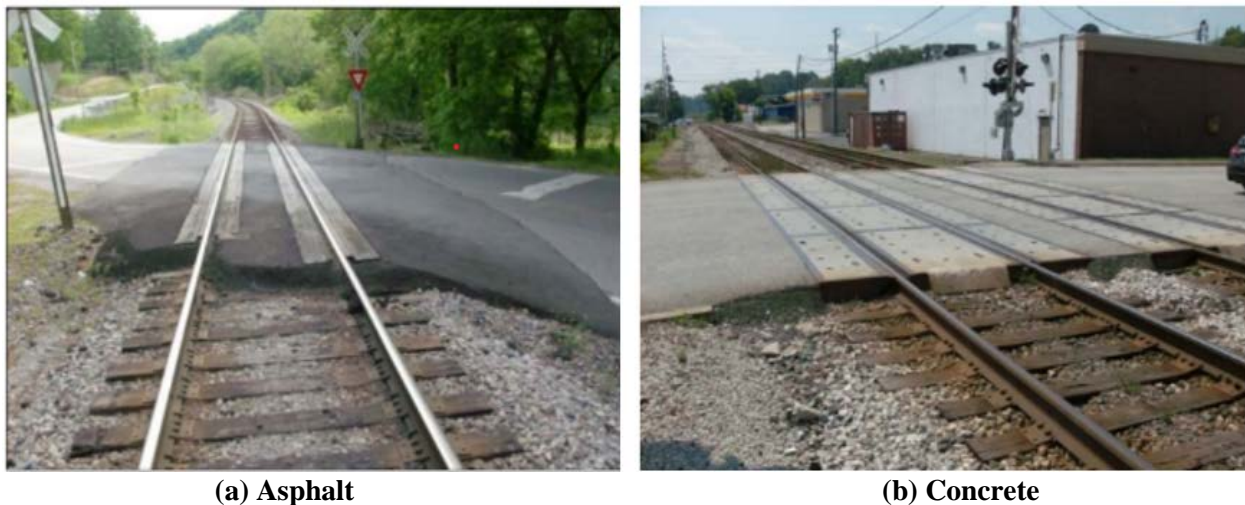
Illinois, Indiana, Iowa, Georgia, Michigan, and West Virginia have successfully developed standard grade crossing management practices (44). Crossing attributes, such as crossing surface type, affect safety at HRGCs (31). A smooth structure of the crossing surface is vital for many reasons, including expanding lifespan, maintaining cost control, and minimizing the number of stuck/stalled vehicles (44). It is common to observe large numbers of crossings with unpaved (all-granular) track beds that deteriorate rapidly compared to the paved track bed, as shown in Figure 2-7. One of the issues that stem from unpaved rail and road intersections is stuck/stalled vehicles. Meanwhile, standard highway-rail grade crossing attributes such as a flat surface are essential to avoid stalling of vehicles across railroad tracks.

Figure 2-7. Paved Crossing Track Beds and Surfaces (44)

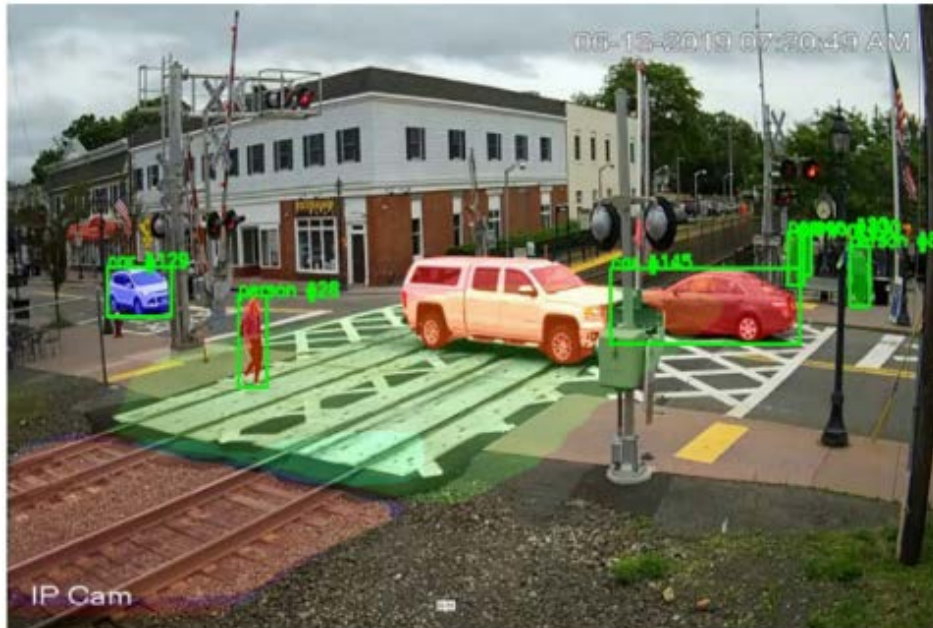
as shown in Figure 2-9. This software automates the detection of grade crossing violations and trespass activities from static camera video feeds (64). The main purpose of this project was to develop a deep learning-based computer vision tool for automating the detection of grade crossing violations and railroad right-of-way trespass activities from static camera video feeds.

Figure 2-9. Example of an Automated Video Processing at an HRGC (64)

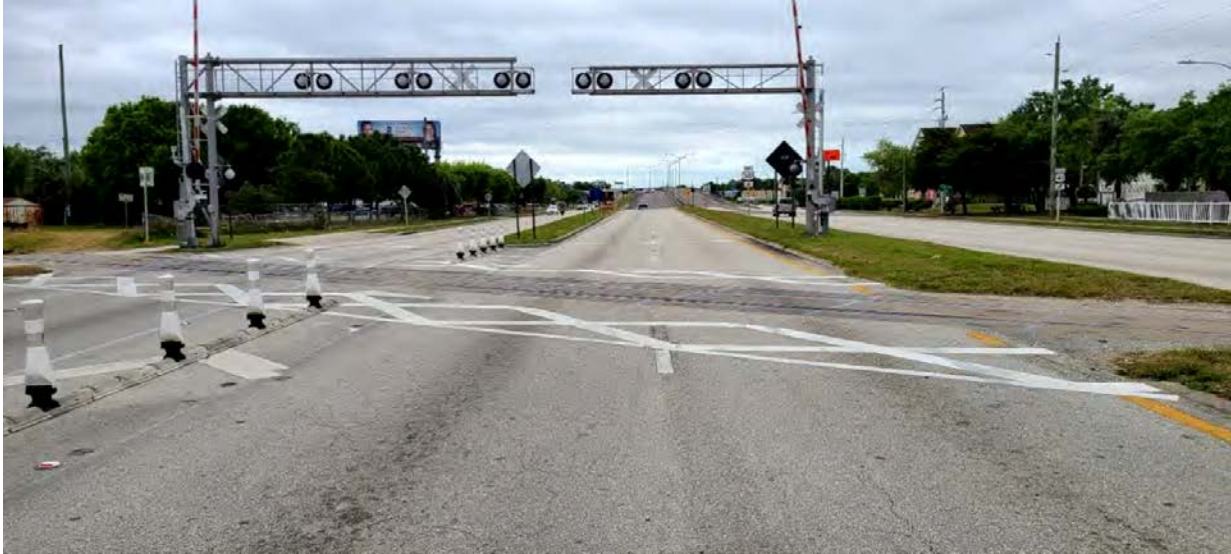
District One conducted a four-day before (pre-install of RDE) and after (post-install of RDE) data collection (video recording) and evaluation (data description). The purpose was to evaluate the effectiveness of the pavement markings placed within the dynamic envelope. Note that the location also had additional pavement markings to positively influence driver behavior and reduce the number of vehicles that come to a stop within the dynamic envelope. Figure 3-3 illustrates an implemented RDE in District One.

**Figure 3-3. Example of RDE Implementation in FDOT District 1
(U.S. 41/301 @ 13th Avenue E)**

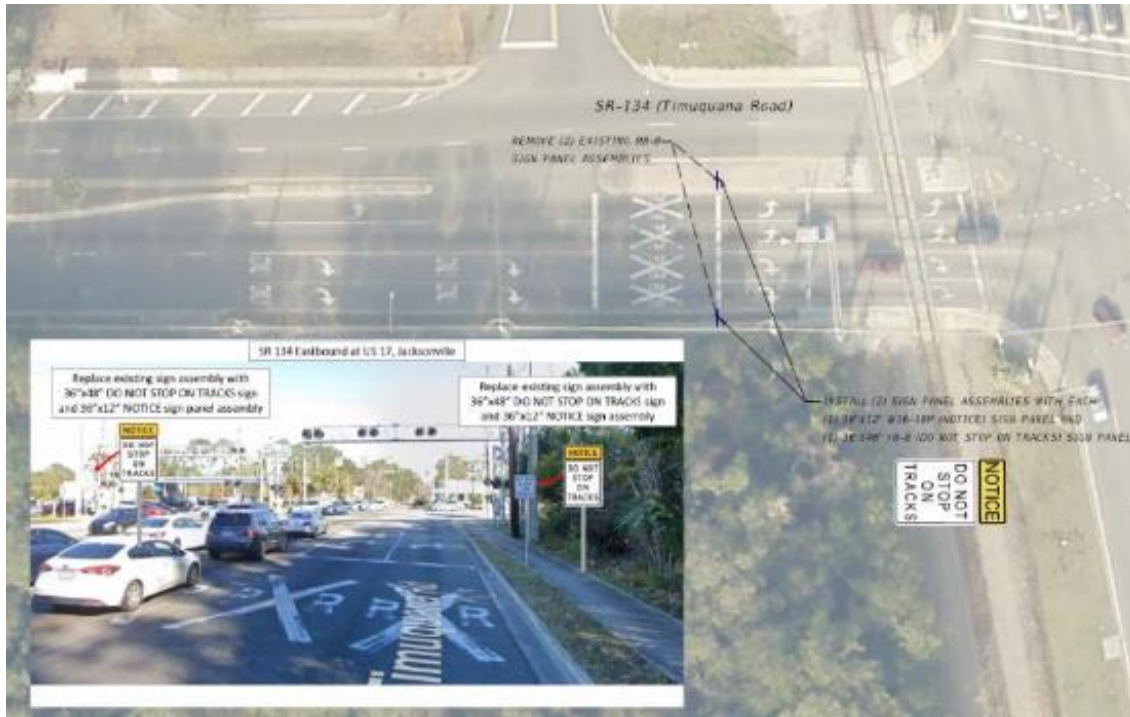
come to a stop within the dynamic envelope. Figure 3-4 illustrates an implemented RDE in District Two.

Figure 3-4. Example of RDE Implementation in FDOT District 2 (US-17/SR-15 @ SR-134)

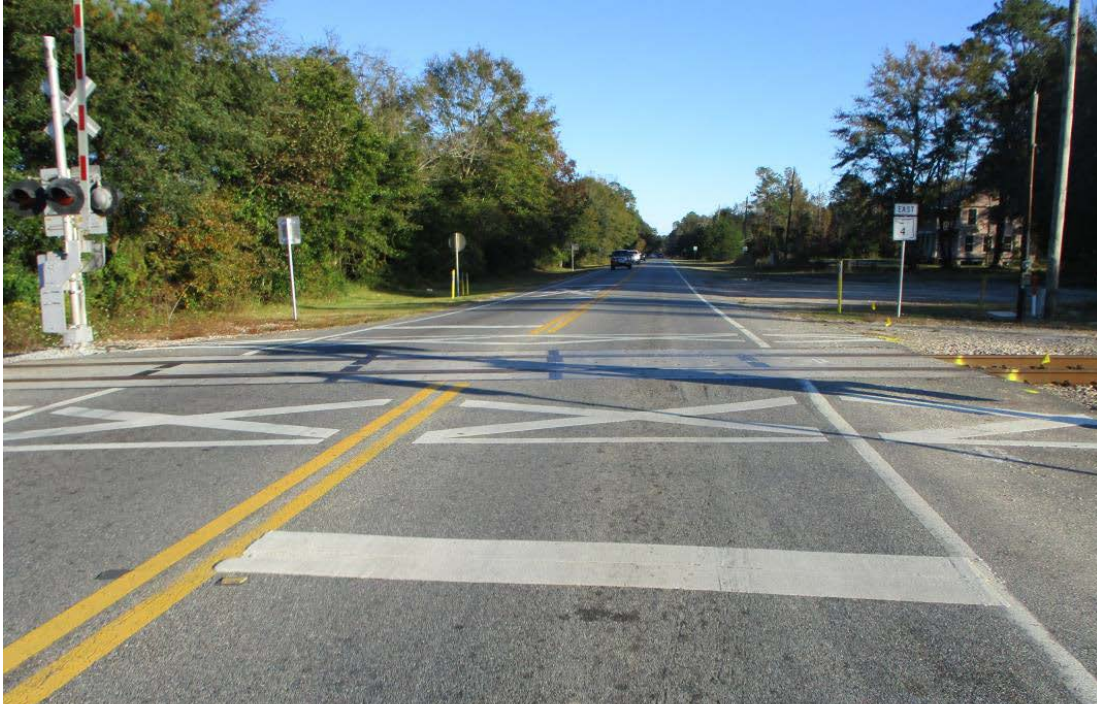
District Three conducted a four-day before (pre-install of RDE) and after (post-install of RDE) data collection (video recording) and evaluation (data presentation). The purpose of the study was to evaluate the effectiveness of the pavement markings placed within the dynamic envelope. Note that the location also had additional pavement markings to positively influence driver behavior and reduce the number of vehicles that come to a stop within the dynamic envelope. Figure 3-5 illustrates an implemented RDE in District Three.

Figure 3-5. Example of RDE Implementation in FDOT District 3 (SR-4 @ SR-95 [US-29] in Escambia County)

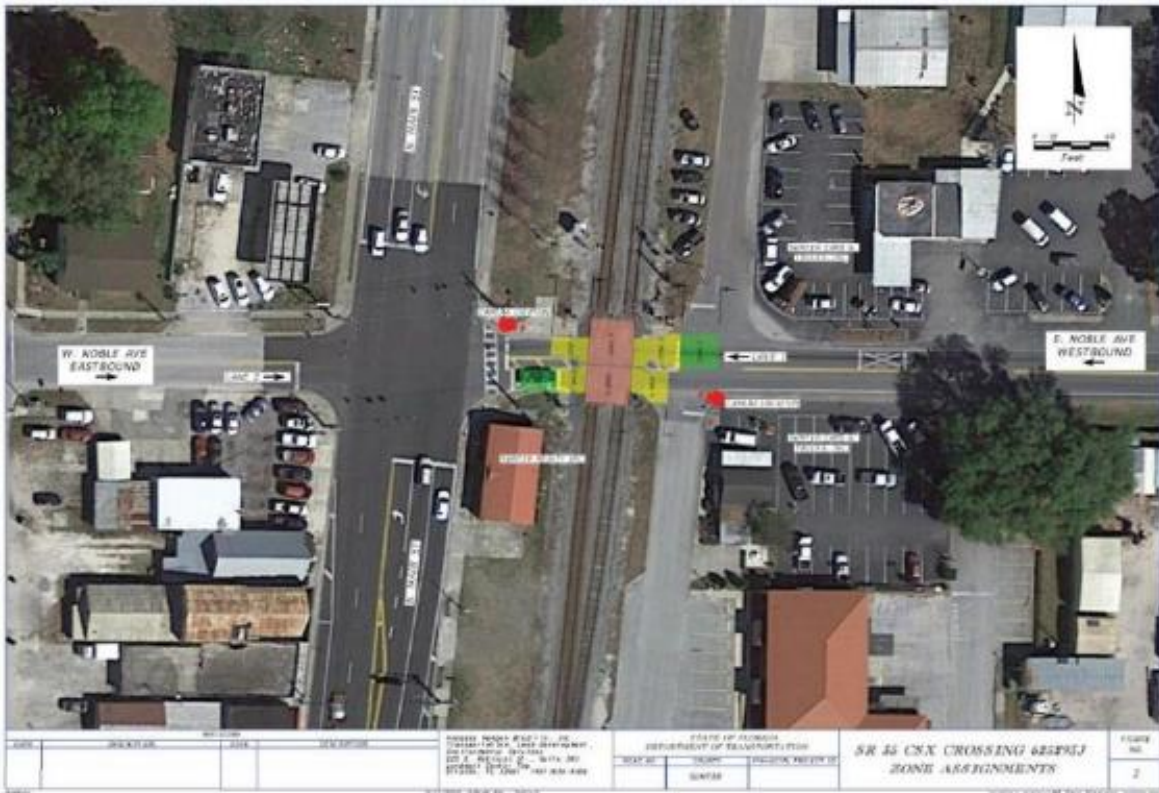
For data collection, four-day traffic data were collected covering weekday and weekend day traffic conditions. Eight-hour counts were collected during these days from 7:30 a.m. to 9:30 a.m., 11:00 a.m. to 1:00 p.m., 4:00 p.m. to 6:00 p.m., and 10:00 p.m. to 12:00 a.m. covering peak traffic conditions and off-peak nighttime conditions. The recorded traffic data were analyzed for traffic volumes by individual travel lanes and motorist stopping behavior in various assigned zones. Figure 3-7 illustrates the positioning of the cameras.

Figure 3-7. Positioning of the Cameras at an HRGC to Collect Driver’s Stopping Behaviors

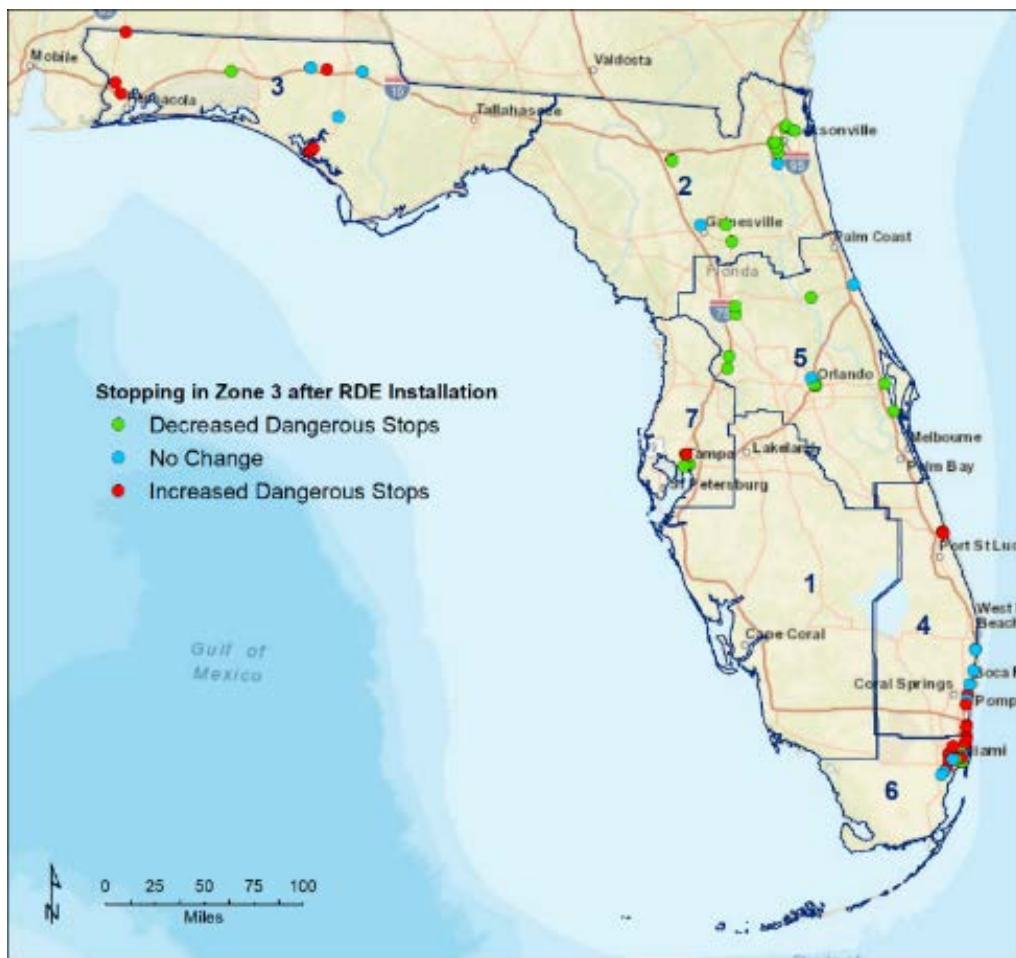
Figure 3-9 presents locations of HRGCs with positive, negative, or no change in the vehicle stoppings in Zone 3 after the RDE implementation. It could be found that after the implementation of RDE, the Zone 3 stopping behaviors were reduced in 31 locations, remained the same in 18 (the change in stopping behaviors was less than 1%), and increased in 31 crossings.

Figure 3-9. Impacts of FDOT STRIDE Program on Zone 3 Stopping Behaviors in Florida

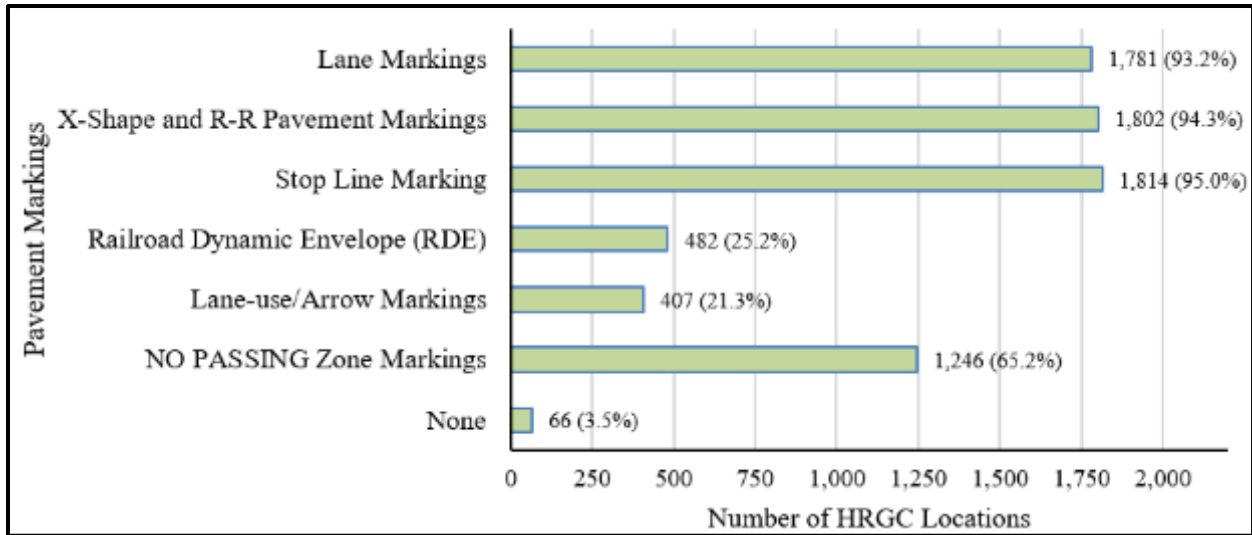
As can be inferred from Figure 4-18, the review revealed that lane markings, X and the letters RR, and STOP line markings exist in at least 93.2% of HRGCs. Despite being optional, the RDE markings were found at approximately a quarter of HRGCs. The goal of these additional markings is to reduce the number of vehicles that come to a stop within the dynamic envelope, a violation of most applicable State highway traffic laws, thus reducing the possibility that a vehicle is present on the tracks when a train approaches. Research indicates that the addition of the dynamic envelope pavement markings reduces the number of vehicles that stop within the dynamic envelope zone and increases the number of vehicles that stop properly and safely behind the stop line (6). Only 66 (i.e., 3.5%) HRGCs do not have grade crossing-related pavement markings.

Figure 4-18. Pavement Marking Types in the Vicinity of HRGCs

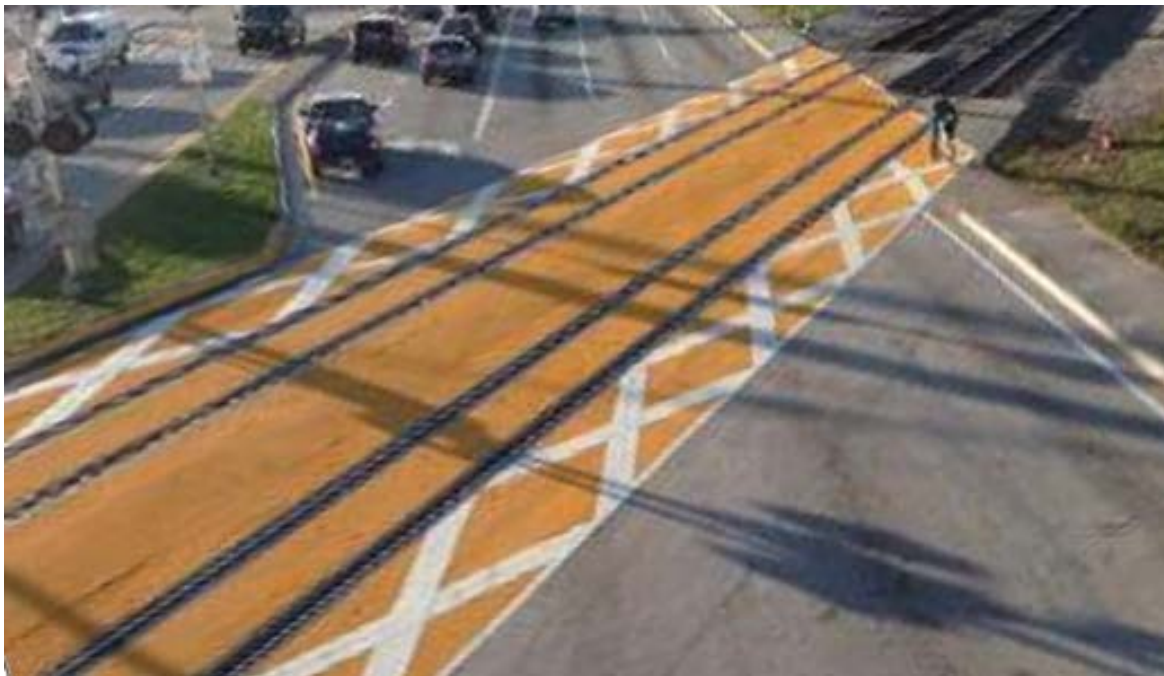
Figure 5-3. RDE on Yellow Pavement Marking Installed in District 4

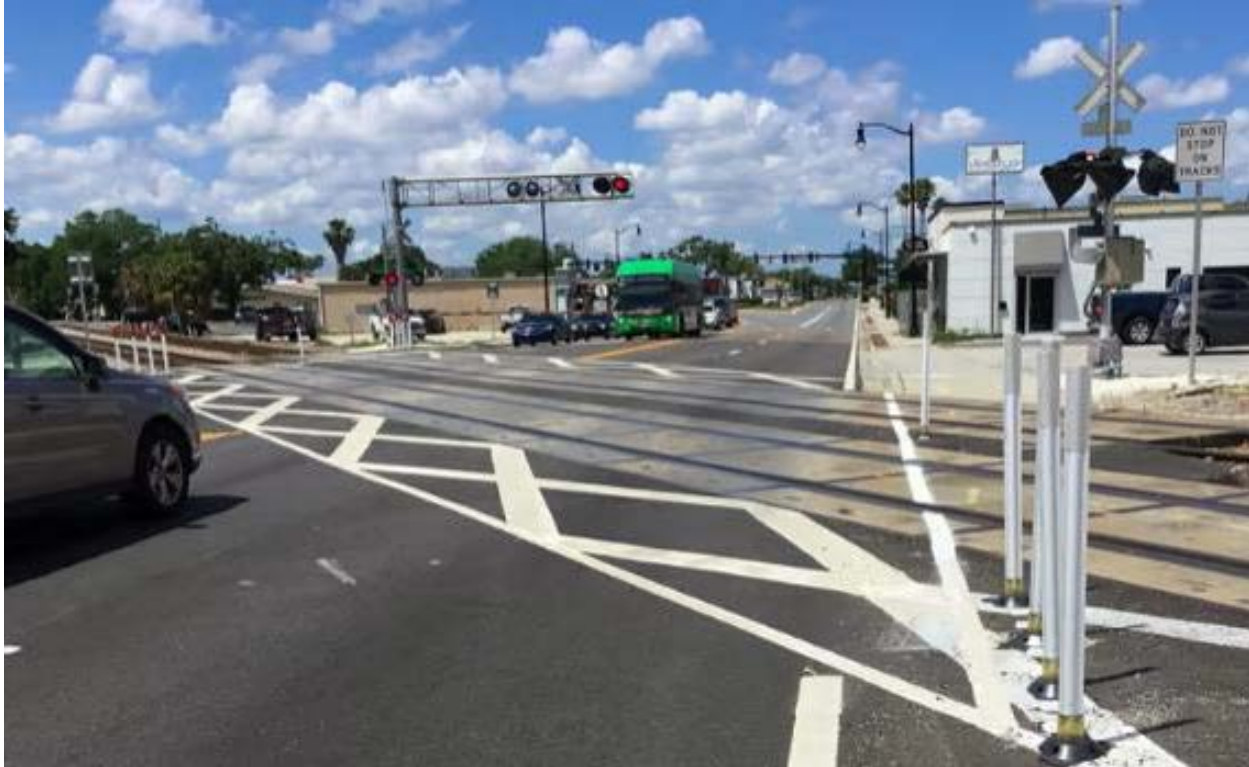
Figure 5-5. Delineators next to Railroad Tracks
(Source: <https://www.news4jax.com>)

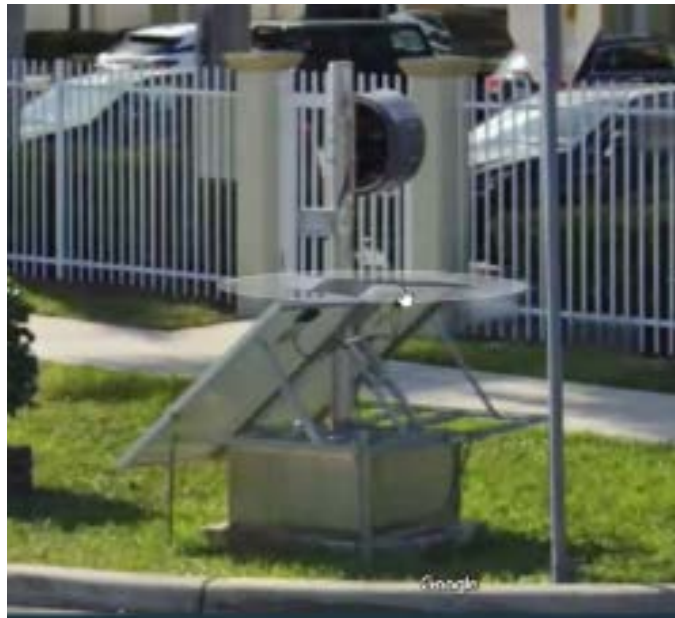
Figure 5-9. Brightline Violation Warning System in Miami, Florida

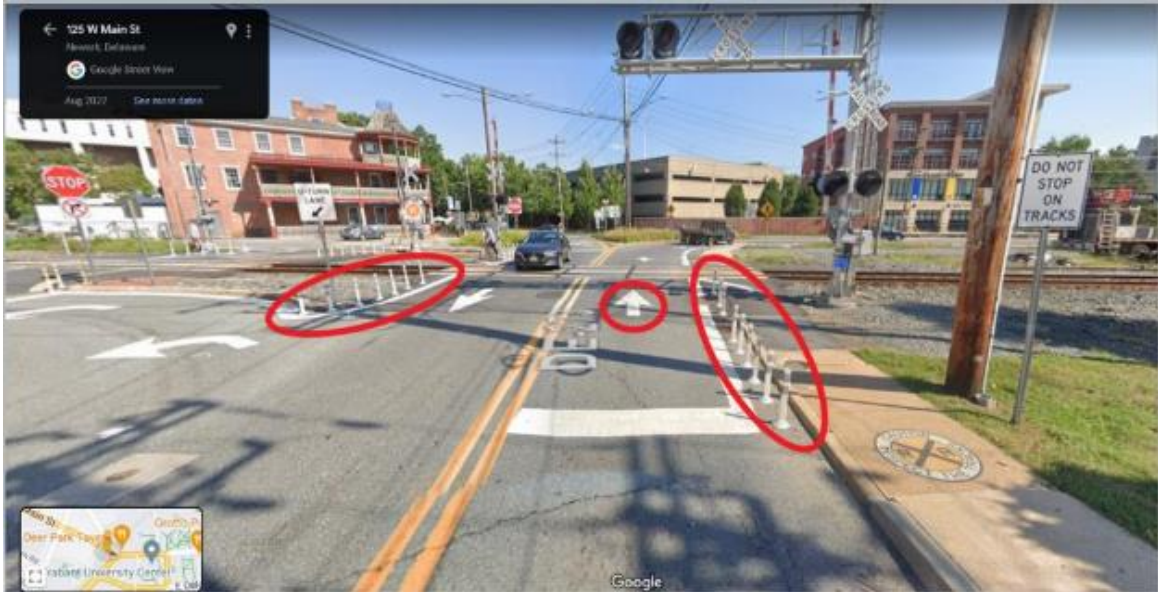
Figure 5-12. Delineators and Pavement Arrows on Eastbound at an HRGC in Newark

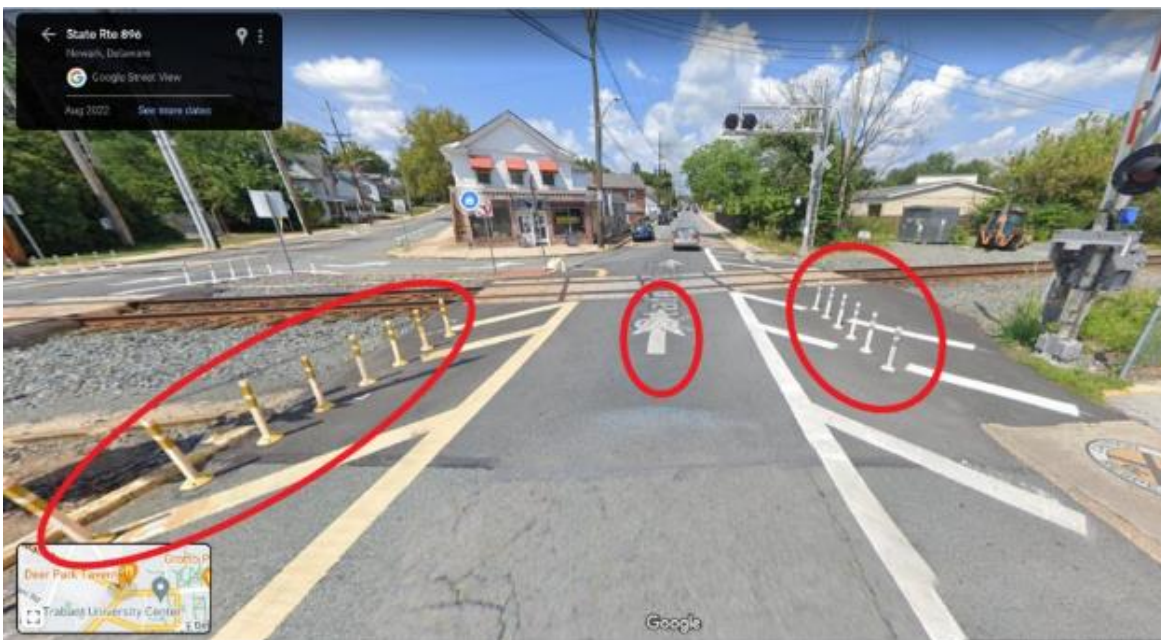
Figure 5-13. Delineators and Pavement Arrows on Westbound at an HRGC in Newark

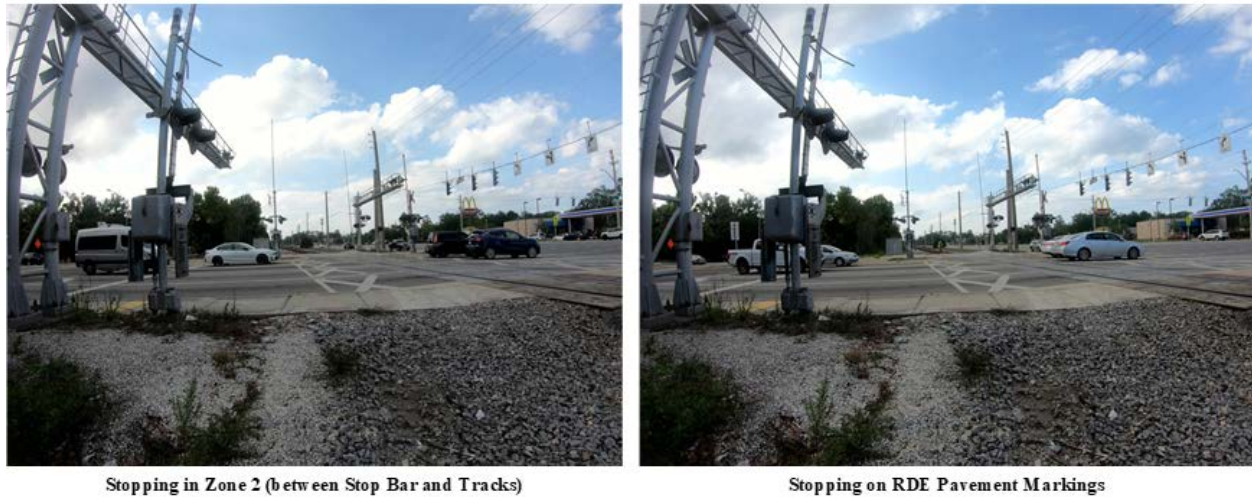
Figure 6-7. Observed Incorrect Stopping Behavior at US-17 @ SR-134, District 2

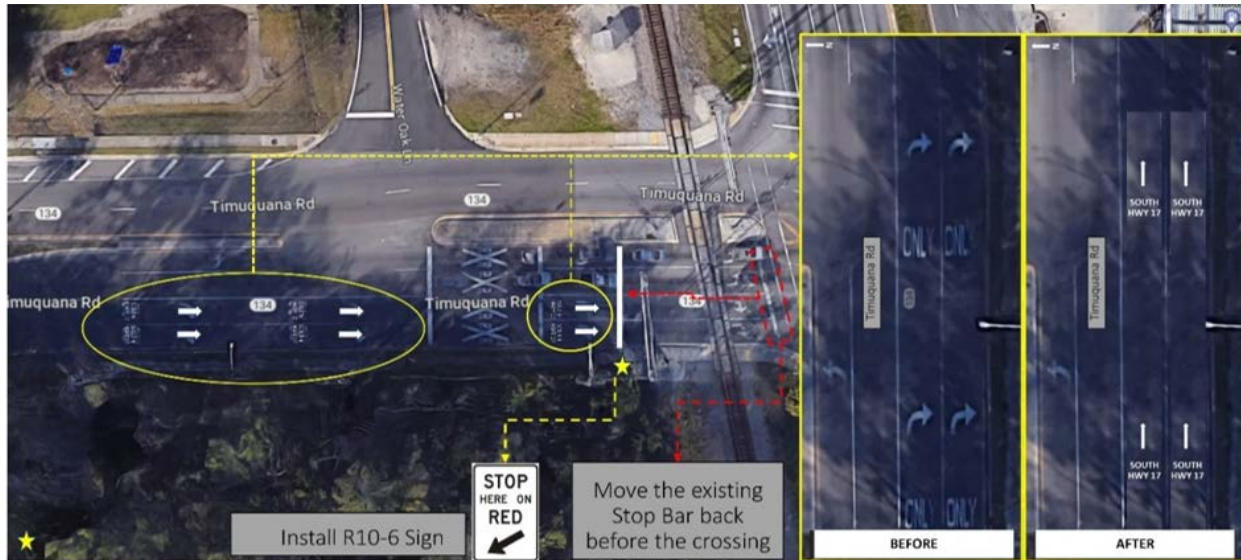
Figure 6-10. Proposed Countermeasures at US-17 @ SR-134, District 2

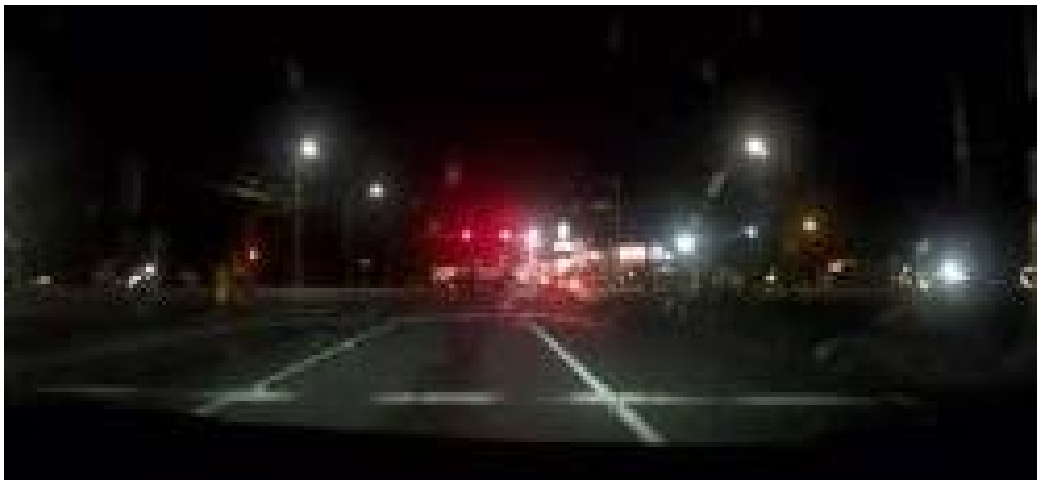
The lighting level at RDE the pavement markings and track areas are low, as shown in Figure 6-13. The foot-candle readings on the roadside near the tracks is 0.25 fc (SB) and 0.24 fc (NB).

Figure 6-13. Driver's View on RDE at Night at SR-389 @ US-231, District 3

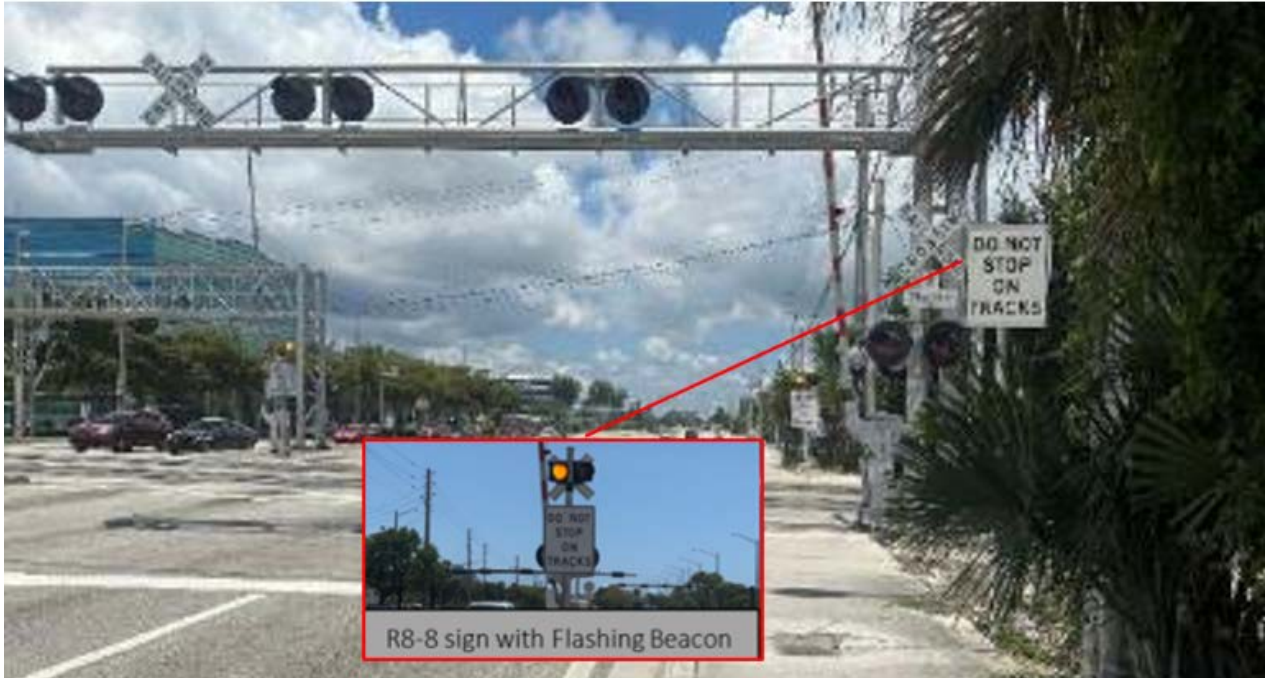
Figure 6-24. Suggested Countermeasure of R8-8 Signs at W Cypress Creek Rd @ N Andrews Ave, District 4
