Initial Report on Testing of Simulated Skyway Trestle Span Beams

December 12, 2006

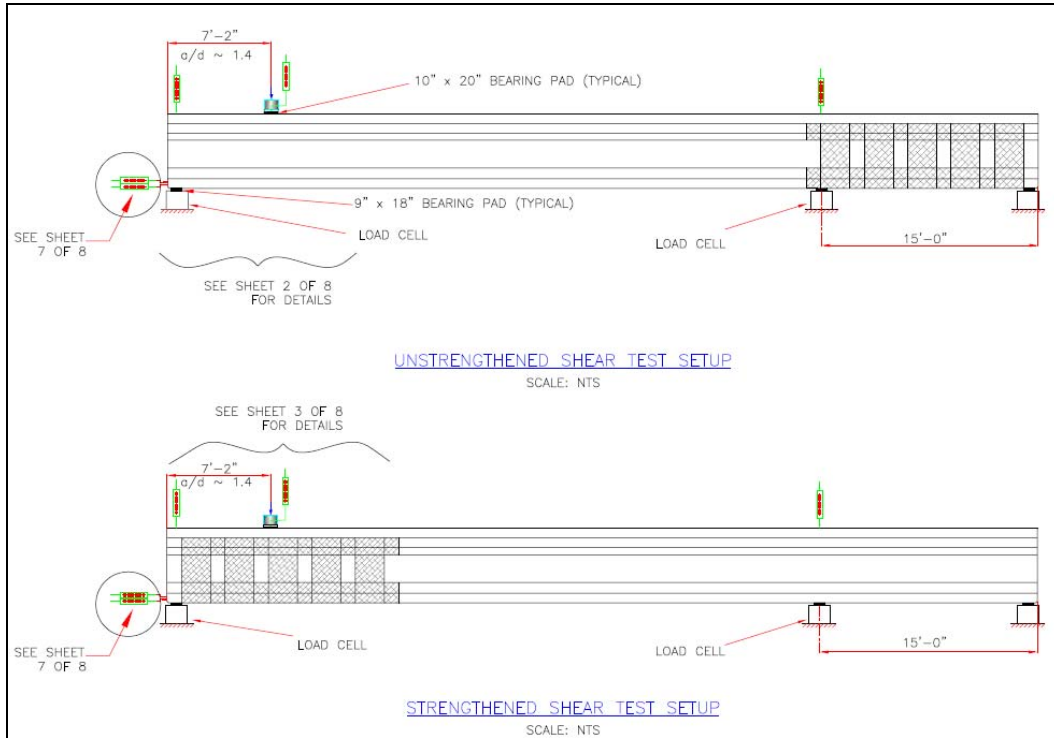
Figures 2 and 3 show the four tests in elevation. Figure 2 shows the elevation of the test with the load offset 7 feet two inches from the end. Figure 3 is similar but with the load offset 15 feet. The expectation was that the two different offsets would demonstrate different failure mechanisms. In both cases, loads were applied under manual control at a rate of around 250 pounds per second. At several load levels, the hydraulic system was locked and the beams were examined for cracks. This was done at predetermined levels
