# *SHRP R06D Round 7 IAP Evaluation of 3D Radar*

## *Final Report*

Agreement No. BE291

Infrasense, Inc.

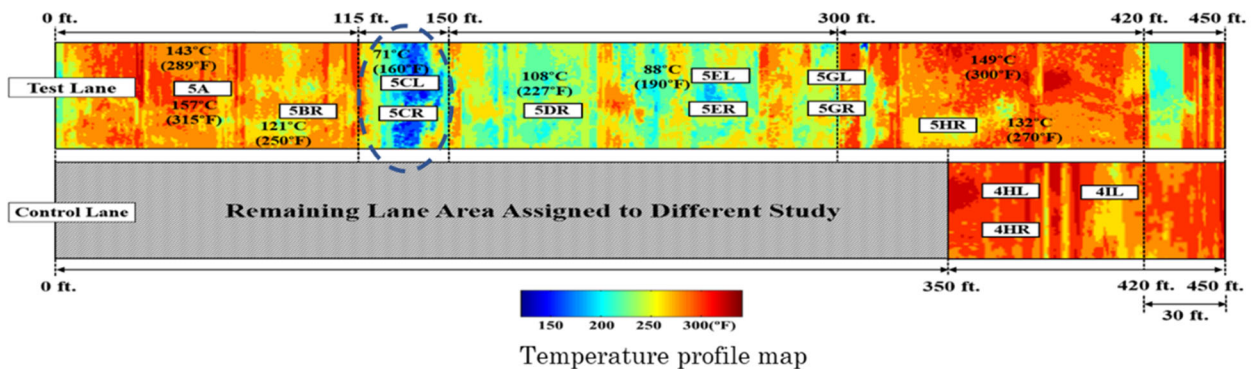
**Lane 5 – Segregation.** To generate localized areas of segregation on the test lane, end of load segregation was simulated. The paver wings were dumped to send coarser mix into the paver at end of each truck load. The tarps were removed from the truck loads upon arrival at the site to increase potential for segregation. Also, the screed heater on the paver was cycled on and off during construction. These techniques were effective in generating localized segregation. The temperature profile measured during paving using an infrared thermal imaging camera confirmed the presence of segregation, as shown in the Figure 8. Circled area shows denoted temperature zone.

Figure 8: Contour map showing spatial distribution of surface temperature values over the Lane 5.

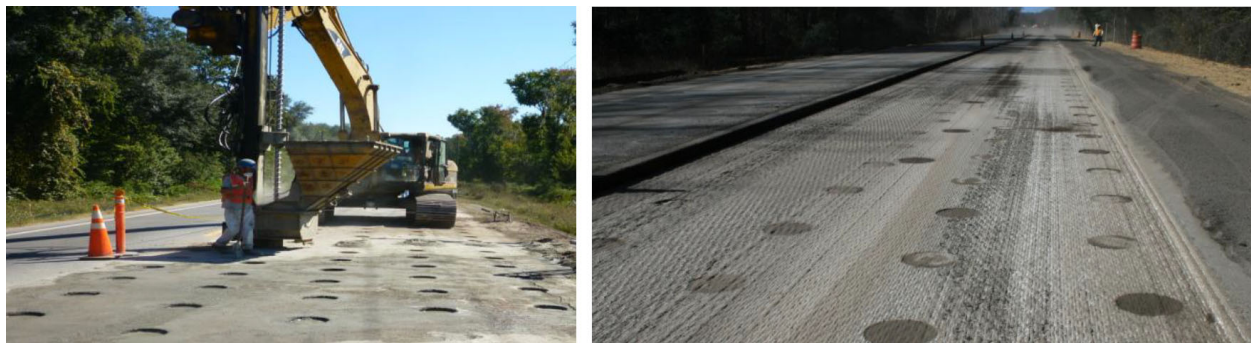
Elevation measurements taken from the westbound test area in the time between 3/27/08 and 9/2/10 showed minor settlement of approximately 0.001 inch developed after the installation of grout columns indicating approximate 50% reduction of settlement when compared to the control section. The control section showed approximately twice the settlement measured from the test section with maximum observed average settlement of 0.41 inch observed in the inner wheel patch [3, 4]. In spite of the fact that SSC and SAM improved the pavement stiffness, uneven settlement was observed between the grout columns and the surrounding soil. Figure 9 displays the photograph taken during the section rehabilitation fieldwork.

Figure 9: SSC installation grid layout on SR 100 (left); roadway surface after the milling (right) [5].

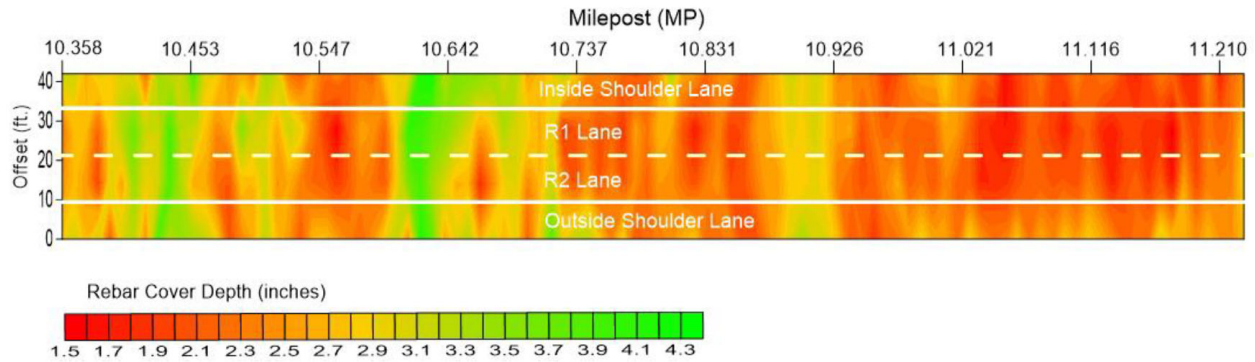
- The GPR data shows that the average cover depth to the top layer rebar is 2.49 inches and 2.32 inches in the left and right driving sides respectively, and for the merge lane is 2.93 inches. The predominant concrete cover calculated for the whole bridge is fairly uniform with indicated average depth to the top layer rebar of 2.58 inches in the travel lanes and 2.65 inches in the shoulder lanes.
- The minimum and maximum cover depth to rebar in the travel lanes is 1.01 inches and 4.78 inches, respectively. The minimum cover depth to the top layer rebar is about 1.01 and 0.47 inches for the travel and shoulder lanes respectively. The maximum cover depth to the top layer rebar is about 4.78 and 5.56 inches for the travel and shoulder lanes respectively.

Figure 10 shows the contour map of the concrete cover depths to the rebar generated from an analysis of the GPR data [6]. The goal of carrying out the 3D GPR survey has been to compare the concrete cover data with that generated by the FDOT survey

Figure 10: Contour map showing concrete cover depth to rebar (2 GHz air-launched GPR data, FDOT).  
Not to scale.

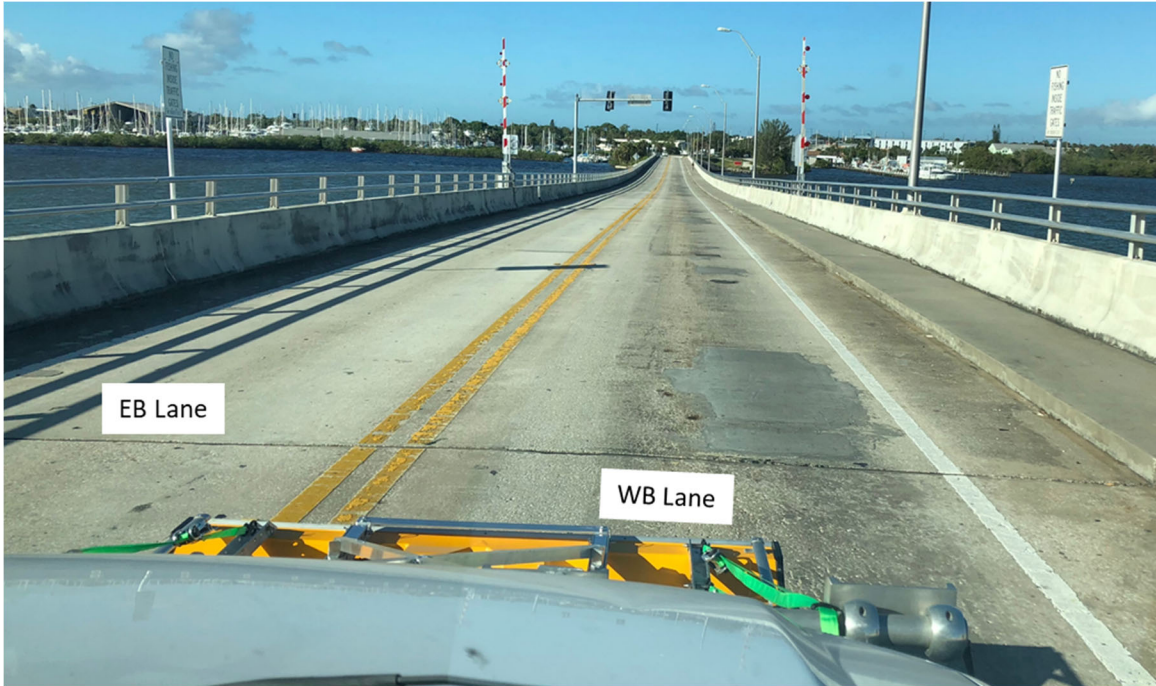
**Bridge # 940045** is a movable (bascule) bridge that was built in 1963 and consists of two lanes, one in each of the westbound and eastbound directions, and one pedestrian walkway. It is located on SR A1A (Florida State Road A1A, N Causeway). The bridge spans over the Intracoastal Waterway connecting the barrier island to the mainland in approximately 200' East of US 1 (SR 5) in Fort Pierce, Florida. The bridge deck comprised of 43 spans made of cast-in-place concrete. The main span is a 103-foot-long double-leaf bascule flanked by two 45-foot, 2 $\frac{3}{4}$ -inch rolled steel beam spans. The whole length of the bridge is 2054.6 feet, from approximate MP 0.33. to MP 0.719, with width from curb to curb of 37.7 feet. Figure 19 and Figure 20 display the overall bridge condition observed from the survey vehicle. It should be noted that signs of moderate deterioration can be visually observed over the westbound lane, while the eastbound lane cover appears to be in better condition.

Figure 19: General view of St. Lucie bridge deck. Camera pointing West. Vehicle positioned ~50 ft. to the west from the bascule span.

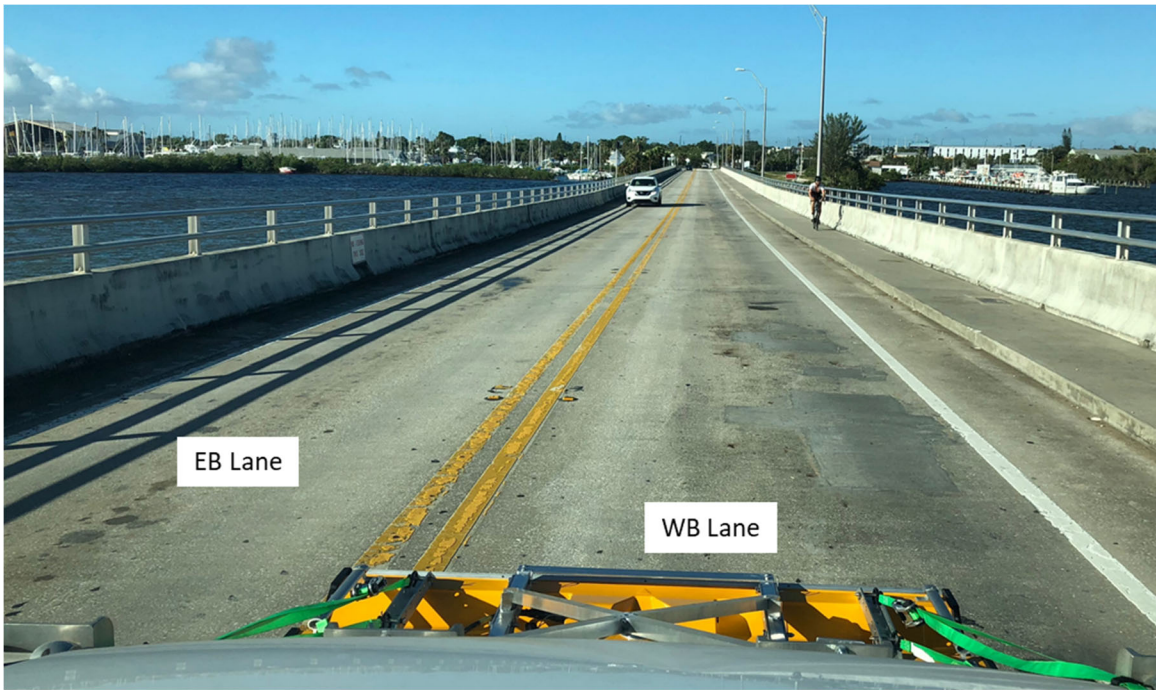
Figure 20: General view of St. Lucie bridge deck. Camera pointing West. Vehicle positioned ~450 ft. to the west from the bascule span.

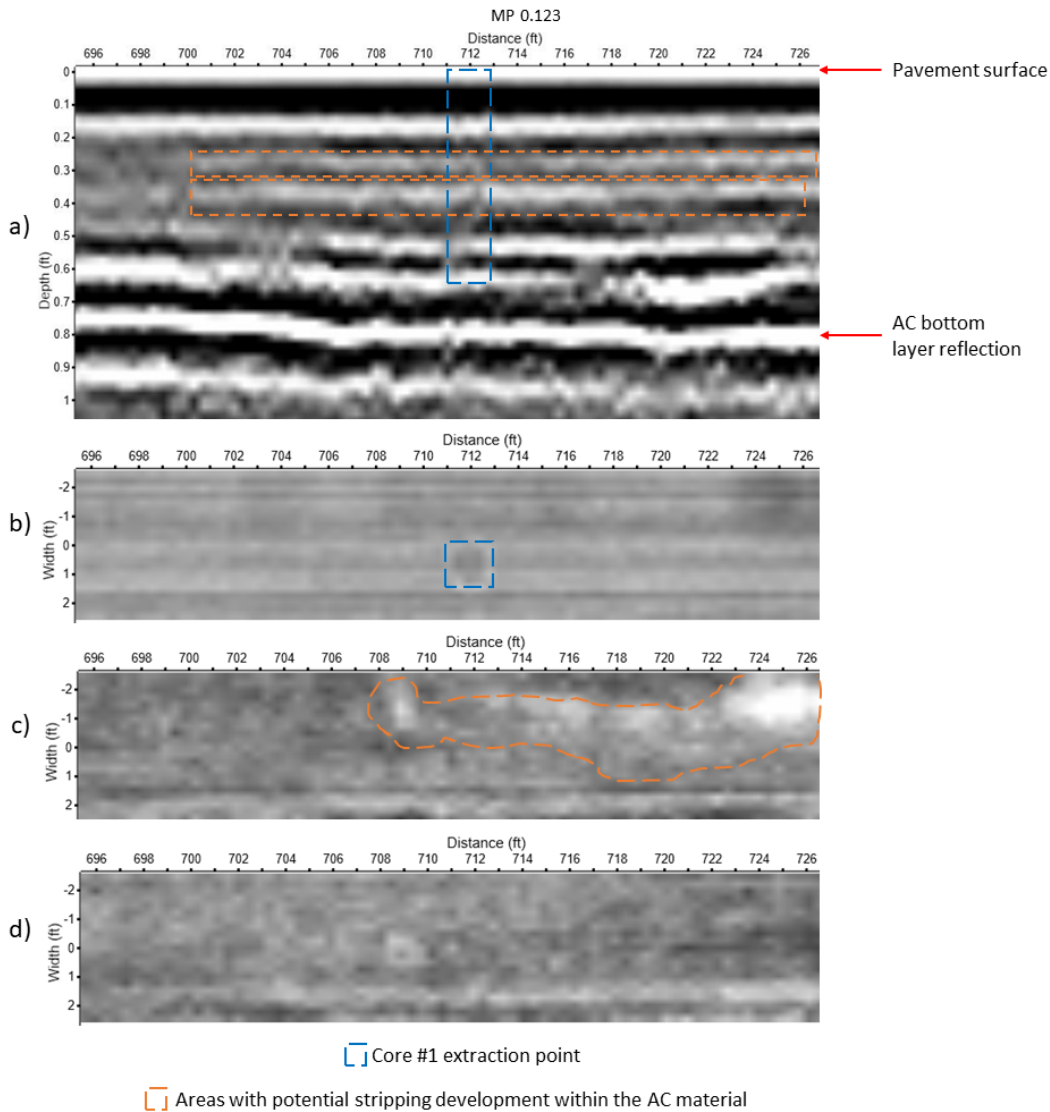
Available core control data were used to constrain and verify the reliability of the interpretations of the 3D-Radar data. Figure 22-27 show the core locations superimposed over the 3D-Radar data. Figure 22 represents 3D-Radar data collected in proximity of core #1 extraction point (MP 0.123, R2), where the roadway depression was noted. Core extraction revealed evidences of cracking below the pavement layer. Reflection activity spot related to the observed damage can be clearly recognized on 3D-Radar data. Figure 22b displays corresponding GPR C-scan obtained from depth of 0.4 inches. Figure 22c and Figure

22d exhibit GPR C-scans obtained from depths of 3.23 inches and 4.26 inches, where signs of potential stripping development can be recognized. Orange frames indicate areas with potential raveling/stripping developed within the pavement material. Additional layer reflectors observed between the surface and base reflection can be indicative of broken bond between the bitumen and aggregate leaving a lower density material layer within the asphalt. The dielectric properties of stripped HMA can be affected by the presence of moisture content and/or air voids; stripping development can be also accounted to the incompatible aggregate and asphalt binder, reduced adhesion, and/or the impact of moisture content separating the asphalt binder from the aggregate.

**Figure 22: 3D-Radar cross-section in proximity of the core #1 extraction point (a); I-10 reflection at the depth of 0.48 inches. (b); I-10 reflection at the depth of 3.23 inches (c); I-10 reflection at the depth of 4.26 inches (d).**

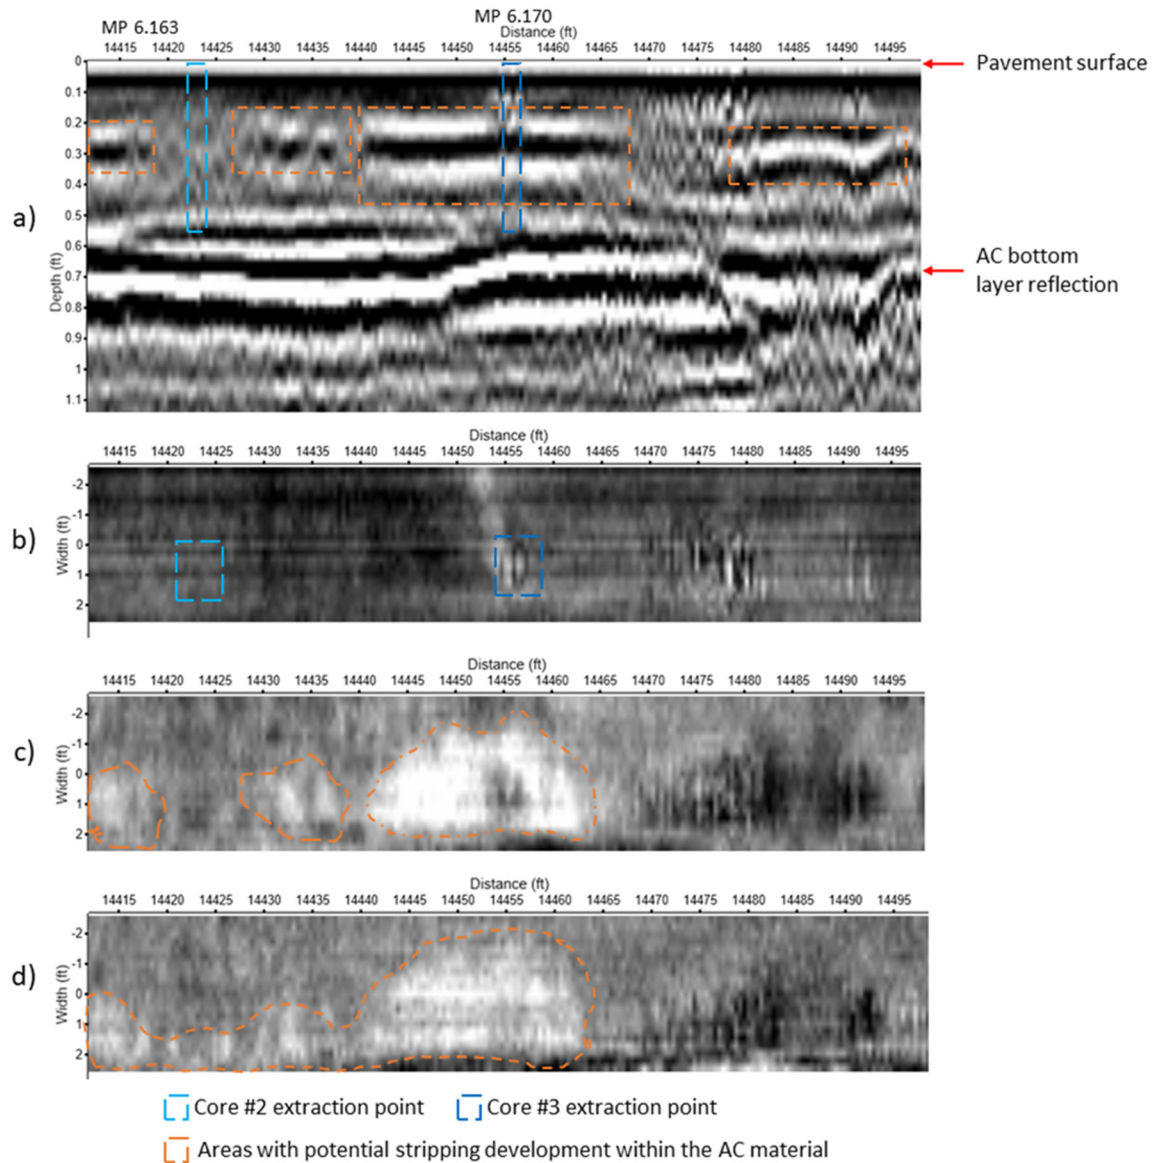
Figure 23 represents 3D-Radar data collected in proximity of cores #2 and #3 extraction points (MP 6.163 and MP 6.170, R2). Core #2 showed no damage, which corresponds well with very low reflection activity

noted in 3D-Radar data. Core #3 that was extracted in proximity of the area, where the roadway depression and signs of limerock dust bleeding through the asphalt were noted, revealed evidences of Class II C type cracking below the pavement layer.

Figure 23: 3D-Radar cross-section in proximity of the cores #2 and #3 extraction points (a); I-10 reflection at the depth of 1.44 inches (b); I-10 reflection at the depth of 2.71 inches (c); I-10 reflection at the depth of 4.51 inches (d).

Figure 23b displays corresponding GPR C-scan obtained from depth of 1.44 inches. Figure 23c and Figure 23d exhibit GPR C-scans obtained from depths of 2.71 inches and 4.51 inches, where signs of potential stripping development can be recognized. Moderate reflection activity can be observed over the core #3 extraction point on corresponding 3D-Radar data. Orange frames indicate areas with potential raveling/stripping developed within the pavement material.

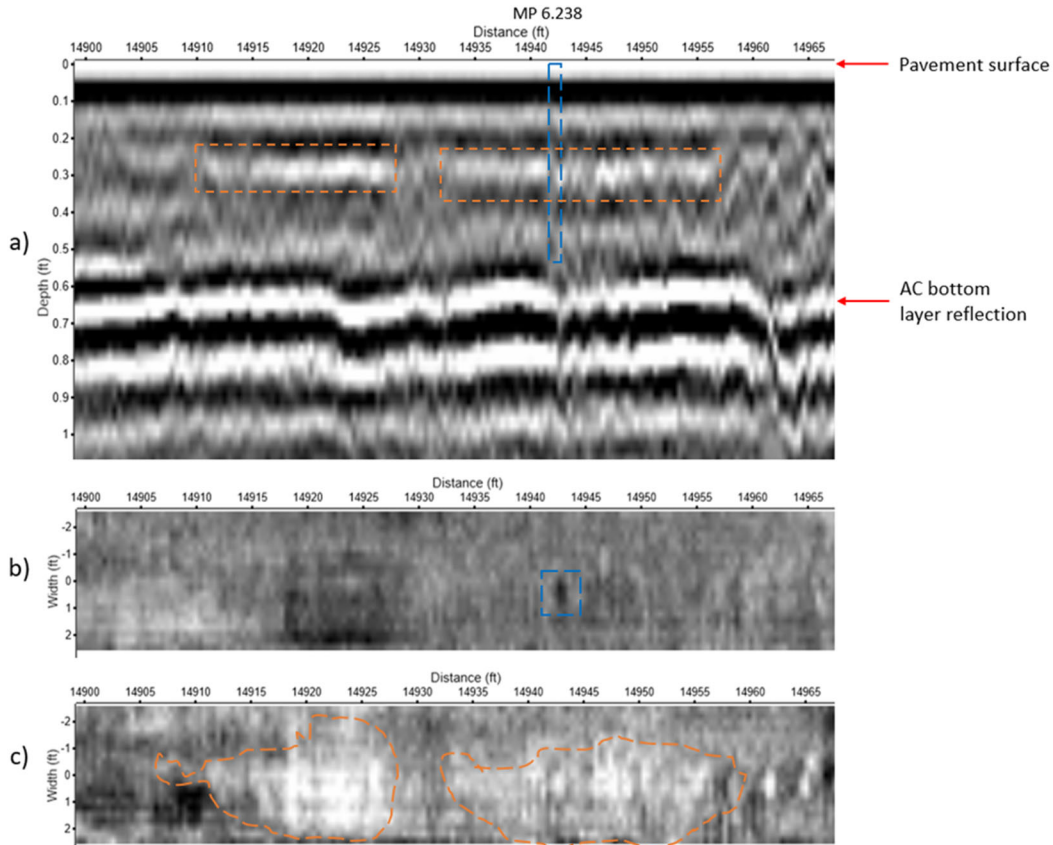
Figure 24 represents 3D-Radar data collected in proximity of core #4 extraction point (MP 6.268, R2). Core #4 that was extracted in proximity of the area, where the roadway depression and signs of limerock dust bleeding through the asphalt were noted, revealed evidences of cracking below the pavement layer. Core showed moderate damage which correlates well with observed reflection activity spots in Figure 24c. Figure 24b and Figure 24c exhibit corresponding GPR C-scans obtained from depth of 2.4 inches and 3.48 inches, respectively. High reflection activity can be observed over the core #4 extraction point on corresponding 3D-Radar data. Orange frames indicate areas with potential stripping developed within the pavement material.

Figure 24: 3D-Radar cross-section through the core #4 extraction point (a); I-10 reflection at the depth of 2.4 inches (b); I-10 reflection at the depth of 3.48 inches (c).

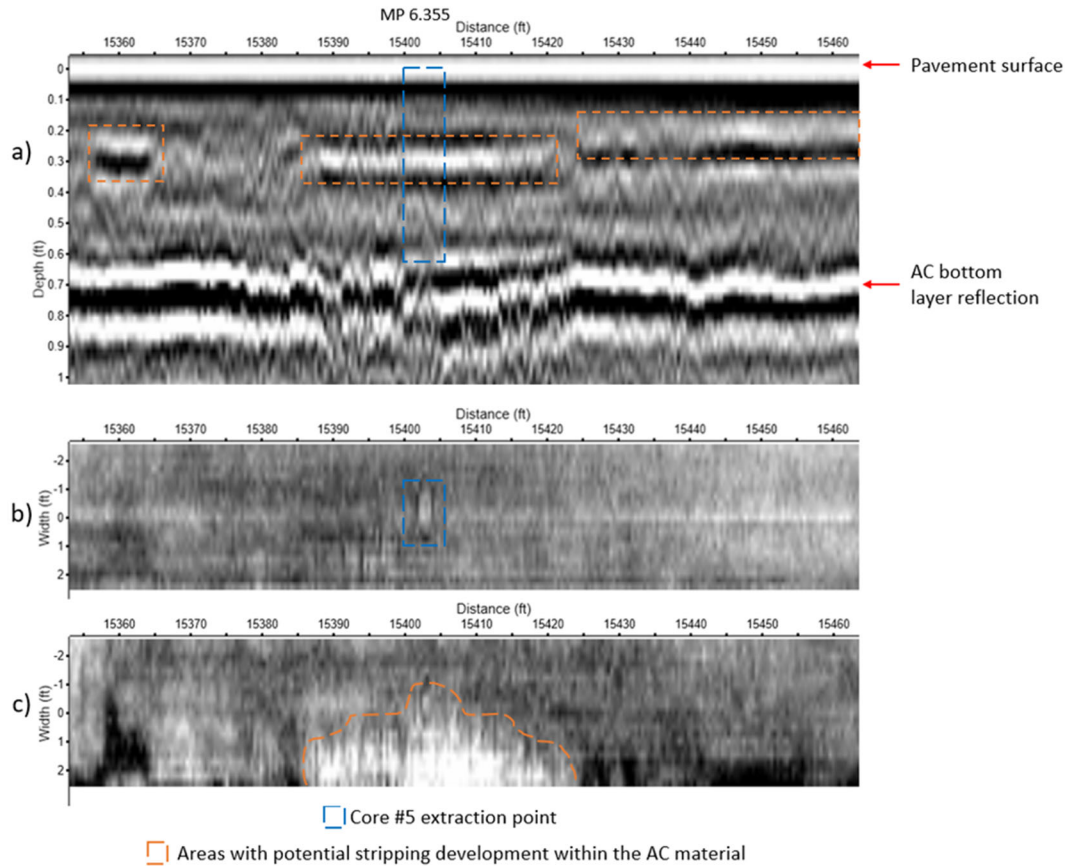
Figure 25 represents 3D-Radar data collected in proximity of core #5 extraction point (MP 6.355, R2). Core #5 showed no damage; however, some reflection activity can be observed within the asphalt layer at depth of approximately 3.6 inches. Figure 25a display the GPR B-scan with corresponding GPR C-scans obtained from depth of 1.94 inches (25b) and 3.6 inches (25c), respectively. Orange frames indicate areas with potential stripping developed within the pavement material.

Figure 25: 3D-Radar cross-section through the core #5 extraction point (a); I-10 reflection at the depth of 1.9 inches (b); I-10 reflection at the depth of 3.6 inches (c).

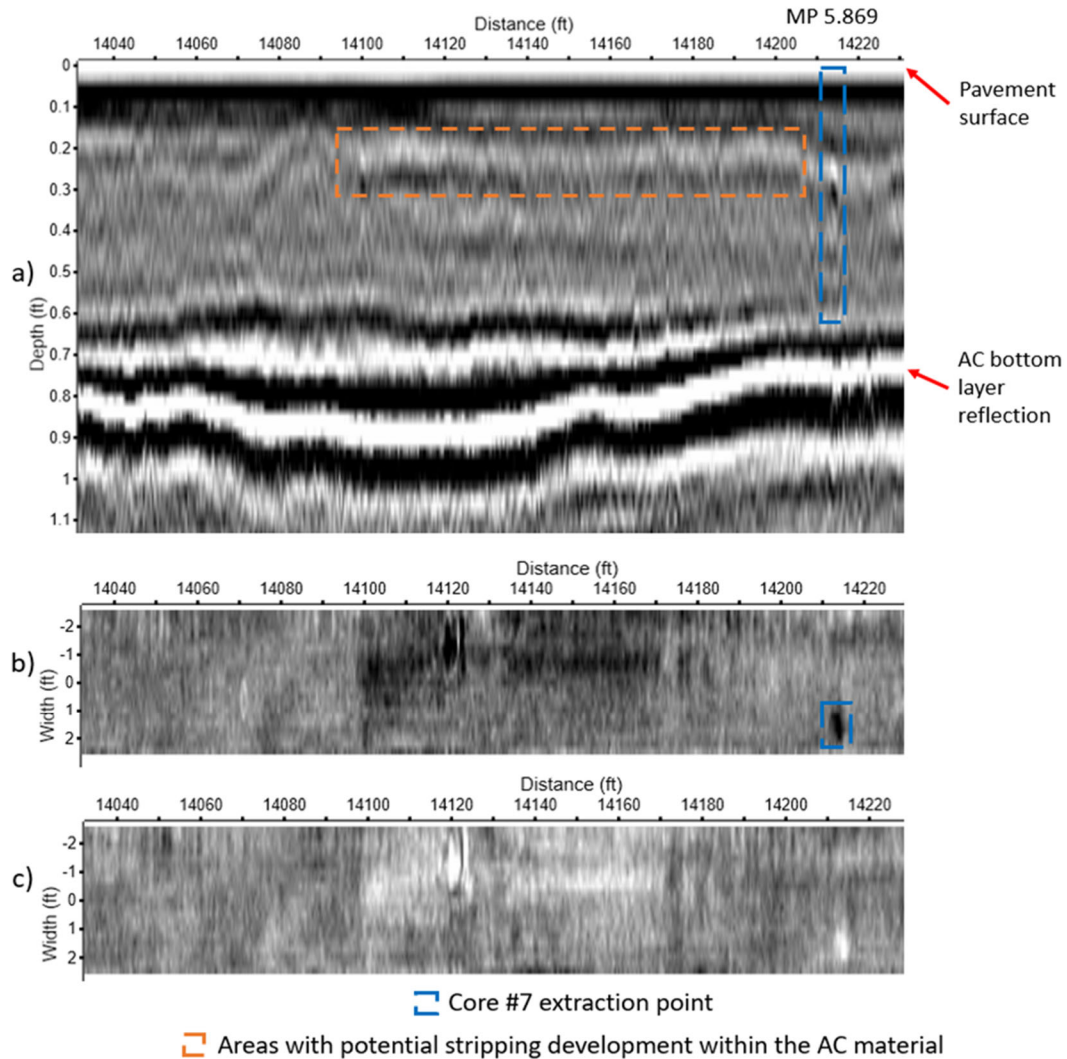
Figure 27 represents 3D-Radar data collected in proximity of core #7 extraction point (MP 5.869, L2). Core #7 revealed evidences of cracking below the pavement layer. Corresponding GPR C-scans obtained from depth of 2.9 inches and 3.6 inches are shown in Figure 27b and Figure 27c, respectively. Orange frames indicate areas with potential stripping developed within the pavement material.

3D GPR survey results were examined in proximity to core locations for deviations of dielectric values and presence of internal reflectors at variable depths which are not normally seen within intact pavement layers and can be indicative of stripping. Anomalous interlayer activity was identified and reported as potential stripping development within the pavement material.

Figure 27: 3D-Radar cross-section through the core #7 extraction point (a); I-10 reflection at the depth of 2.9 inches (b); I-10 reflection at the depth of 3.6 inches (c).

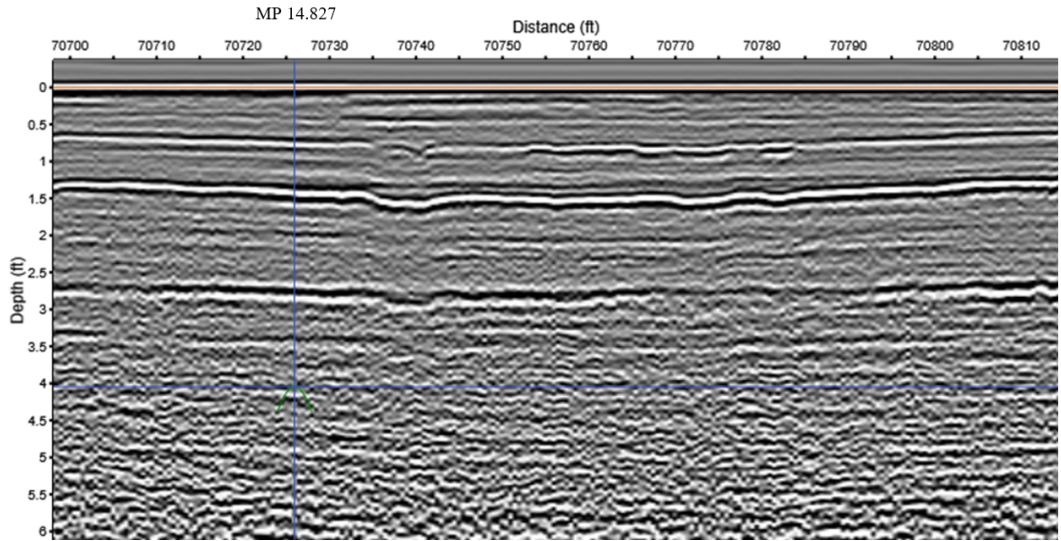
**MP 14.810-14.830 – Potential Depression.** Figure 31 below shows a segment of 400 MHz data indicating an area of potential moisture infiltration. Figure 32 shows a segment of 3D-Radar data collected over the same area. The moisture indications that appear in the 400 MHz data does not appear in the 3D-Radar data.

Figure 32: 3D-Radar data collected in the vicinity of MP 14.827.

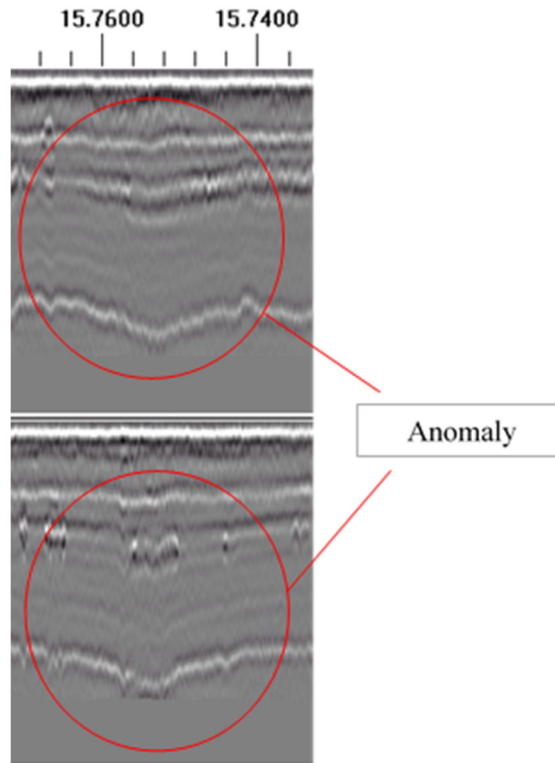
Figure 33: Air-launched GPR scan showing near surface anomalies in vicinity of the MP 15.76 [12].

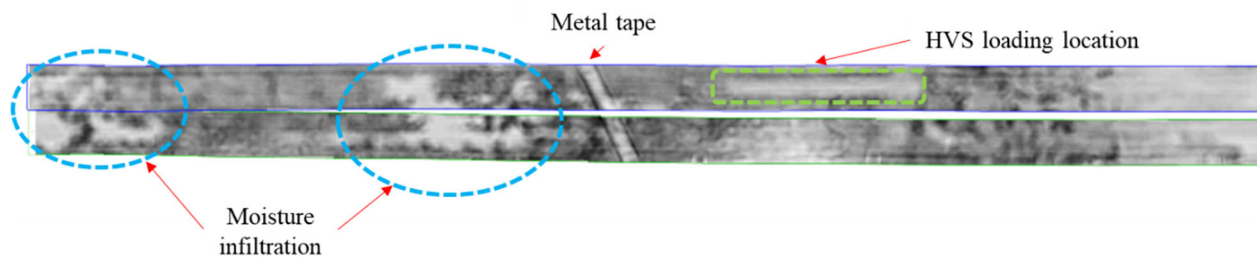
**Lane 3 – Delamination.** Figure 3 shows a depth slice of the 3D-Radar data at a depth of approximately 2 inches. The areas circled in blue in Figure 36 are most likely where moisture has infiltrated the sand interface between the two layers – otherwise nothing would show up with GPR in a purely de-bonded condition.

Figure 36: 3D-Radar depth slice at 2 inches in Lane 3.

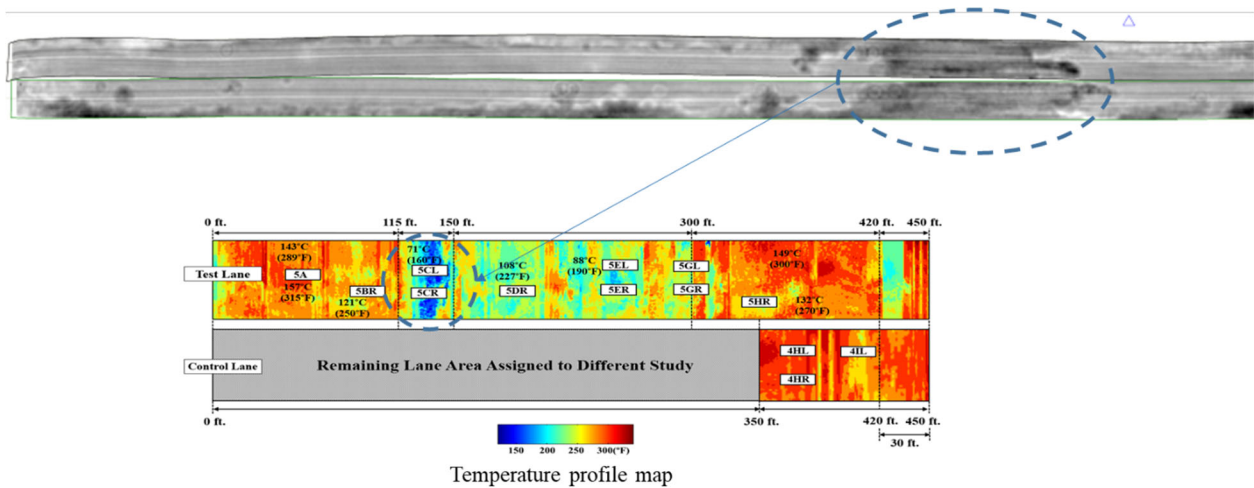
**Lane 5 – Segregation.** During the construction of Lane 5 the paving process was modified in order to generate localized segregation. The temperature profile measured during paving using an infrared thermal imaging camera confirmed the presence of segregation, as shown in the bottom part of Figure 38. The top part of Figure 38 shows a 3D-Radar depth slice selected to best reveal the effects of segregation. The circled area indicates the anomalous zone, corresponding with the low temperature area denoted on the temperature profile map.

Figure 38: 3D-Radar data depth slice at 1.5 inches in Lane on top; contour map showing spatial distribution of surface temperature values at the bottom.

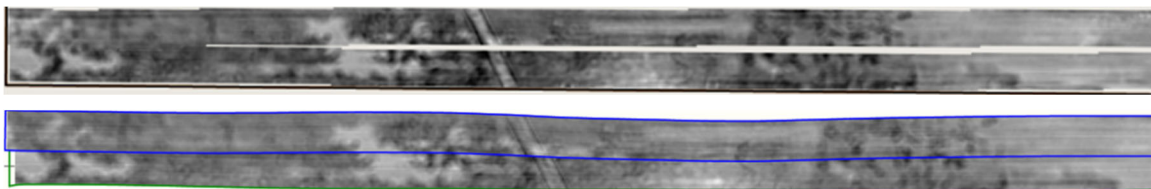
To test the repeatability of proposed testing procedure, repeat tests were carried out on lanes 3, 4, and 5. Data was collected in both directions for each lane. In each case, the data in the opposite direction was collected on the opposite side of the lane, so close to full lane coverage was obtained for each pair of data files. The primary difference between repeated files is the position of the vehicle, since it is not possible to drive exactly in the same position each time. Since the 3D-Radar data is geositioned, the display of the data reflects these positional differences. Figure 39 and Figure 40 below show repeat testing depth slice results for Lanes 3 and 4. Note that the primary difference is the spatial geometry of the pass, and not in the underlying data. For Lane 3, there is also some spatial distortion – the middle section is wider in the lower image than in the upper image. This sort of distortion does not occur in the Lane 4 data.

Figure 39: Repeat test results for Lane 3.

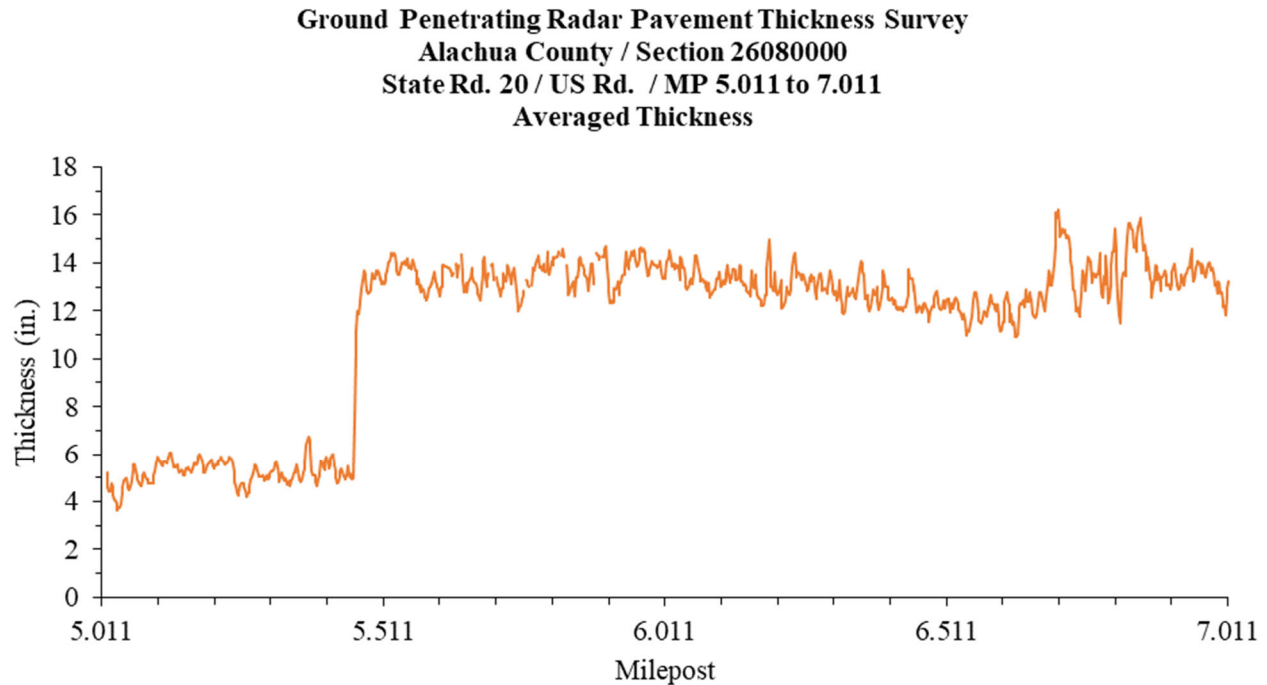
Florida Department of Transportation survey was conducted on March 1st, 2017 using four 2 GHz air-launched GPR antennas mounted to the FDOT GPR survey vehicle. An evaluation of pavement asphalt thickness presented as a line chart displayed in Figure 41 showing the chart of variation of average thickness (vertical axis) as a function of GPR profile length (horizontal axis).

Figure 41: Chart showing the average asphalt thickness (vertical axis) measured using FDOT air-launched GPR system vs distance along the SR 20 (horizontal axis).

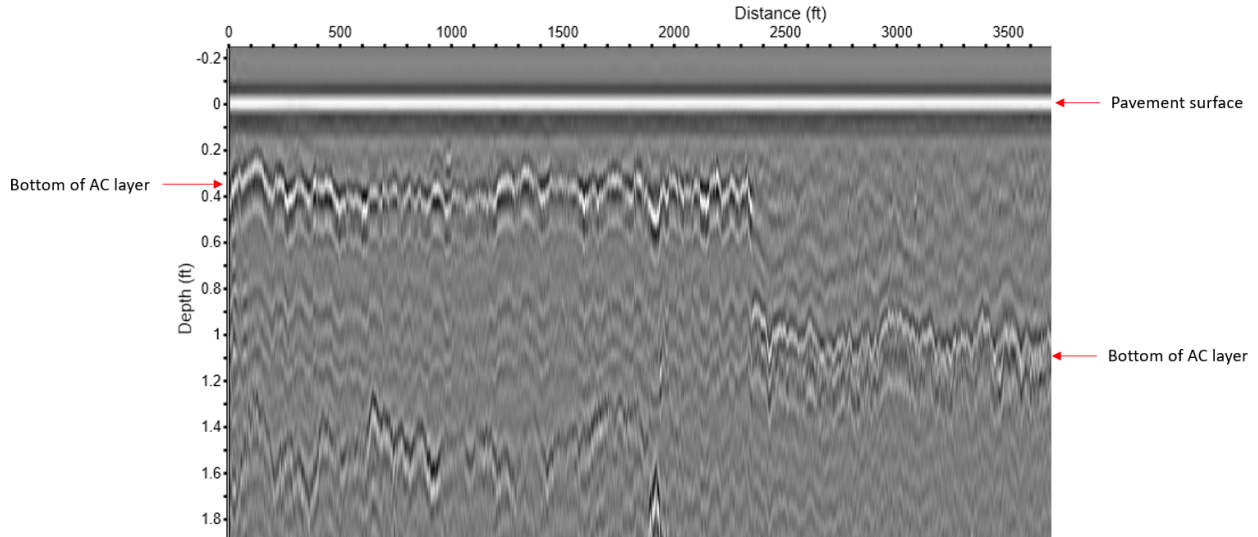
The purpose of carrying out the 3D GPR survey has been to see if data collected with 3D-Radar system can be used to perform pavement thickness evaluation. The 3D-Radar survey was carried out on February 14, 2017, between approximately MP 5.0 and 7.0. Two lines of data were collected, in the right and left sides of the outside eastbound lane. Figure 42 displays 3D GPR cross-section through tested area showing significant drop in assumed reflection depth representing the bottom of pavement material at approximate 2400 ft. mark. Figure 43 shows a segment of stitched file containing both left and right sides of eastbound driving lane of SR 20. Red line represents the tracked AC bottom layer interface with significant drop in the depth on approximately 2325 ft. (MP 5.33).

Figure 42: 3D-Radar section through tested area, eastbound Driving lane (right side) of SR 20.

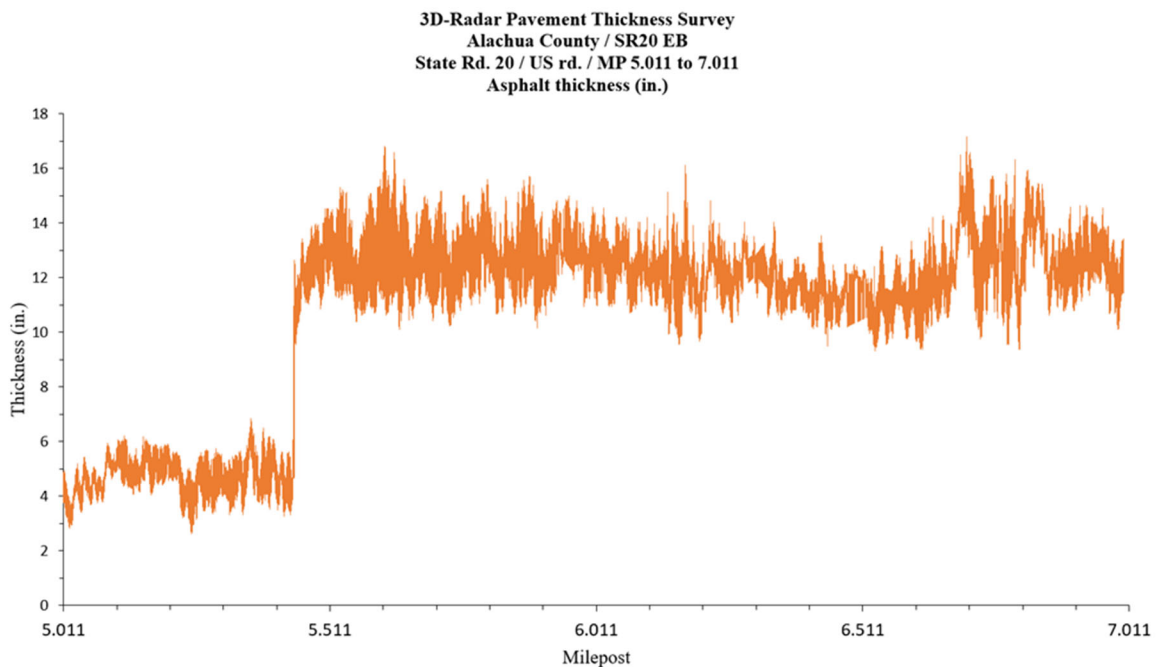
Using Examiner software, the bottom of AC layer was identified and traced in the same manner as in the related FDOT survey. The AC layer thickness was calculated from the arrival time of the reflection from the top and bottom of the AC layer. The assumed dielectric permittivity of 5 was used to convert reflection times to reflection depths. The value had to be assumed since Examiner does not presently have the ability to calculate dielectric constants. The value of 5 is typical for dry asphalt; the range of calculated reflection depths obtained from the 3D-Radar data with assumed dielectric constant of 5 correlated well with the outcomes of FDOT survey. It should be noted that pavement thickness and its dielectric properties cannot be assumed homogeneous for extended pavement sections and can significantly vary within the relatively short distance. Figure 44 displays the linear plot of AC layer thickness showing the distribution of asphalt thickness values calculated using 3D-Radar system, vs distance along the SR 20. 3D GPR survey provided similar level of thickness evaluation precision as previously performed conventional air-launched investigation.

Figure 44: Plot showing the distribution of asphalt thickness values (vertical axis) measured using 3D-Radar system vs distance along the SR 20. (horizontal axis).

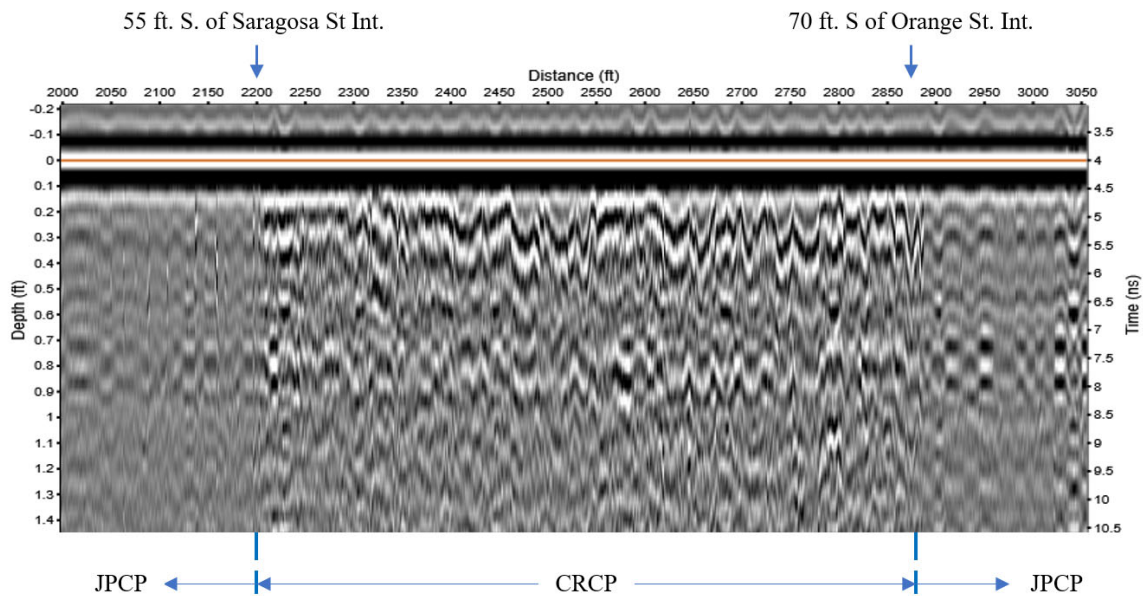
survey area (other than the bridge deck) appears to be Jointed Plain Concrete pavement (JPCP – see Figure 47), however, the figures show that the pavement composition tend to vary considerably in the northbound and southbound directions in the region where the piles are known to exist. In the northbound section (Figure 45), the segment in the pile area appears to be continuously reinforced (CRCP), with transverse rebar at approximately 6 feet spacing (Figure 48). Note that the southbound profile of Figure 46 shows substantial settlement of the concrete pavement, with asphalt fill having been placed to maintain the horizontal grade of the roadway. Note also that the portion of the southbound roadway that has subsided includes both CRCP and plain concrete pavement with no apparent joints (PCP). It appears likely that the CRCP construction is present to transfer the vehicle loads to the piles. The 3D-Radar survey data has revealed the essential features of the pavement construction, particularly in the pile-supported area. There is no clear evidence of voids or “loose” soil anomalies under the concrete, as mentioned in the EGS report described in Section 3. It is possible that the voids detected in the EGS survey were outside of the range covered by the 3D-Radar survey. The timber piles were not directly observed in the 3D-Radar data. The 3D GPR survey revealed considerable detail regarding the pavement substructure condition. Note that the 3D-Radar survey took one hour to complete and required no lane closures. This is a significant reduction in the time and cost that was associated with the traditional GPR survey approach used by EGS. Also, the nature of the 3D-Radar presentation in Examiner has made pavement features appear clearer during analysis.

Figure 45: 3D-Radar data cross-section, northbound driving lane, right side.

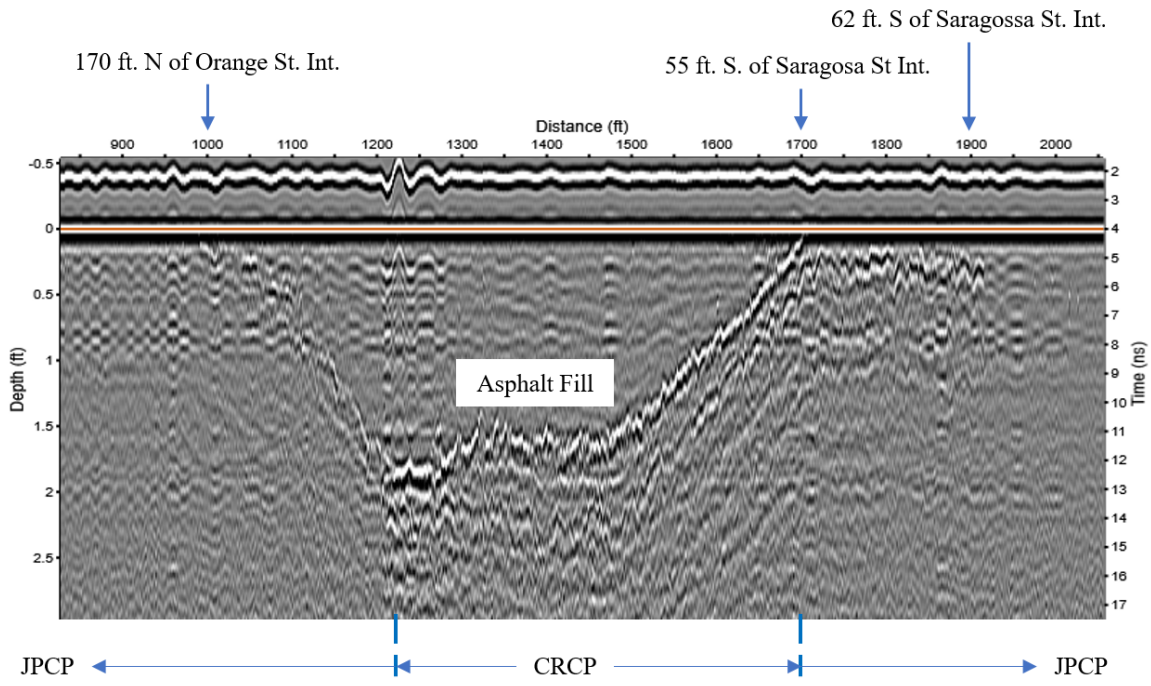
Figure 46: 3D-Radar data cross-section, southbound driving lane, right side.

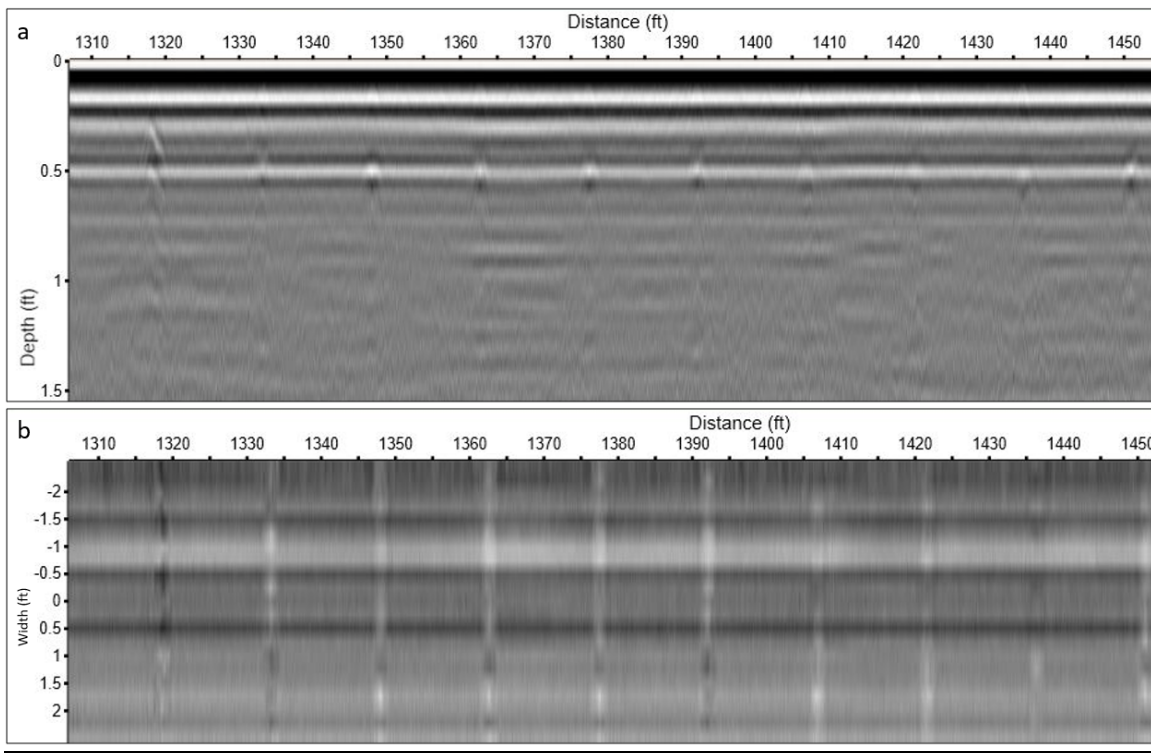
Figure 47: Typical GPR image from SR 5 tested section showing regularly spaced joints reflections on B-scan (a) and C-scan (b) from the depth of 6 inches.

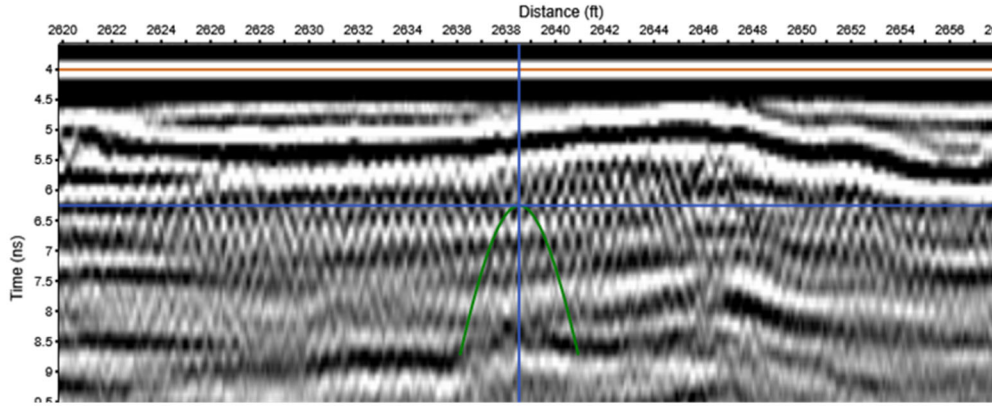
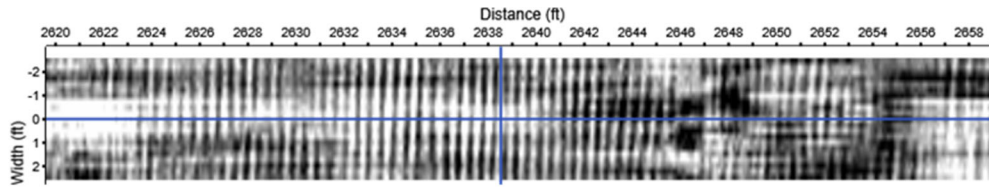
B-scan showing rebar pattern in 3D Radar data cross section.

C-scan showing transverse rebar at ~6 inches.

Figure 48: Example of 3D-Radar data collected over the northbound lane, showing details of CRCP construction.

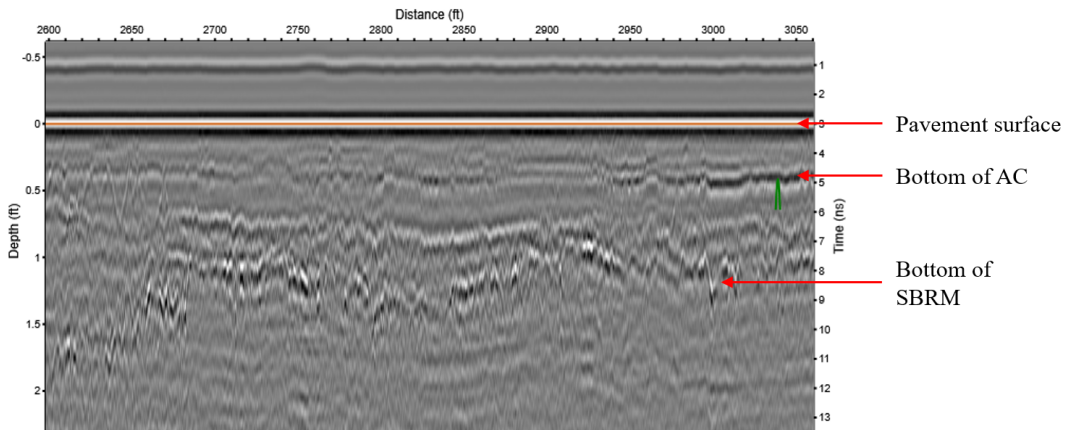
3D-Radar data were collected on February 16, 2017 in the eastbound direction between MP 3.04 and MP 3.80. Two lines of data were collected, one each in the right and left sides of the eastbound lane. Figure 49 and Figure 50 show the cross-sections of 3D-Radar data. The upper asphalt layers and the SBRM layer as described above. Worth of note is the variation of amplitude at the boundary between the asphalt and the SBRM. This variation could be an indication of accumulation of moisture as suggested in the SMO study.

Figure 49: Example of 3D-Radar data section through the distressed area. Left side, eastbound.

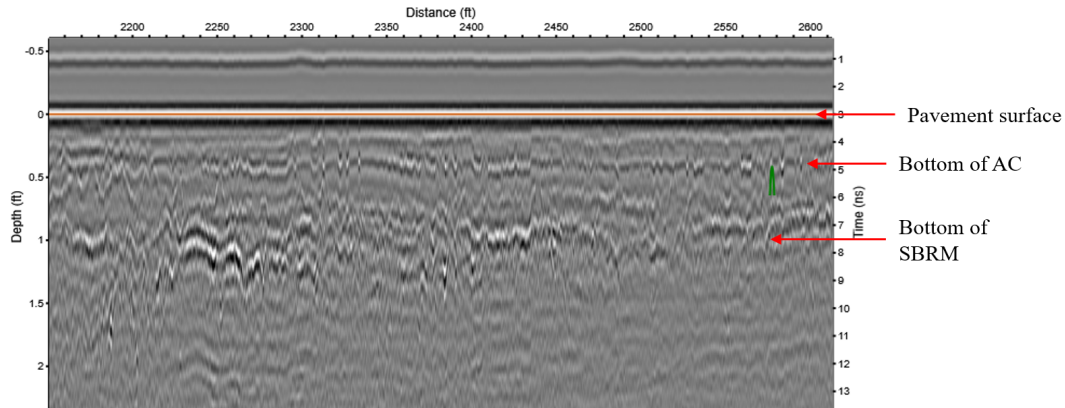
Figure 50: Another example of 3D-Radar data section through the distressed area. Right side, eastbound.

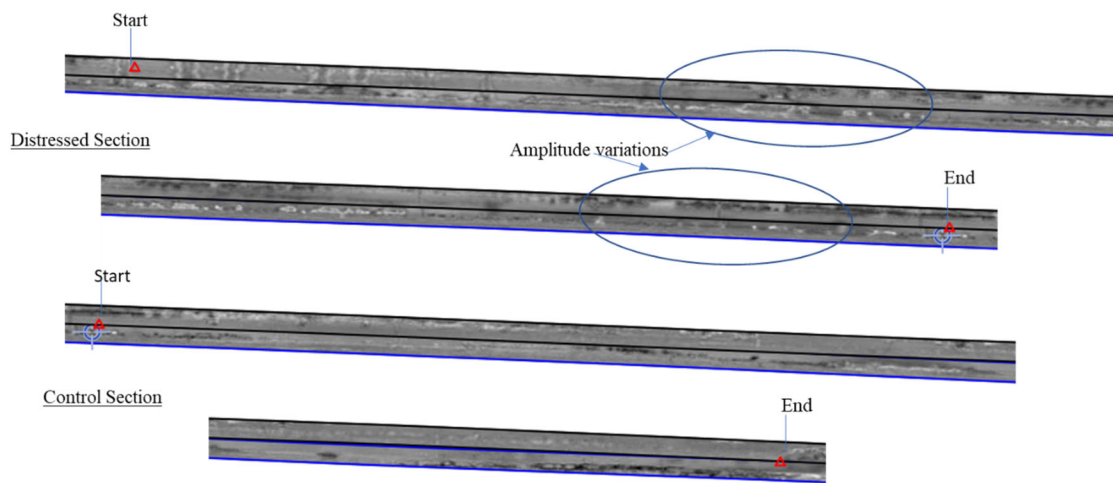
Figure 51 shows a depth slice through the section at a depth of approximately 5 inches, directly below the bottom of the AC. 3D GPR survey showed considerable amplitude variations observed in the "distress" area, much more so than in the "control" area. This observation supports the theory that moisture infiltration into this boundary is contributing to the pavement distress.

Figure 51: Reflection at the bottom of the AC layer at a depth of 4.8 inches.

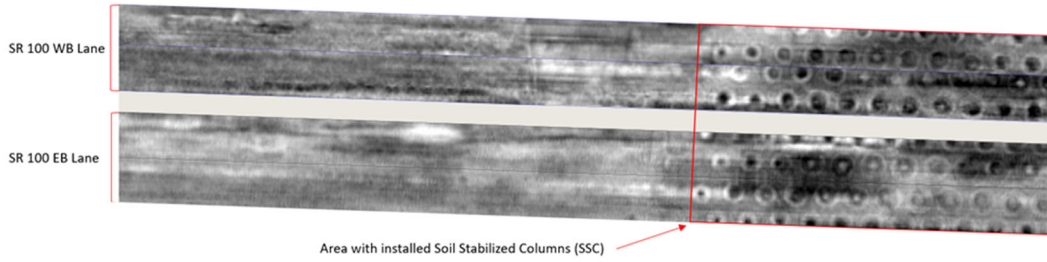
The objective of carrying out the 3D-Radar survey was to see if any details of the pavement structure can be revealed which explain the observed strength reduction. The survey was carried out on February 15, 2017 between Sipprell Road (MP 6.791) and Indian Lakes Forest Rd., (MP 8.287). Four lines of data were collected – two in the eastbound lane (right and left sides) and similarly two in the westbound lane. As a result, section of the SR 100 with installed piles can be easily delineated on the processed GPR data. The section is approximately 3720-ft. long. Figure 52 and Figure 53 show a depth slice through the section at a depth of approximately 5.7 inches. The beginning and the end of the test area with installed Soil

Figure 52: SR 100 eastbound and westbound reflections at the top of the area with installed SSC grid. Beginning of the test area.
