# *SHRP R06D Round 7 IAP Evaluation of 3D Radar*

## *Final Report*

Agreement No. BE291

Infrasense, Inc.

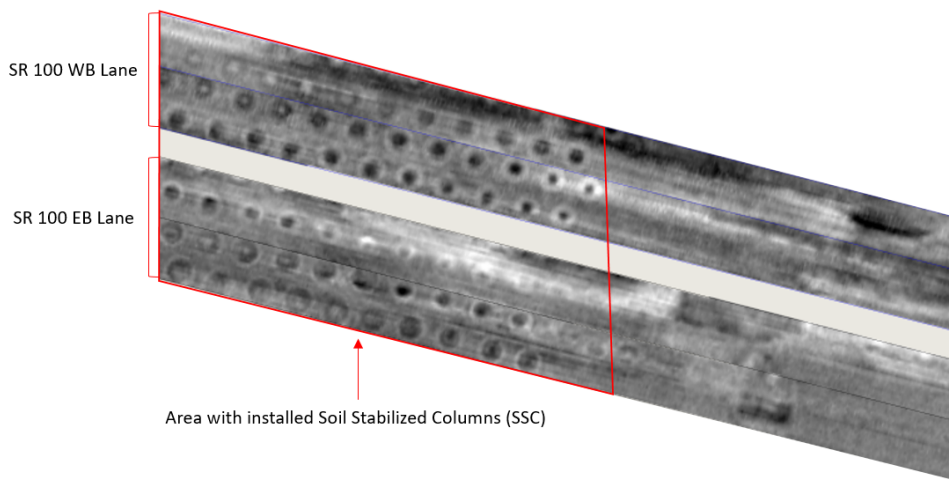
Figure 53: SR 100 eastbound and westbound reflections at the top of the area with installed SSC grid. End of the test area.

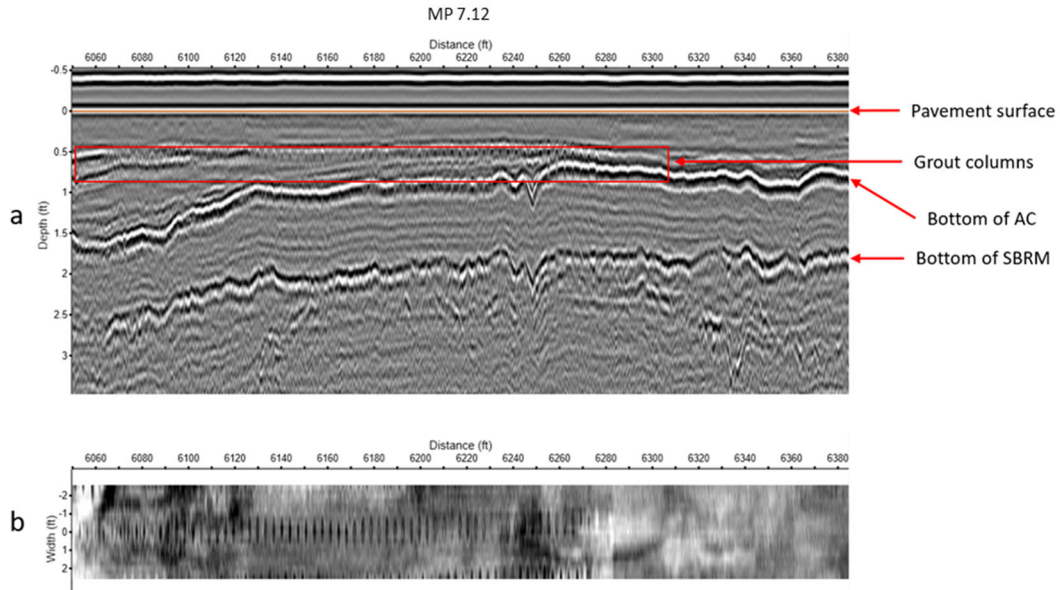
Figure 55 displays the B-scan with corresponding C-scan obtained from depth of 5.9 inches. (55b). Hyperbolic reflections associated with SSC can be clearly seen starting from 6275 ft. mark. An isolated area with approximate length of 30 ft. with no piles installed was noted on the eastbound lane. Figure 56 and Figure 57 display the feature associated with a gap within the SSC grid pattern. Anomaly of similar character was noticed on the left side of eastbound lane.

Figure 55: Example of 3D-Radar data cross-section collected over the through the area with installed grout columns.

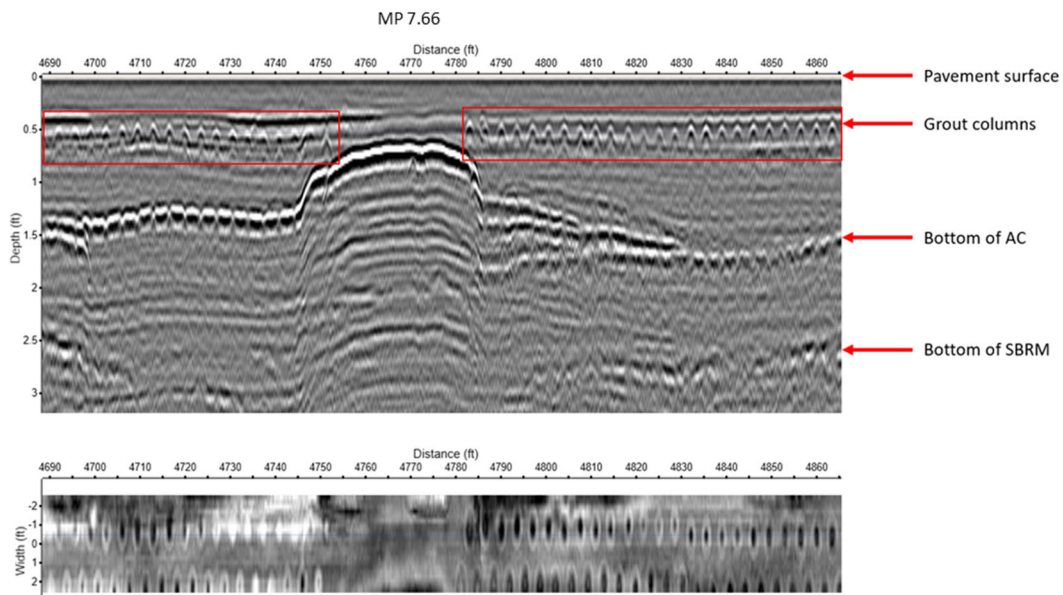
Figure 56: Another example of 3D-Radar data cross-section collected over the through the area with installed grout columns.

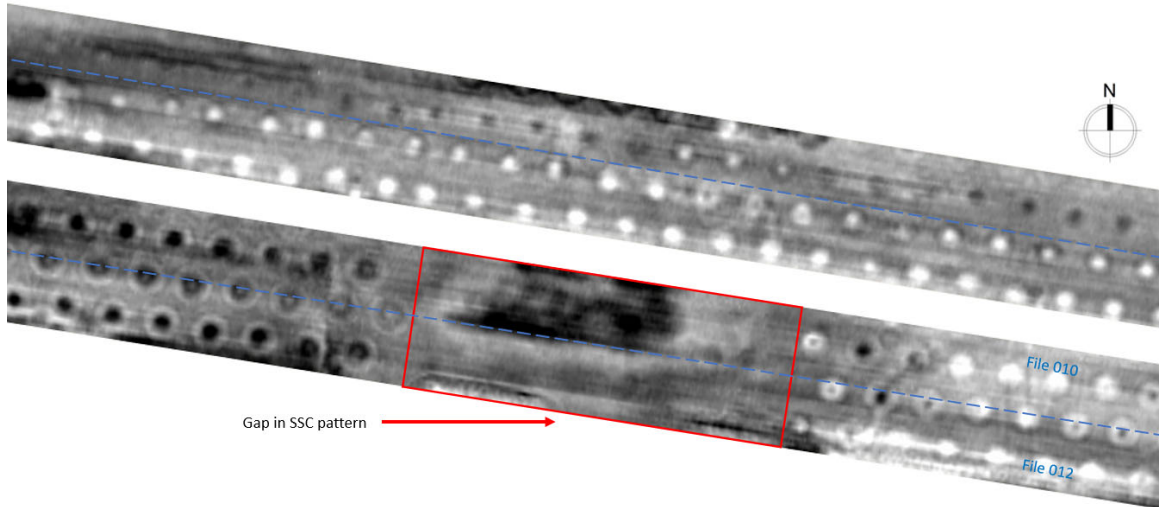
Figure 57: SR 100, westbound lane (top) and eastbound lane (bottom) reflections, showing the gap in SSC grid pattern.

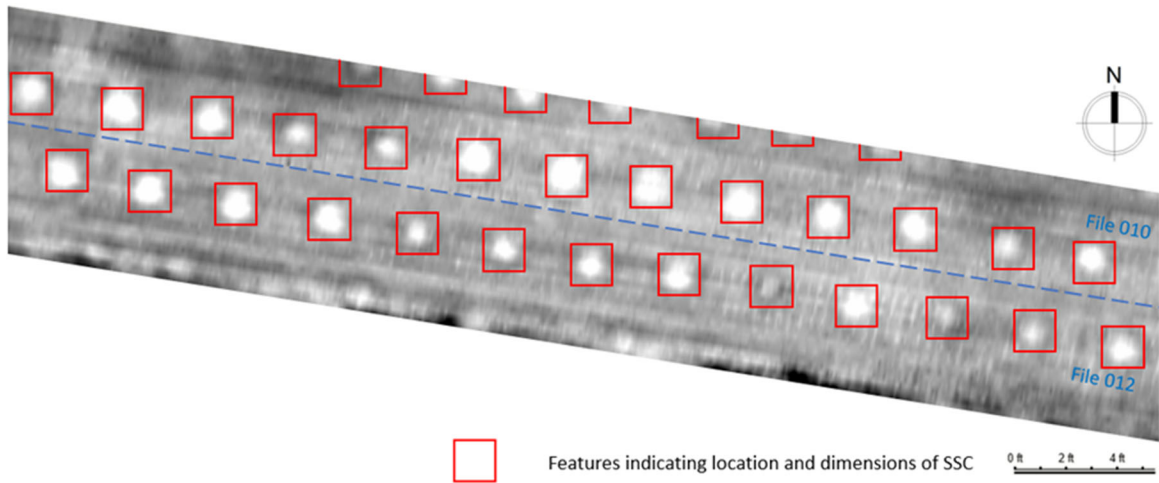
The precise location and layout of individual piles can be obtained as it shown in Figure 58 showing the GPR section at the depth of 5.15 inches. Location and disposition of piles (~3 ft. lateral and ~3.5 ft. transverse spacing according to the 3D-Radar data) can be clearly seen along with their approximate dimensions (11 – 12.5 inches in diameter according to the 3D-Radar data).

Figure 58: SR 100, eastbound lane. Reflection, showing the pattern of installed SSC arrangement.

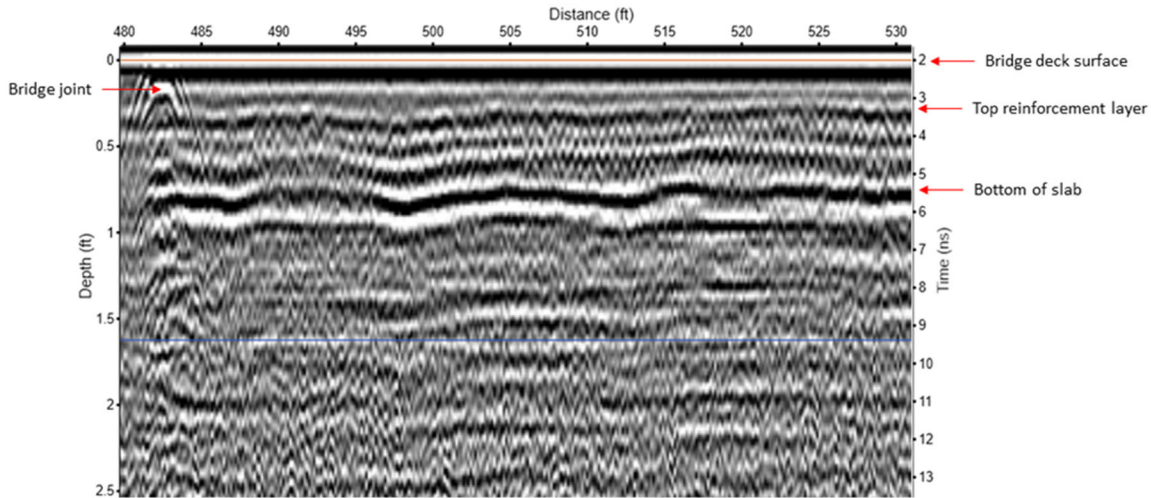
The 3D-Radar survey was carried out on February 16, 2017 between 11:00 and 12:30 AM. Ten lines of data were collected, five each in the westbound and eastbound lanes. The 3D-Radar system was used to comparatively evaluate the concrete cover. Rebar reflections appear as a layer in the 3D-Radar data as it is illustrated in Figure 61:

Figure 61: GPR cross-section showing the identified rebar layer. Left side, eastbound lane.

Using dedicated software (Examiner), x- and y-coordinates from each hyperbolic maximum were matched with a measure of two-way travel time of electromagnetic waves propagation to calculate a depth of rebar cover. A dielectric permittivity of 6 was used to convert reflection times to reflector depths. This value had to be assumed since Examiner does not currently have the capability to directly measure dielectric constant for each channel. Figure 62 displays the enlarged area of GPR cross-section through the stitched file (covers the eastbound lane) showing the area with traced reinforcement reflector. The 3D-Radar system demonstrated the ability to identify areas of variable concrete cover thickness. Figure 63 shows the contour map of the concrete cover depths to the rebar, generated from the 3D-Radar data (top) compared to the results obtained with FDOT system (bottom). The distribution of cover depth values over the bridge deck surface demonstrated reasonably good correlation for air-launched and 3D-Radar data sets. The discrepancies in spatial distribution and degree of concrete cover observed between the air-launched and 3D-Radar GPR interpretations can be explained by several factors including different GPR systems employed, and differences in tracking of the rebar layer. 3D GPR data were used to generate a contour plot of rebar depth, which is generally agrees with the FDOT results, generated using 2 GHz horns, with some minor discrepancies.

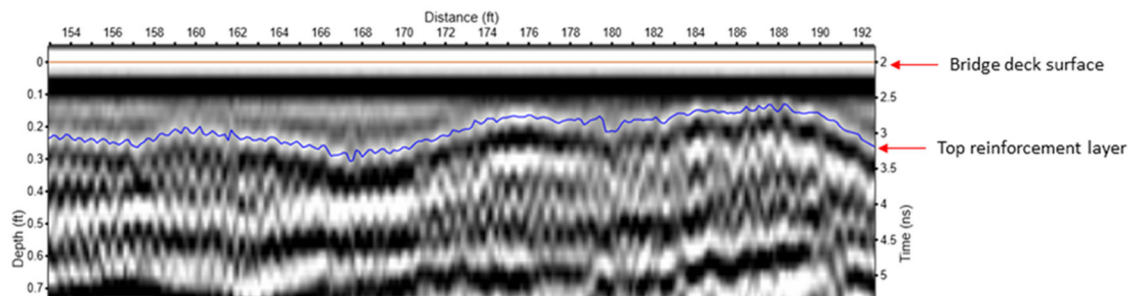
Figure 62: Example of 3D-Radar data cross-section showing the identified rebar layer (blue line).

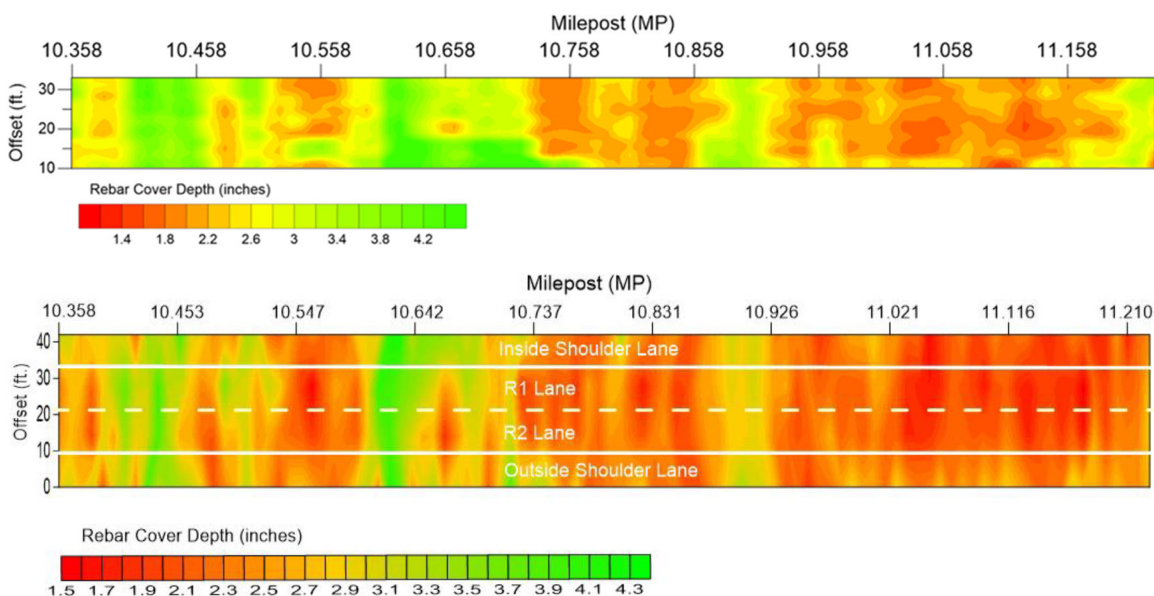
Figure 63: Contour map showing concrete cover depth to rebar, generated from 3D-Radar survey data (top); contour map showing concrete cover depth to rebar, generated from 2 GHz air-launched GPR data (bottom). Not to scale - axis were adjusted for better data representation.

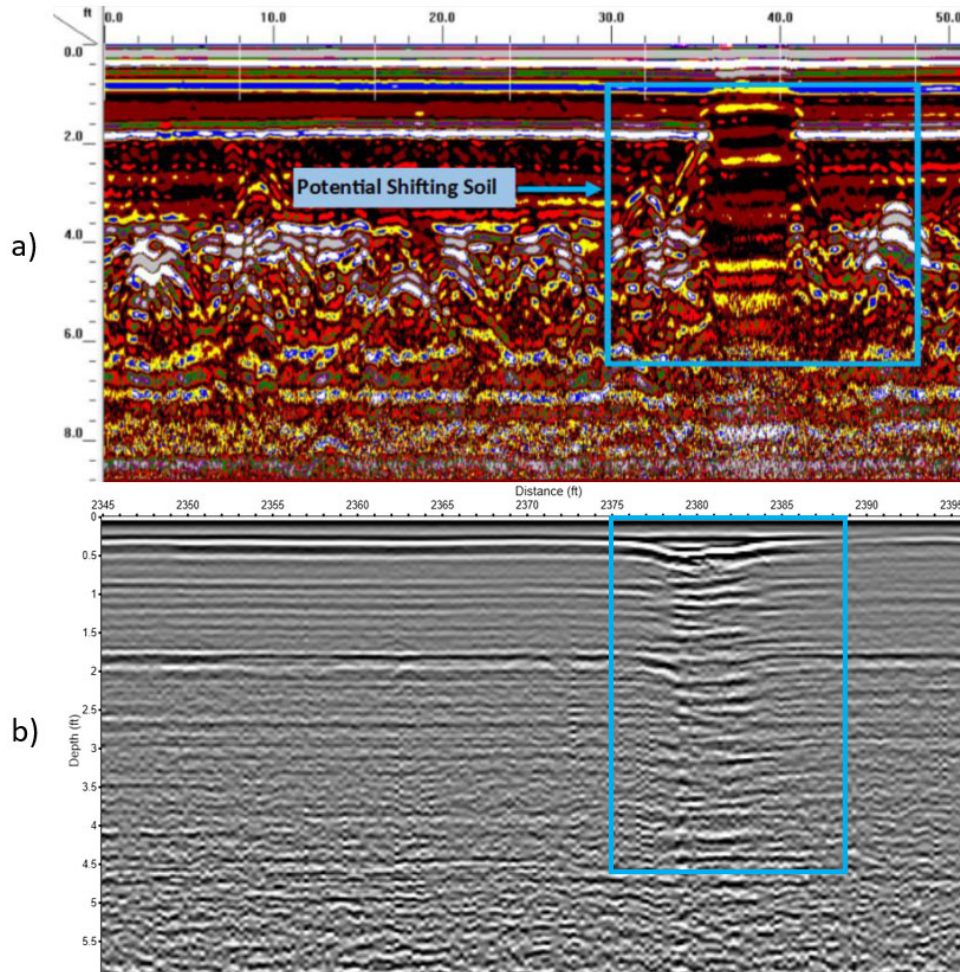
Blue frames represent features identified as potential shifting soils; green frames indicate features that were detected on both 3D-Radar and ground-coupled GPR unit data; orange frames represent features that were noticed on 3D-Radar data only; red frames represent features which were not noticed on 3D-Radar data in proximity of the third test location.

Figure 64: Segment of the 400 MHz GPR data showing reflections associated with shifting soil (a); segment of 3D-Radar data collected in proximity to the first test location displaying similar features (b).

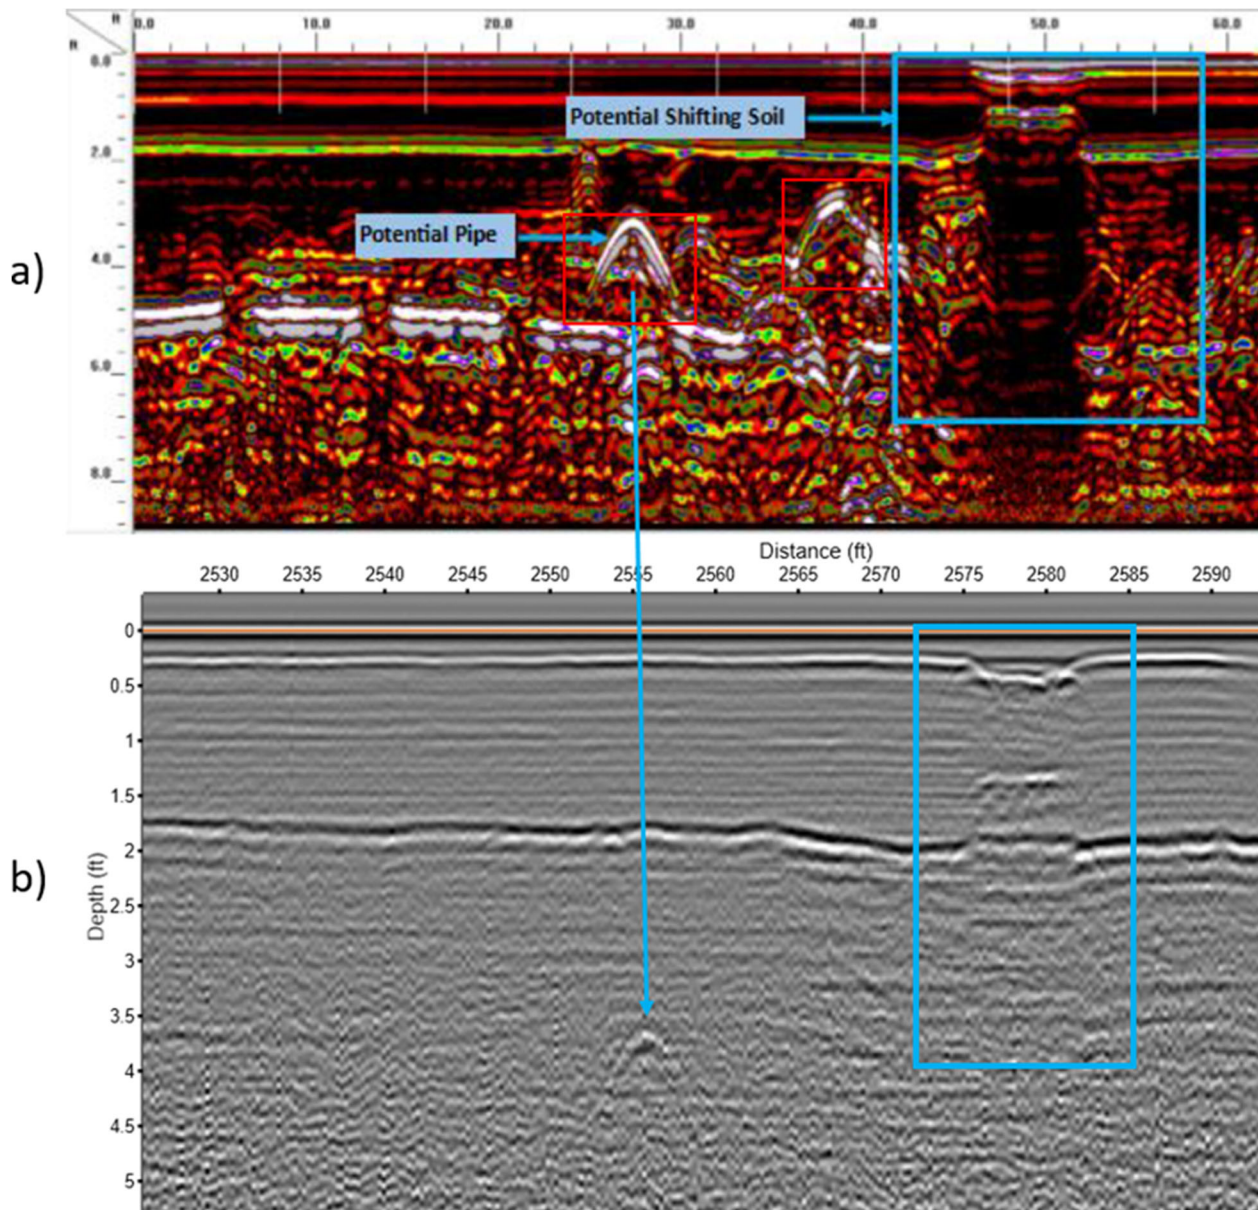
Figure 65: Segment of the 400 MHz GPR data showing reflections that can be associated with pipe and shifting soil (a); segment of 3D-Radar data collected in proximity to the second test location displaying similar features (b).

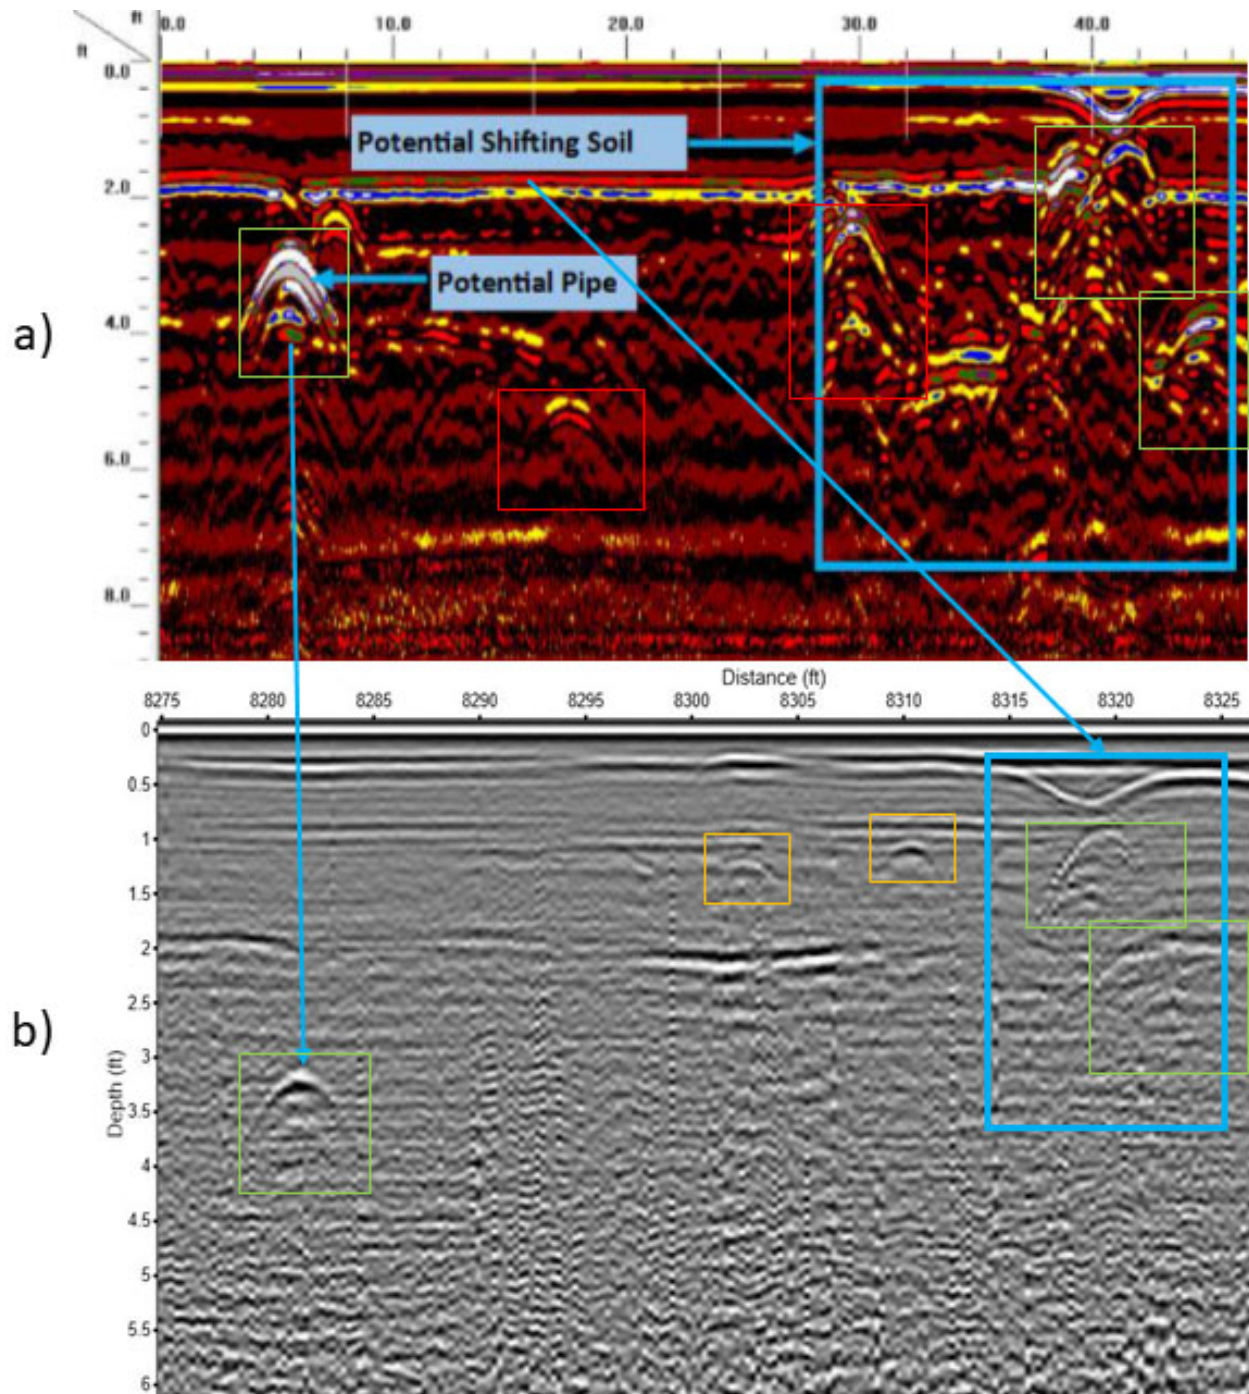
Figure 66: Segment of the 400 MHz GPR data showing reflections associated with potential pipe and shifting soil (a); segment of 3D-Radar data in proximity of the third test location displaying similar features (b).

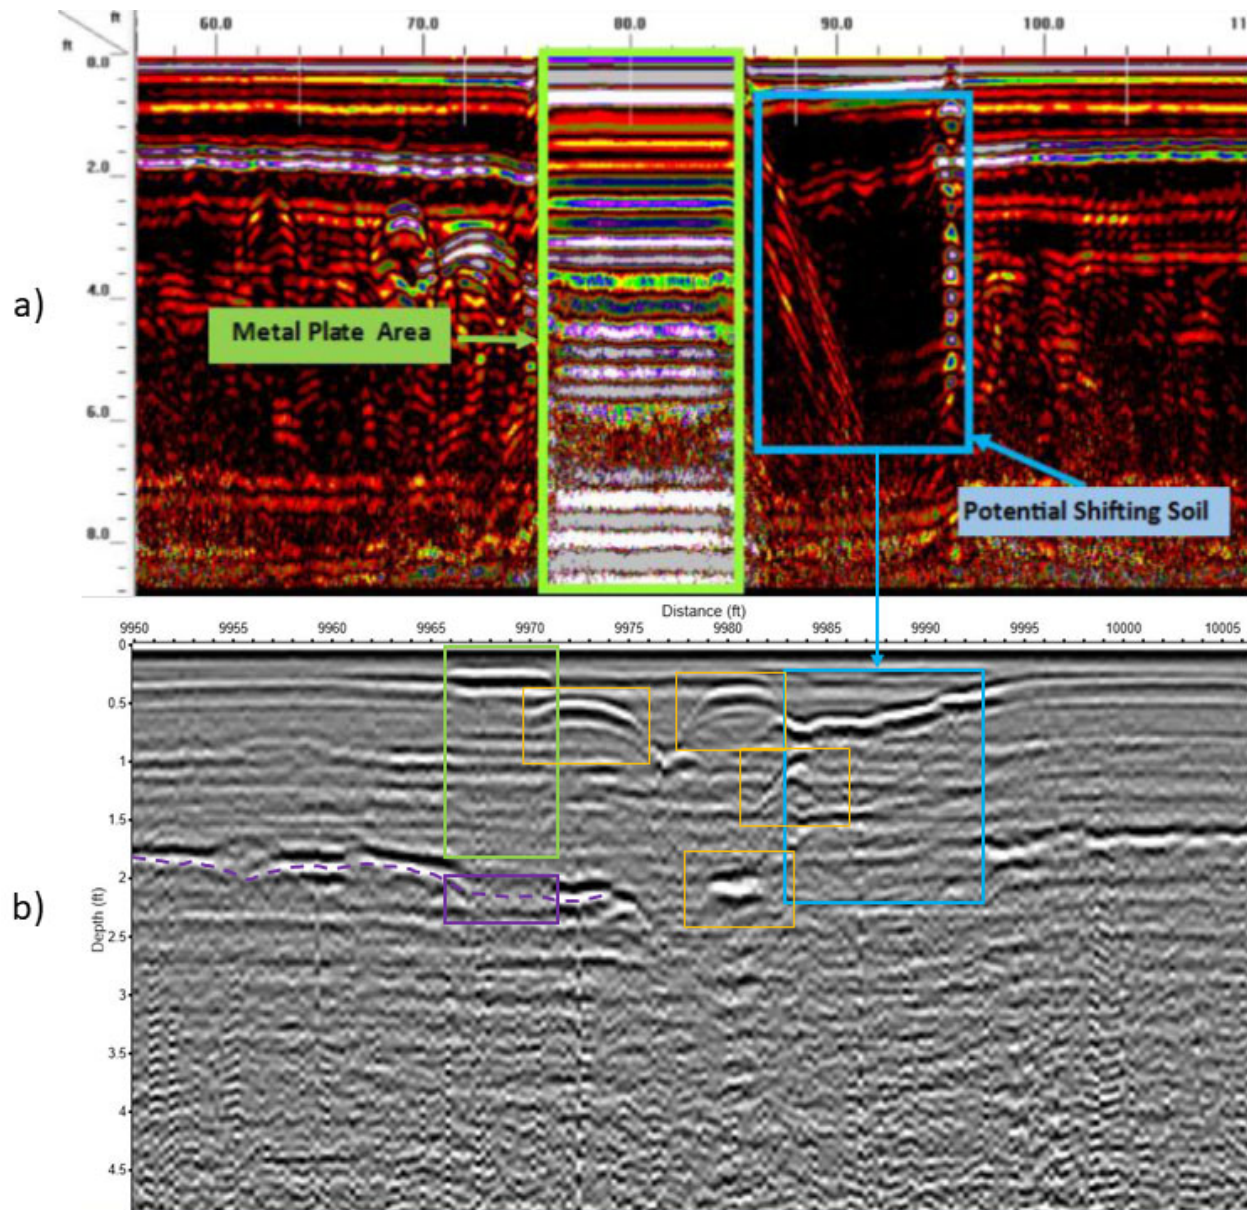
Figure 67 displays two segments of GPR data collected on fourth test location [8] using ground-coupled GPR unit equipped with 400 MHz antenna (4a) and 3D-Radar system (4b). Blue frames represent features identified as potential shifting soils; orange frames represent features that were noticed on 3D-Radar data only. 3D-Radar data reveals more distinct features as it can be seen in Figure 67 (bottom). The reflection pattern that can be associated with metal plate (green frame) is approximately 5 ft.-long on the 3D-Radar data; even though it doesn't exhibit typical ringing effect on 3D-Radar data, the corresponding area of subjacent interface reflection is absent (marked with purple frame). The 3D-Radar survey revealed some subsidence related conditions, but not as thorough as 400 MHz ground coupled GPR.

Figure 67: Segment of the 400 MHz GPR data showing reflections associated with potential pipe and shifting soil (a); segment of 3D-Radar data in proximity of the fourth test location displaying similar features (b).

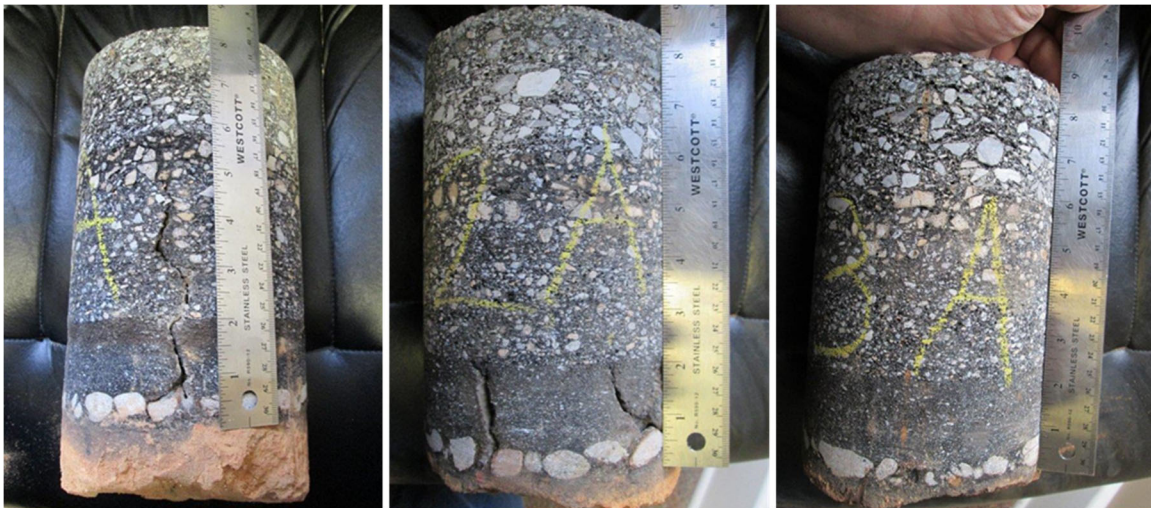
five locations (MP 7.6091, MP 7.7485, MP 8.7899, MP 8.8551, MP 8.8858). Figure 68 shows the condition of pavement section in proximity of MP 7.6091. Figure 69 shows photographs of core samples. The photographs reveal intensive cracking on specimen labeled 1A and 2A; porous nature of the cores can be observed as well. Figure 70 shows a full-depth vertical slice of 3D-Radar data, collected in westbound lane, near MP 7.6. Figure 70b shows a corresponding horizontal slice of 3D-Radar data at approximate depth of 4.2 inches (converted from two-way travel time with dielectric of 5).

Figure 69: Core samples extracted over the Site 1 (Gulf County, SR 22) Pavement section.

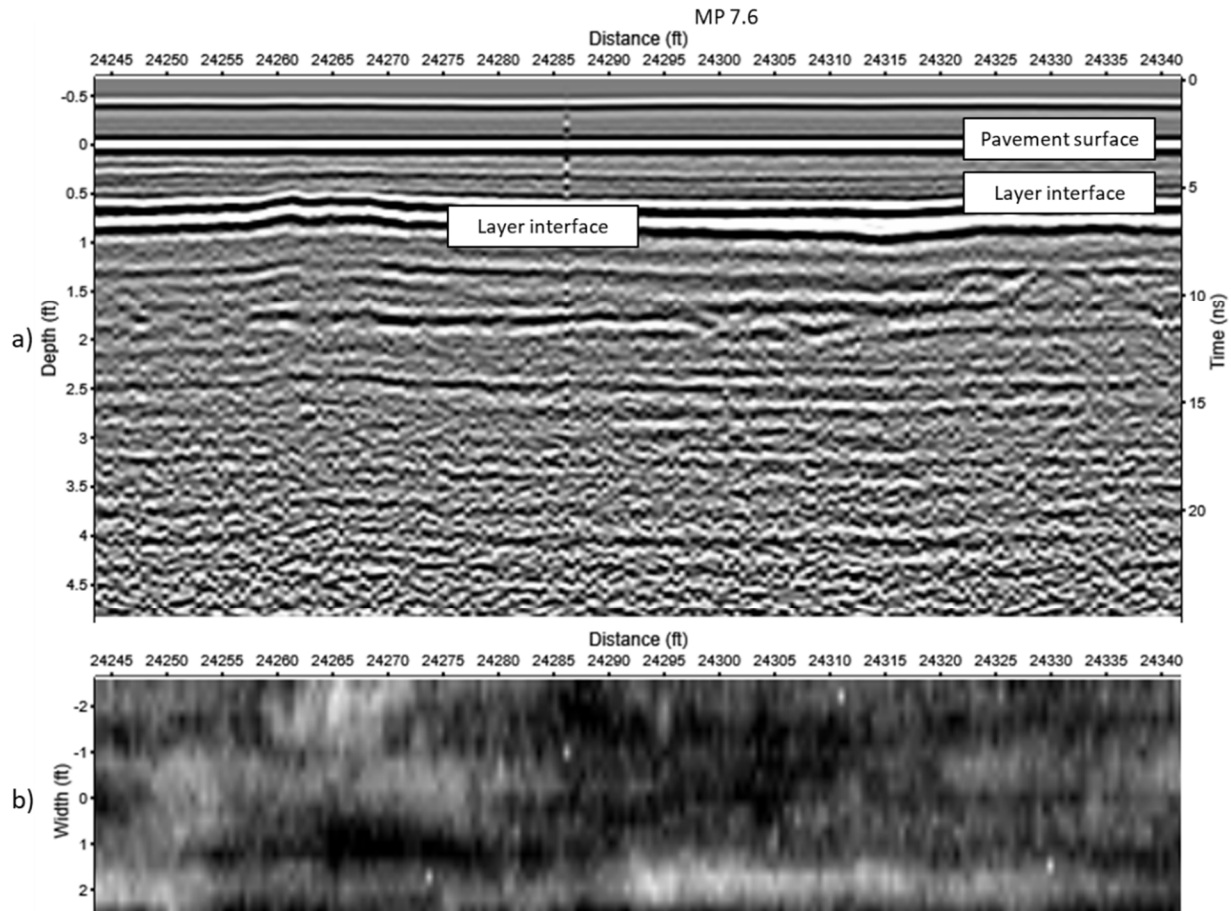
Figure 70: Vertical (a) and horizontal (b) slices of 3D-Radar data in proximity of MP 7.6, SR 22 westbound, right lane. Depth is converted from two-way travel time with dielectric of 5. Horizontal slice (b) was taken from the depth of 4.2 inches.

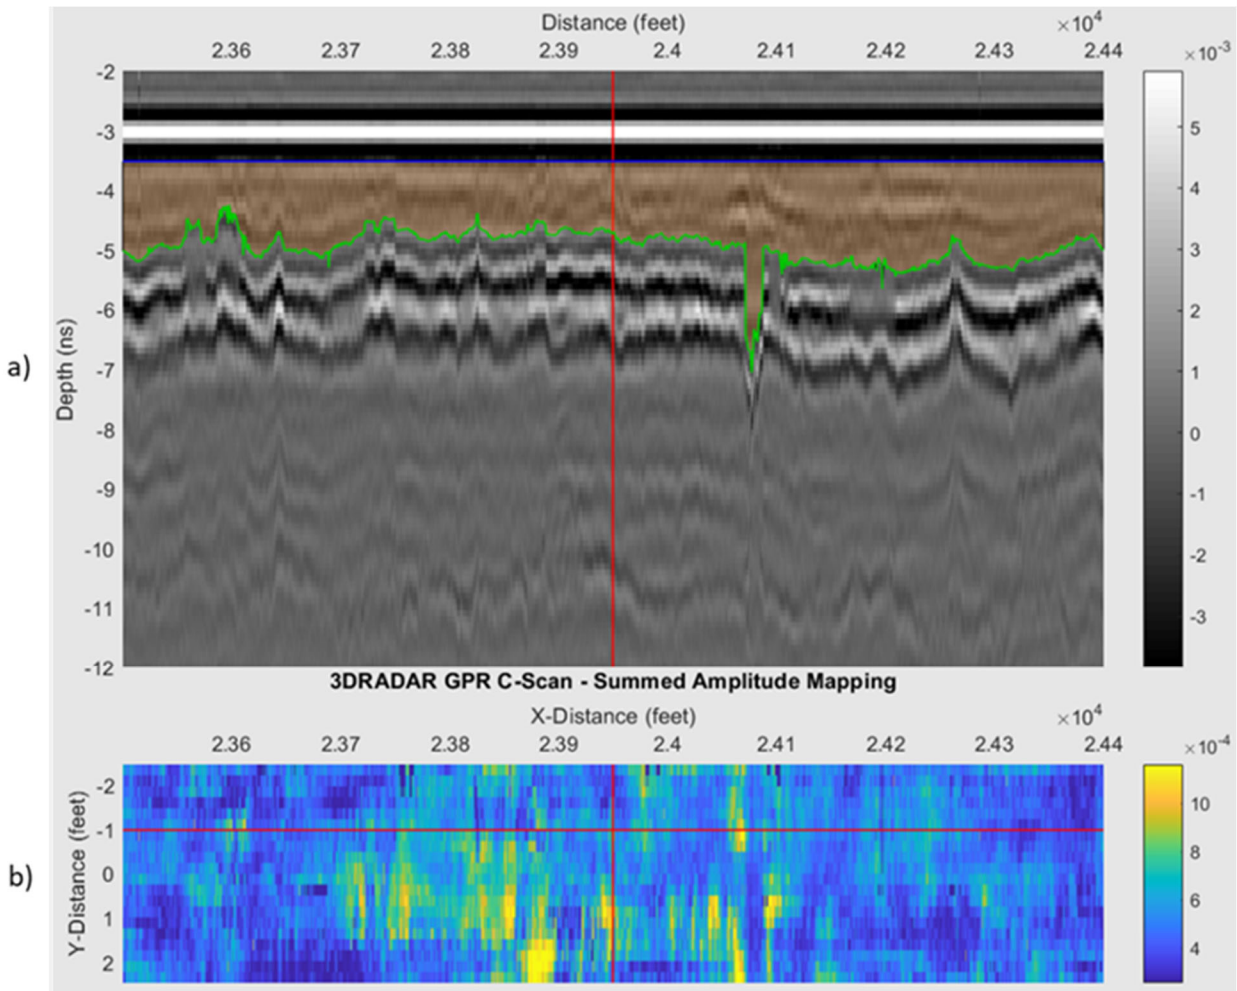
Figure 71 displays the example of Reflection Activity mode of ExploreGPR software showing the segment of 3D-Radar data collected in proximity of MP7.6. Figure 71a shows the b-scan and Figure 71b shows, with color-coded amplitude, the spatial distribution of reflection activity patterns over the specified depth interval shown by the opaque orange shape overlaid on the B-Scan axes.

Activity is defined as the average of the sum of the GPR amplitudes at every point of the GPR scan within the analysis window. The upper boundary of the window is indicated by a blue line at the top of the orange patch, while the lower boundary of the window is indicated by a green line at the bottom of the orange patch. The analysis was carried out on the depth interval defined by the upper limit of 3.5 ns (to exclude the strong surface reflection obtained at 3 ns from analysis) and by a 0.48 ns offset from the traced asphalt layer on the bottom. Interface dip in the right part of the Figure 71 associated with located trench with approximate length of 15 feet.

Figure 71: ExploreGPR interface showing the activity analysis performed on interval limited by 3.5 ns on top and offset of 0.48 ns on top of the traced layer interface on the bottom: a) is the b-scan; b) is a color-coded reflection activity plot for the window specified in a).

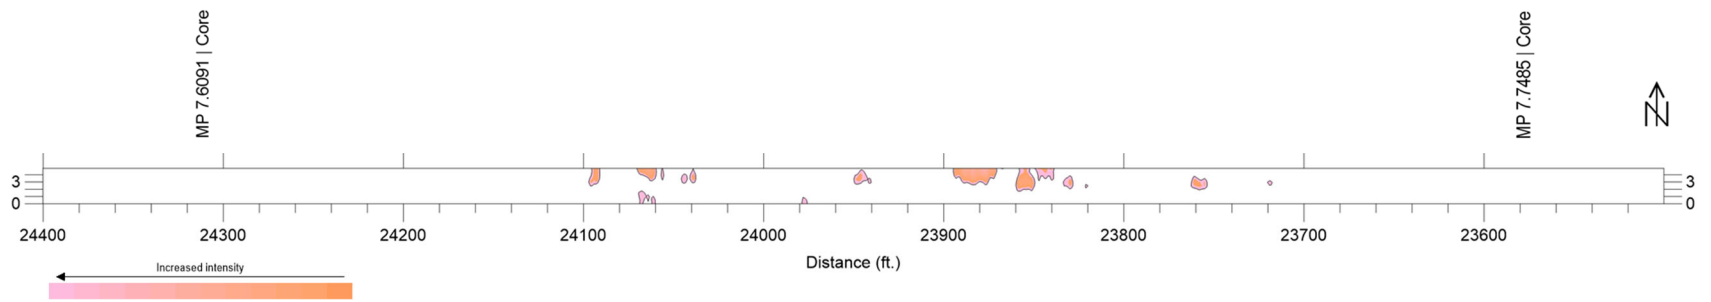
Figure 72 shows the spatial distribution of increased reflection activity within the AC layer covering the SR 22 from MP 7.59 to MP 7.76 in the westbound direction, right driving lane. The map was generated from the ExploreGPR output table using a thresholded Surfer contour plot. Shades of salmon color represent the anomalous reflection activity presented within the selected depth interval. The output data was normalized to a mean of 1.0, and a threshold of 1.5 was used to highlight significant reflection activity. Two parallel 3D-Radar profiles in proximity to the core extraction points have been stitched together with Examiner to enable analysis of the full width of the road lane. Figure 73 displays the Reflection Activity mode of ExploreGPR software showing the stitched section of 3D-Radar data, covering the SR 22 from MP 7.535 to MP 7.913. The analysis was carried out on the depth interval defined by the upper limit of 3.5 ns (0.5 ns. down from the surface) and by a 0.48 ns offset from the traced asphalt layer on the bottom. Figure 73a demonstrates the reflection analysis performed on the specified depth interval, Figure 73b is a spatial distribution of reflection activity patterns over the specified depth interval selected by the opaque orange shape overlaid on the B-Scan axes. It should be mentioned that plotting software interpolates data, filling the gaps between the stitched profiles. Considering the rationale of the proposed analysis method, it does not affect the deliverables.

Figure 72: Reflection activity map covering core locations at MP 7.7485 and MP 7.6091. Westbound direction, right driving lane

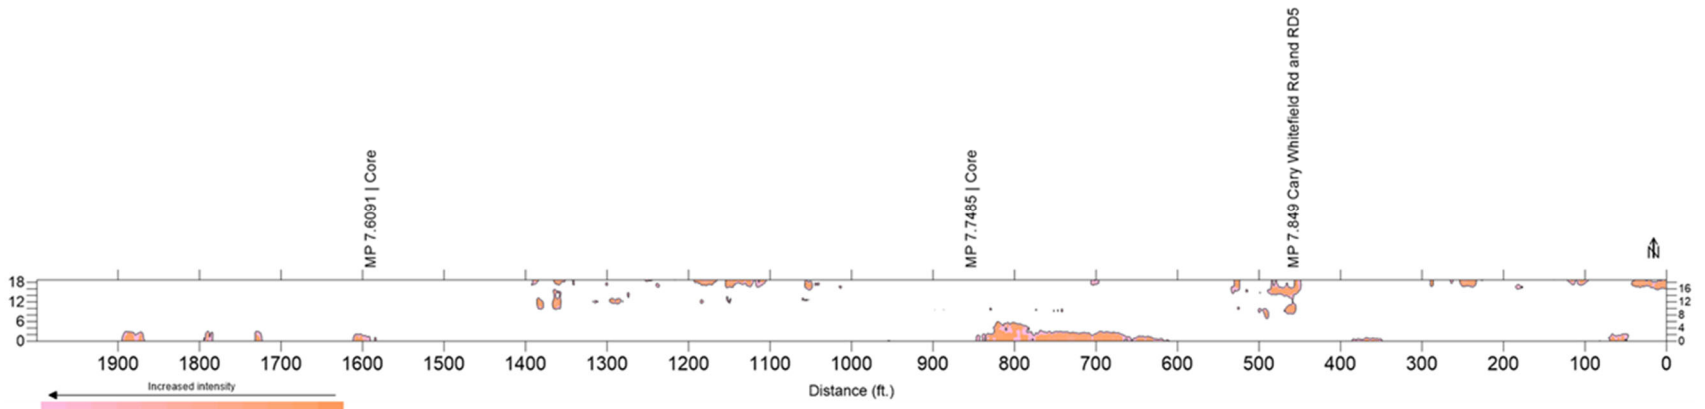
Figure 74 shows the spatial distribution of increased reflection activity within the AC layer of the stitched section of 3D-Radar data covering the whole width of SR 22 from MP 7.535 to MP 7.913. Figure 75 shows the spatial distribution of increased reflection activity within the AC layer of the second stitched section of 3D-Radar data covering the whole width of SR 22 from MP 8.625 to MP 9. It should be noted that due to partial overlap of collected 3D-Radar profiles in proximity to the core extraction points, resulting plots have different roadway widths.

Figure 74: Reflection activity map of pavement section covering Core locations at MP 7.6091 and MP 7.7485.

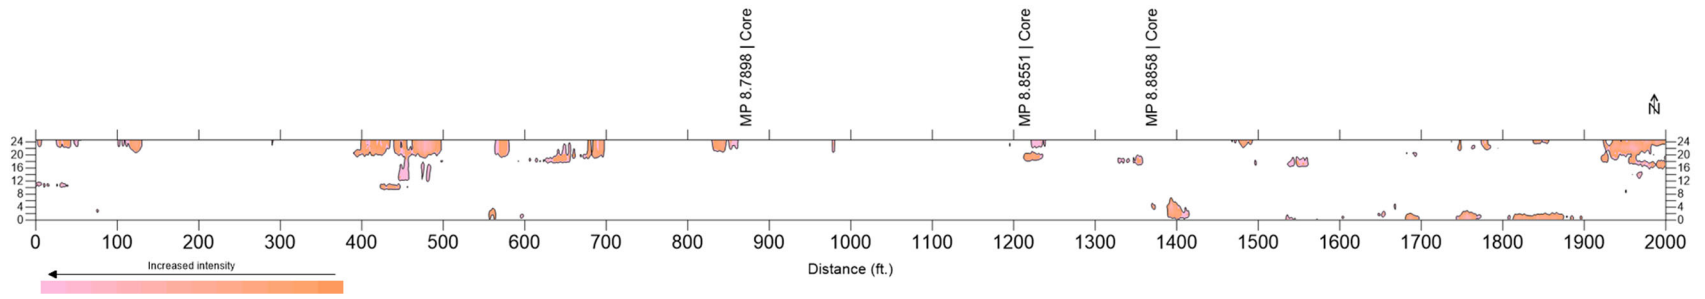
Figure 75: Reflection activity map of pavement section covering Core locations at MP 8.7898, MP 8.8551, and MP 8.8858.

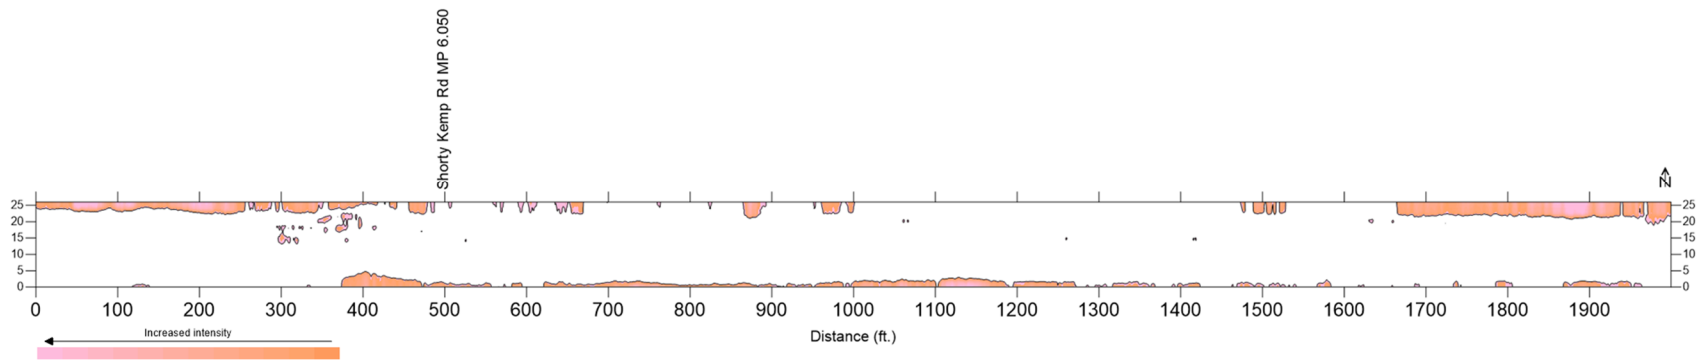
Patterns of increased reflection activity can be observed along the curbs and the turning lane. Resulting map represents the spatial distribution of reflection activity patterns within the isolated depth interval. This type of analysis examine data for deviations of dielectric properties of material and presence of internal reflectors at variable depths which are not normally seen within intact materials and can be indicative, but not limited to the indication of presence of “road worms” distress. Increased reflection activity can be considered as a precursor of developing deterioration and/or delamination, as well as appearance of thin asphalt layers in the upper part of the roadway. The 1.5 threshold (50% above the mean) used in this work is arbitrary, and modification can be made to reflect or eliminate precursor conditions.

Figure 77: Reflection activity map of the control section covering the SR 22 from MP 5.96 to MP 6.34.

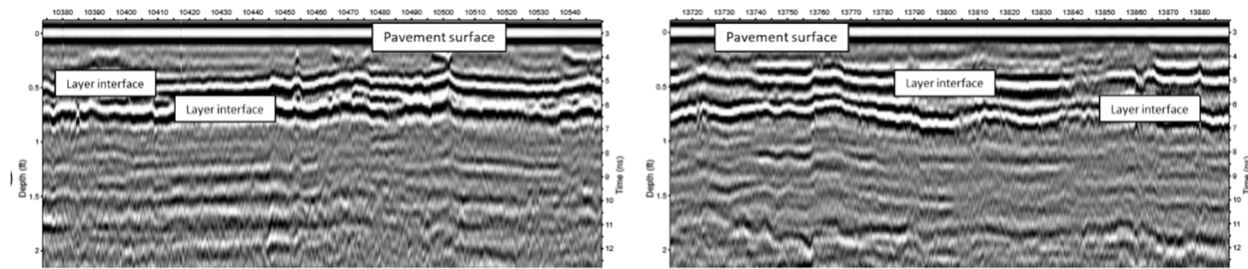
Figure 79 left, demonstrates segment of 3D-Radar data collected in northbound lane in proximity of MP 28.08 (outside of the road worms section). Figure 79, right, displays another segment of the same file, collected in proximity of MP 28.72 (within the road worms section). It should be noted that displayed scans represent the internal condition of pavement in proximity of particular mileposts only, and it can greatly vary from point to point. Approximate points where the photographs were taken were located using reference MP 28.068 (Knotch Pond Ln) and MP 28.326 (Bahoma Rd).

Figure 79: Vertical slices of 3D GPR data collected outside of the “road worms” section (left), and inside the “road worms” section (right). Northbound direction, left lane.

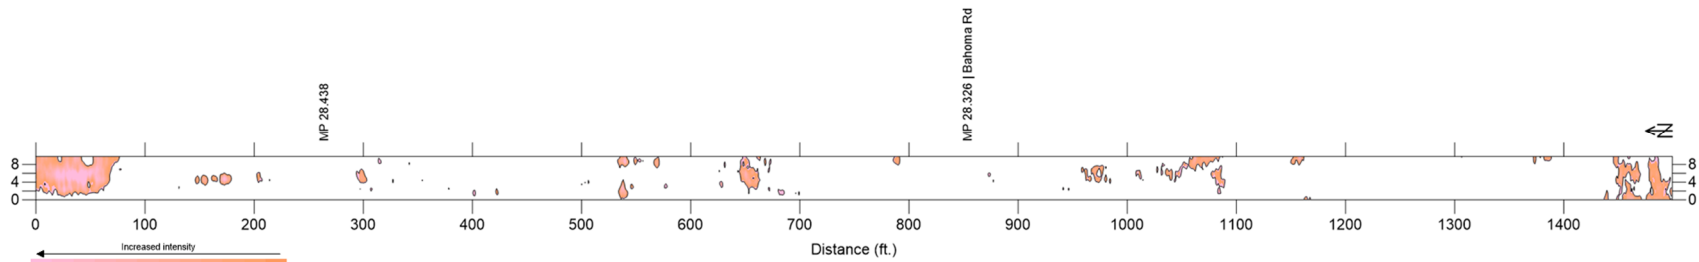
Figure 81 displays the spatial distribution of increased reflection activity within the AC layer of the first stitched section, covering the SR 77 from MP 28.2 to MP 28.49 in southbound direction. Figure 82 shows the spatial distribution of anomalous reflection activity within the AC layer of the second stitched section, covering the SR 77 from MP 28.21 to MP 28.47 in northbound direction. Figure 83 and Figure 84 show the spatial distribution of increased reflection activity within the AC layer of the third stitched section, covering the SR 77 from MP 29.08 to MP 29.27 in southbound and northbound directions, respectively. Figure 85 and Figure 86 show the spatial distribution of increased reflection activity within the AC layer of the third stitched section, covering the SR 77 from MP 29.31 to MP 29.5 in southbound and northbound directions, respectively.

**Figure 81: Reflection activity map of pavement section covering the SR 77 from MP 28.2 to MP 28.49. Southbound lane.**

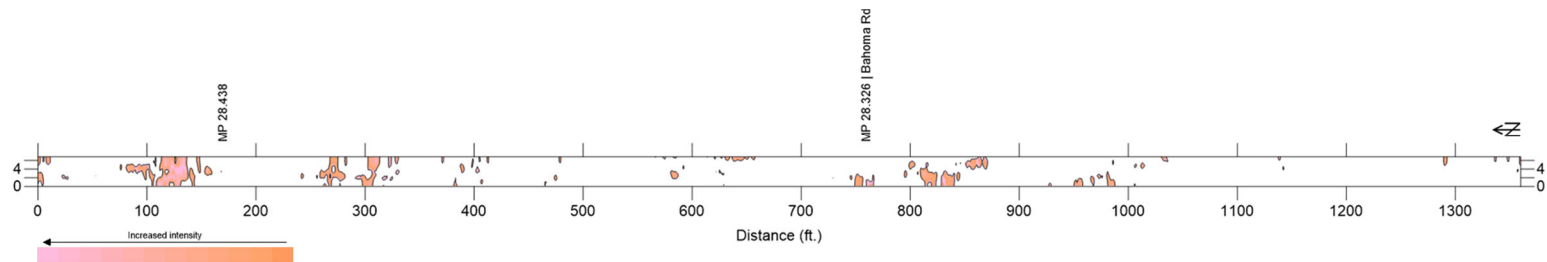
**Figure 82: Reflection activity map of pavement section covering the SR 77 from MP 28.21 to MP 28.47. Northbound lane.**

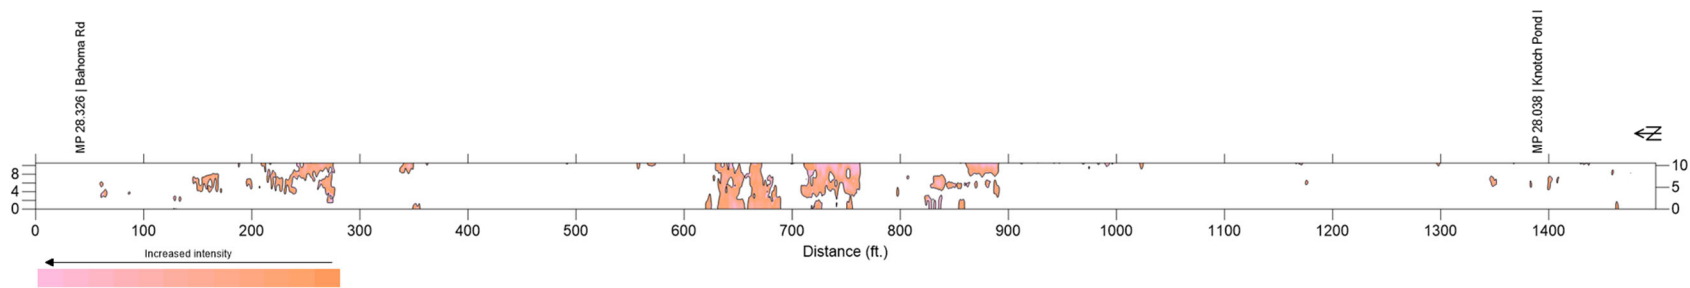
Patterns of increased reflection activity can be observed in the middle part of the control section. Resulting map represents the spatial distribution of reflection activity patterns within the isolated depth interval. This type of analysis examine data for deviations of dielectric properties of material and presence of internal reflectors at variable depths which are not normally seen within intact materials and can be indicative, but not limited to the indication of presence of “road worms” distress. Increased reflection activity in the middle of test section can be considered as a precursor of developing deterioration and/or delamination, as well as appearance of thin asphalt layers in the upper part of the roadway, that does not manifest itself on the pavement surface.

**Figure 88: Reflection activity map of the control section covering the SR 77 from MP 28.047 to MP 28.33 in southbound direction.**

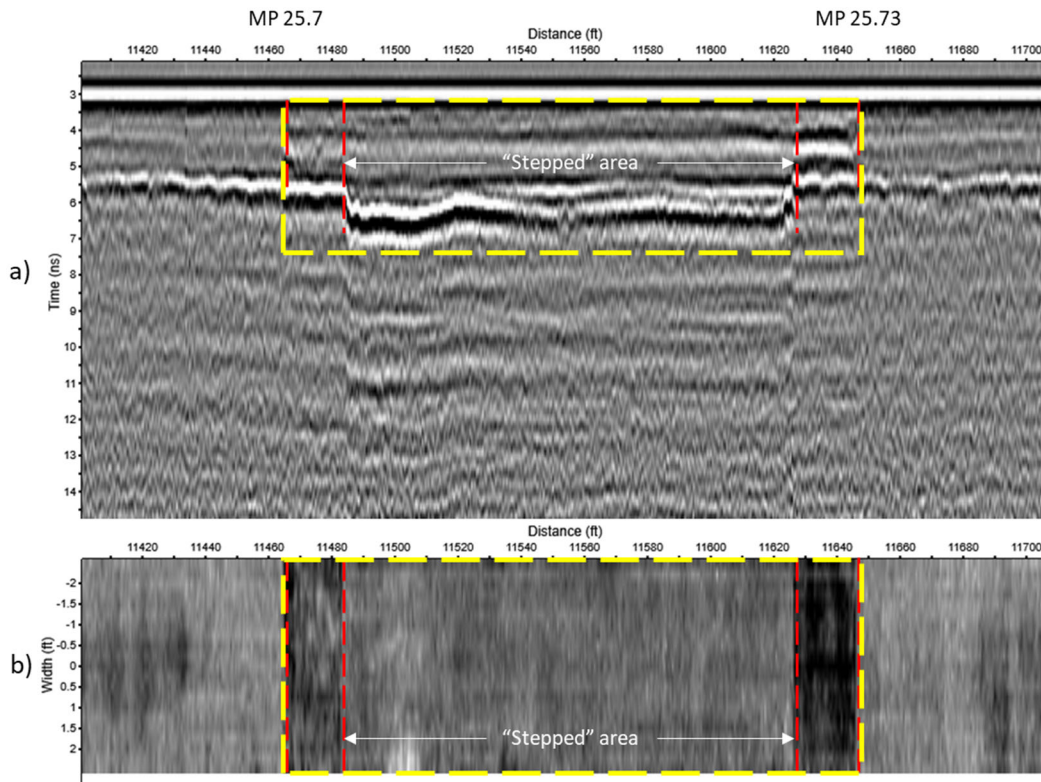
**Figure 89: Vertical (a) and horizontal (b) slices of 3D-Radar data in proximity of MP 25.7. Eastbound direction, right lane.**

Exact location and difference of the material removal depth on the both 140 feet long repair area itself and two additional milled segments can be observed in the part of 3D-Radar data collected in eastbound lane, where the vertical axis represents the depth expressed in ns. Yellow frames indicate the limits of a repaired zone. Red dashed lines delineate areas, where an additional 3 inches milling was performed starting 20 ft. from the begin of repair station to 20 ft. in advance of the end repair station to provide a “stepped” area [11]. Figure 90 represents a series of horizontal depth slices of 3D-Radar data, where the design and depth of the proposed repair area elements can be observed. Converting two-way travel time to depth, with average dielectric of 6, the depth in the B-scans correlate well with the proposed milling depth of 2 inches on the sides and 7 inches depth of the “stepped” area, which correlates with the proposed description of the repair [11]. While the 3D-Radar clearly reveals the repaired area, there are

no obvious indications in the data as to the nature and source of the underlying problem. No significant soil shifts and/or moisture pockets were observed below the repair area at depths up to 4.5 ft. Figure 91 shows full-depth vertical slice of 3D-Radar data in proximity to the repair section (depth was converted from two-way travel time with dielectric of 5).
