# *SHRP R06D Round 7 IAP Evaluation of 3D Radar*

## *Final Report*

Agreement No. BE291

Infrasense, Inc.

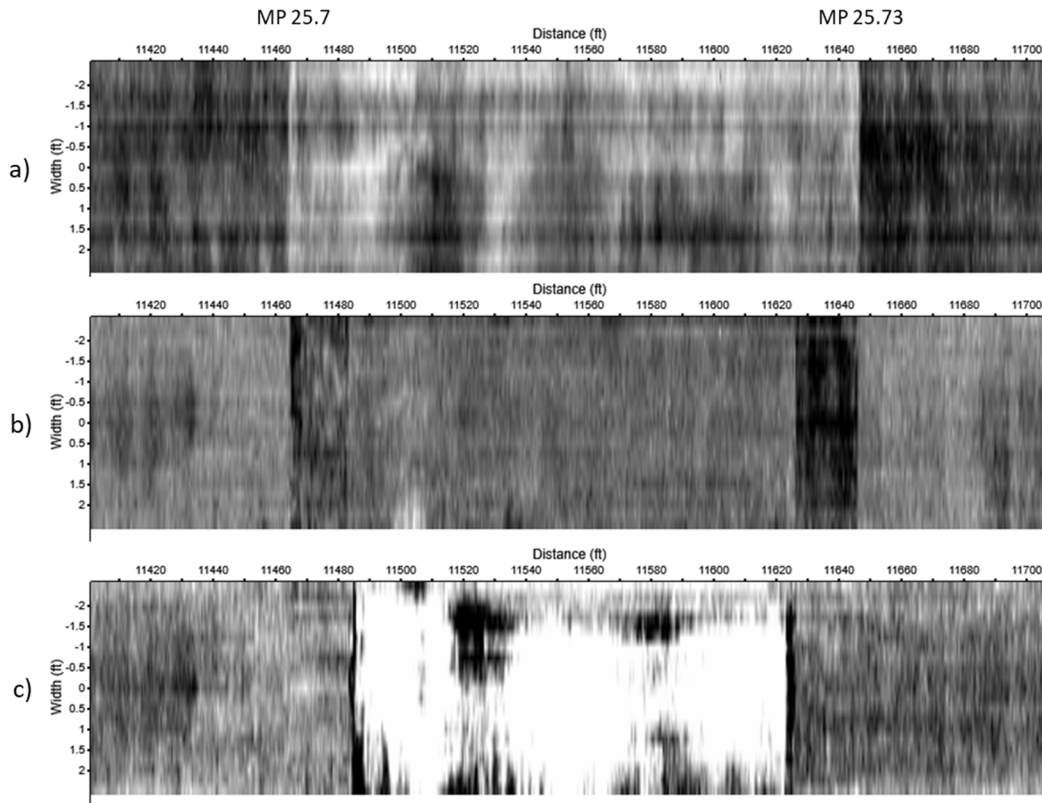
Exact location and difference of the material removal depth on the both 140 feet long repair area itself and two additional milled segments can be observed in the part of 3D-Radar data collected in eastbound lane, where the vertical axis represents the depth expressed in ns. Yellow frames indicate the limits of a repaired zone. Red dashed lines delineate areas, where an additional 3 inches milling was performed starting 20 ft. from the begin of repair station to 20 ft. in advance of the end repair station to provide a “stepped” area [11]. Figure 90 represents a series of horizontal depth slices of 3D-Radar data, where the design and depth of the proposed repair area elements can be observed. Converting two-way travel time to depth, with average dielectric of 6, the depth in the B-scans correlate well with the proposed milling depth of 2 inches on the sides and 7 inches depth of the “stepped” area, which correlates with the proposed description of the repair [11]. While the 3D-Radar clearly reveals the repaired area, there are

Figure 90: Horizontal slices of 3D GPR data in proximity of MP 25.7. Eastbound direction, right lane, at depths of 1 in. (a), 2.2 in. (b), and 7.2 in. (c).

Exact location and extent of repaired section were noted using 3D GPR system. Variations of the material removal depths on the repair area itself and two additional milled segments were also identified.

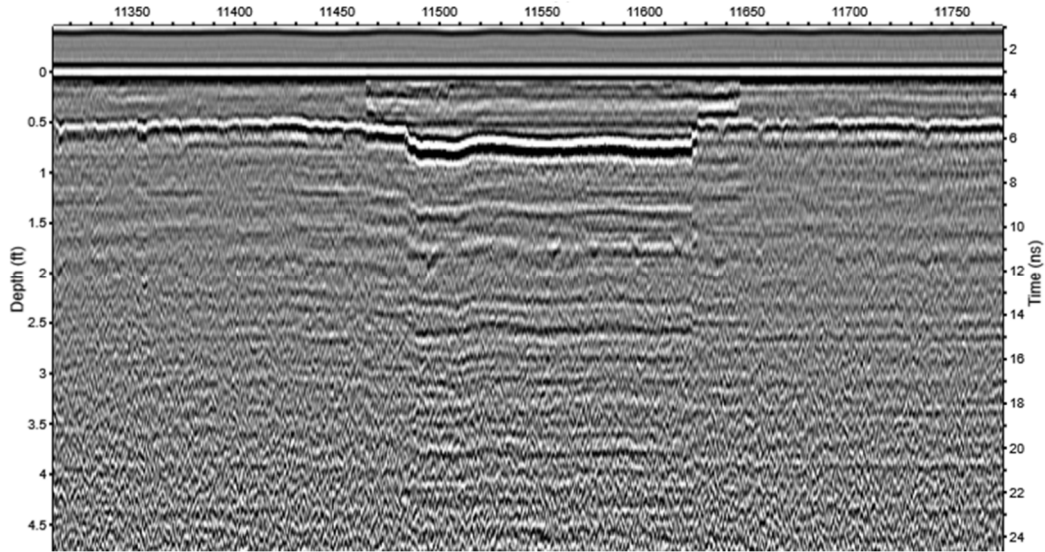
no obvious indications in the data as to the nature and source of the underlying problem. No significant soil shifts and/or moisture pockets were observed below the repair area at depths up to 4.5 ft. Figure 91 shows full-depth vertical slice of 3D-Radar data in proximity to the repair section (depth was converted from two-way travel time with dielectric of 5).

Figure 91: Full-depth vertical slice of 3D GPR data in proximity of the repaired area. Depth is converted from two-way travel time with dielectric of 5.

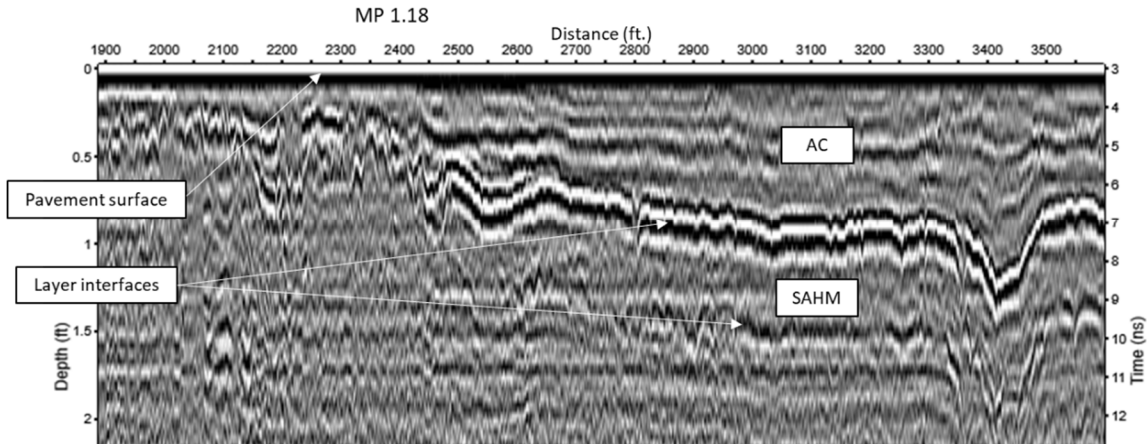
The 3D-Radar data, collected over the northbound pavement section, revealed the presence of sand-asphalt hot mix (SAHM) layer below the asphalt layer. As it can be seen in Figure 93-99 composition of northbound lane pavement is different from the southbound lane design. The presence of SAHM layer was registered on the northbound section, starting from the MP 1.18 (intersection of Harrison Ave and SR 75/US 231).

Figure 93: Vertical slice of 3D GPR data collected in southbound direction on the right lane. In proximity of MP 1.18 (the beginning of two-layered AC over SAHM design).

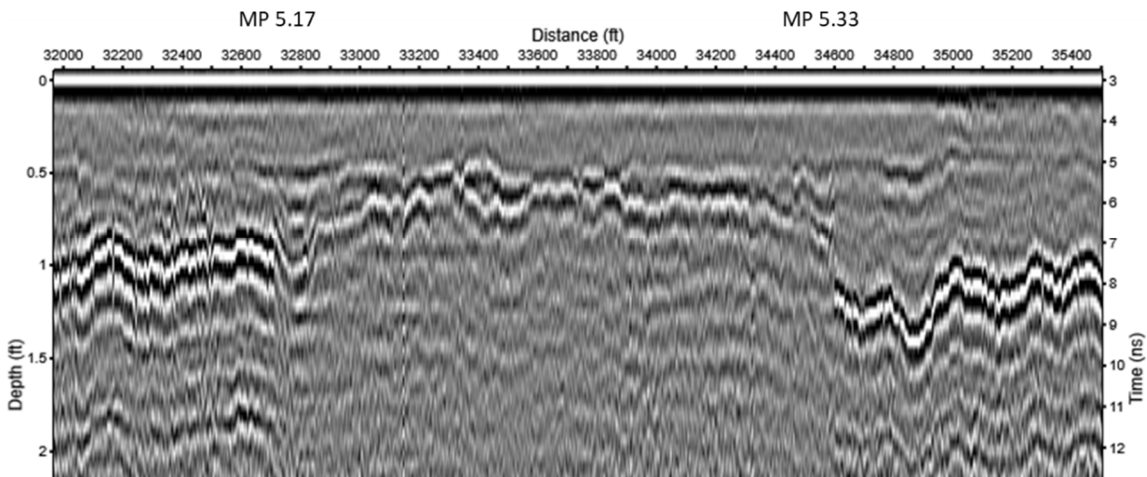
No SAHM layer signatures were observed in area limited by MP 5.17 on the south and MP 5.53 on the north (Figure 94), and over the area limited by MP 10.59 on the south and MP 510.73 on the north (Figure 95).

Figure 94: Vertical slice of 3D GPR data collected in southbound direction on the right lane. Different pavement composition noted between MP 5.17 and MP 5.33.

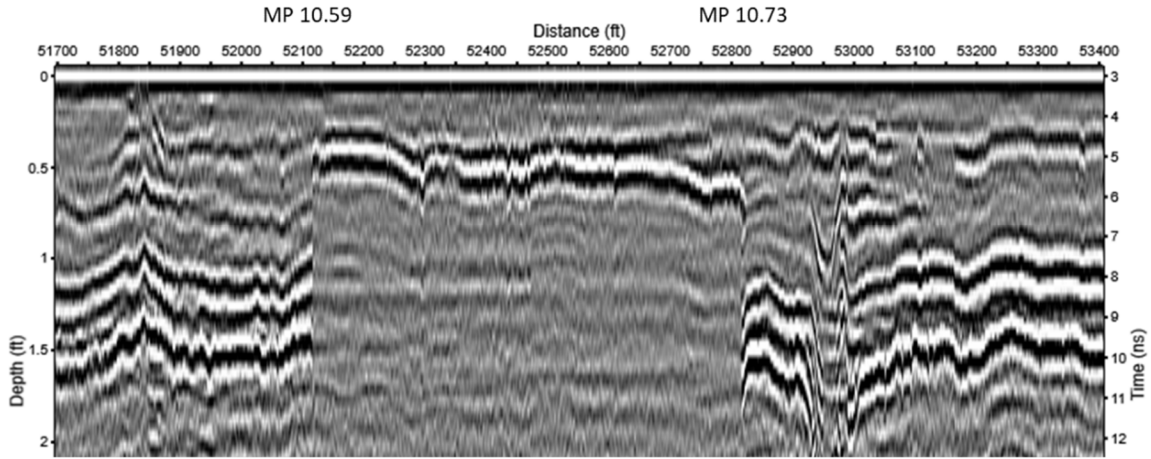
Figure 95: Vertical slice of 3D GPR data collected in southbound direction on the right lane. Different pavement composition noted between MP 10.59 and MP 10.73.

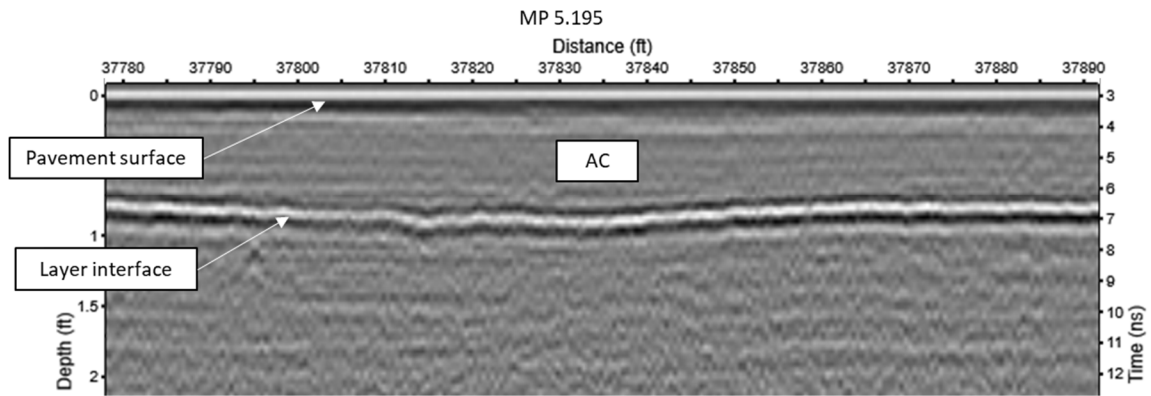
Figure 96: Vertical slice of 3D GPR data collected in southbound direction on the right lane. Displayed part represents the data from 320 ft. south from the intersection with Transmitter Rd, MP 5.195. Pavement design is represented by single AC layer, overlaying the base material.

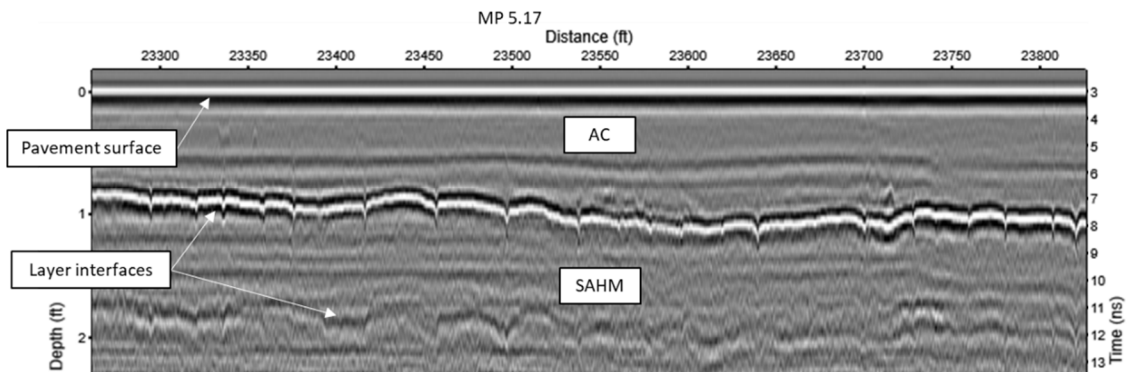
Figure 97: Vertical slice of 3D GPR data. Northbound direction, left lane, 320 ft. south from the intersection with Transmitter Rd. Very clear illustration of pavement design, which is represented by AC material overlaying the SAHM layer.

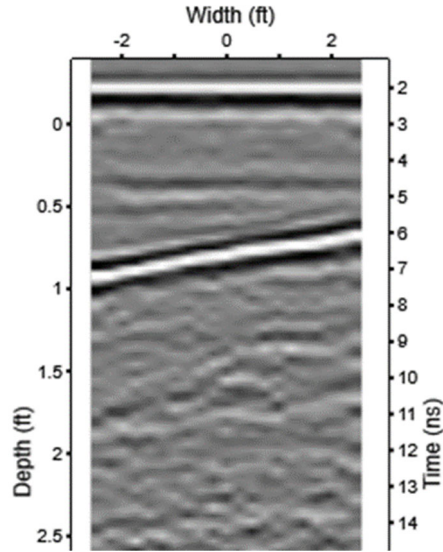
Figure 98: Typical section across the width of the pavement. The AC layer thickness varies by over 2".

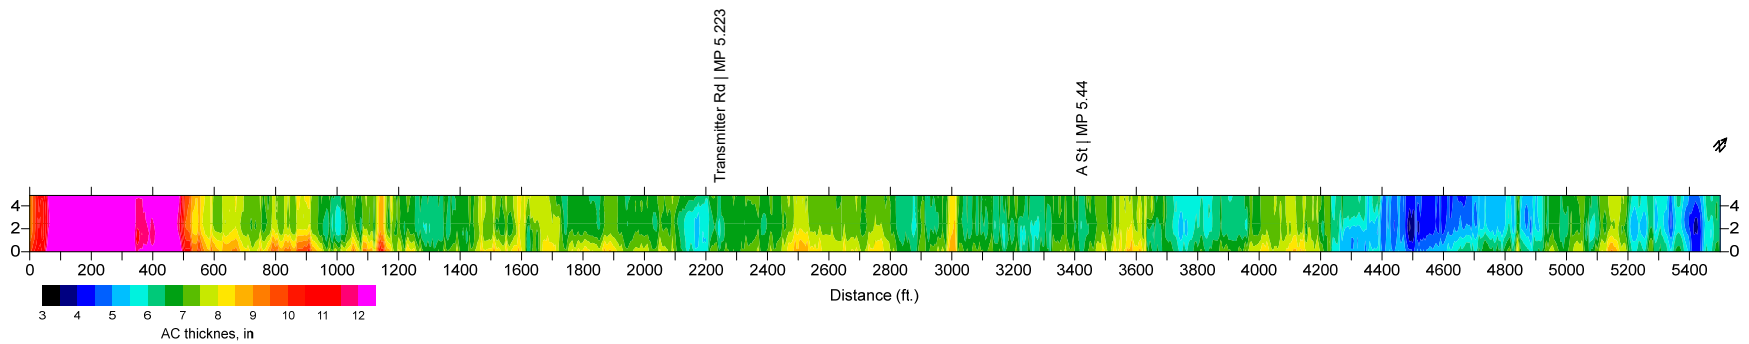
It can be seen from 3D-Radar data (Figure 99), that both material layers greatly vary in depth over the distance. Figure 100 and Figure 101 display the contour maps of AC and cemented material layer (SAHM) thicknesses, observed over the selected control section (northbound lane, SR 75/US 231 from MP 4.79 to MP 5.84). Y-axes were expanded for better data representation.

**Figure 100: Contour map, showing spatial distribution of asphalt thickness values, calculated from 3D-Radar data, collected in northbound direction over the selected segment of SR 75/US 231.**

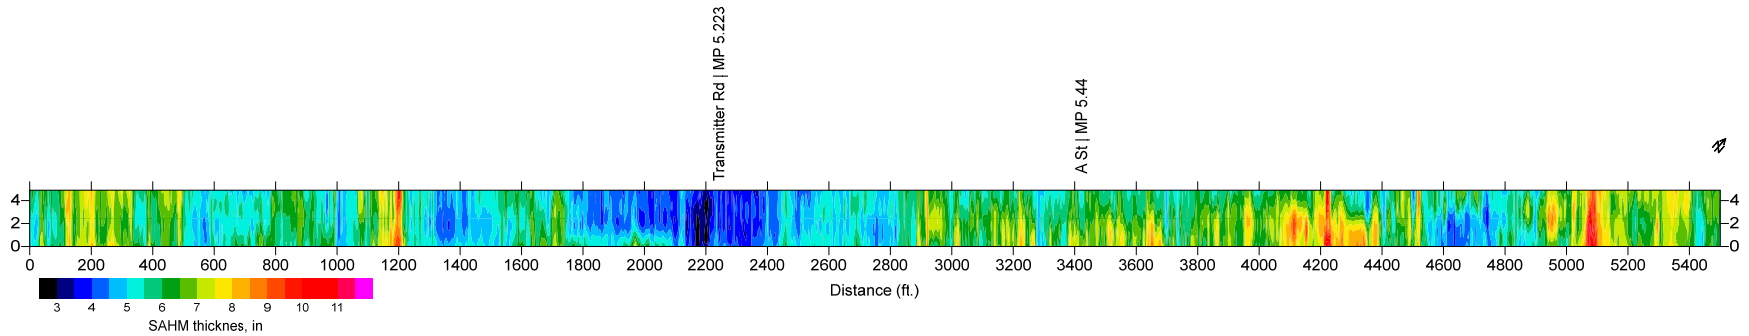
**Figure 101: Contour map, showing spatial distribution of underlying cemented layer thickness values, calculated from 3D-Radar data, collected in northbound direction over the selected segment of SR 75/US 231.**

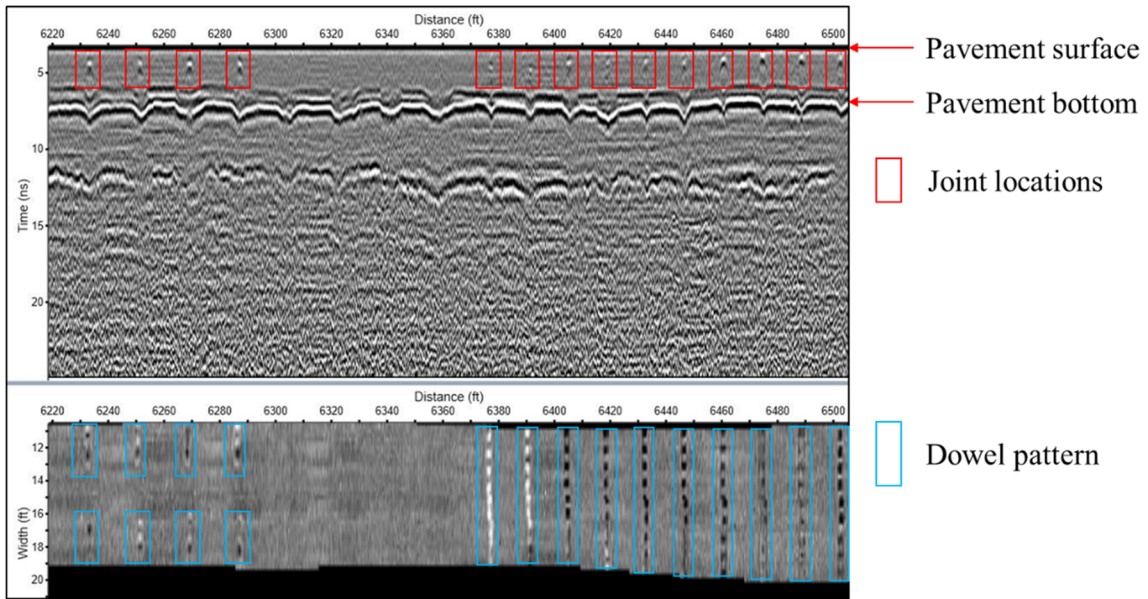
Figure 104: Undoweled section (left) between the SP and SD designs.

3D-Radar did not reveal the presence of proposed transition zones between the sections 13 and 12, 7 and 6, and 1 and 0; however, 3D-Radar clearly indicated existence of undoweled joints located in the last four slabs between the special (SP) and standard (SD) dowel subsections. Figure 107 exhibits the proposed Test Section design (left) and the Test Section design obtained from 3D-Radar survey results.

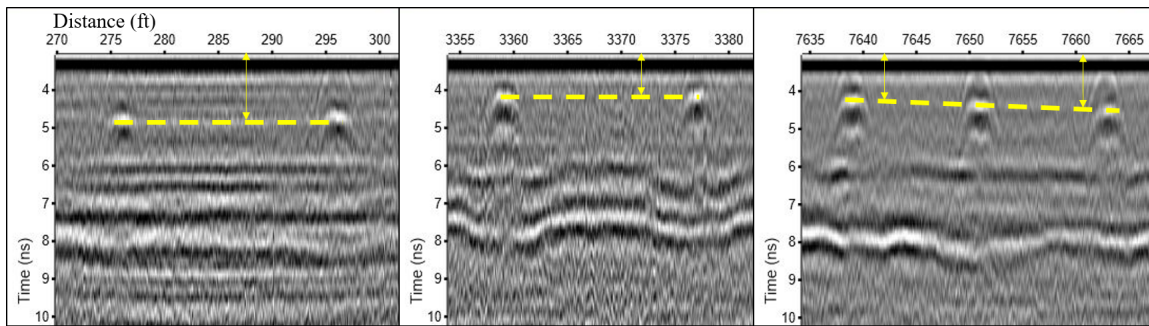
Figure 105: Various dowel depths observed on 3D-Radar data collected over the Test Section.

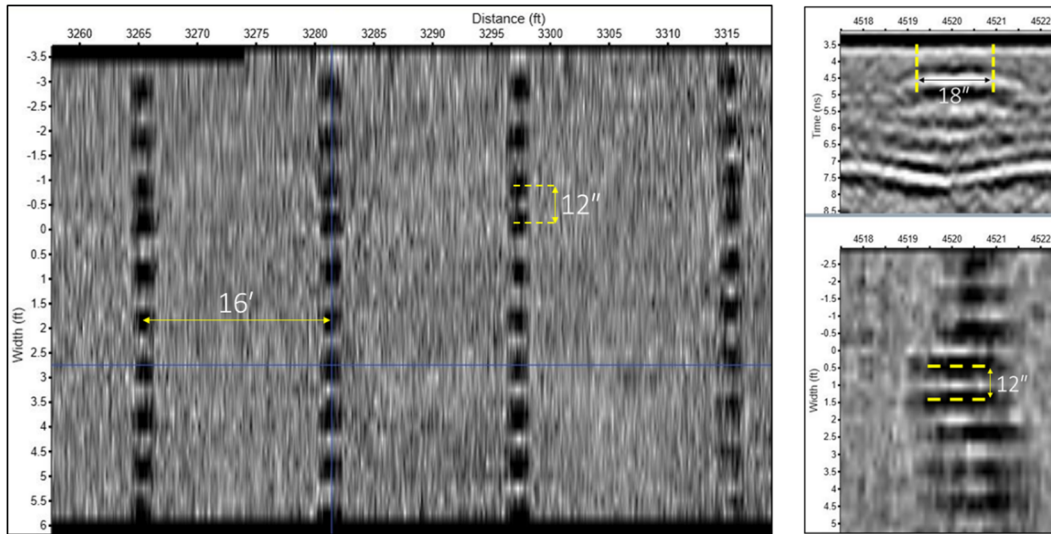
Measurements of dowel bars signatures on 3D-Radar data confirmed 18" dowel length and 12" dowel spacing. Proposed slab dimensions were confirmed with 3D-Radar survey results with minor discrepancies. Example is shown in Figure 106.

Figure 106: Measured dowels dimensions and spacing.

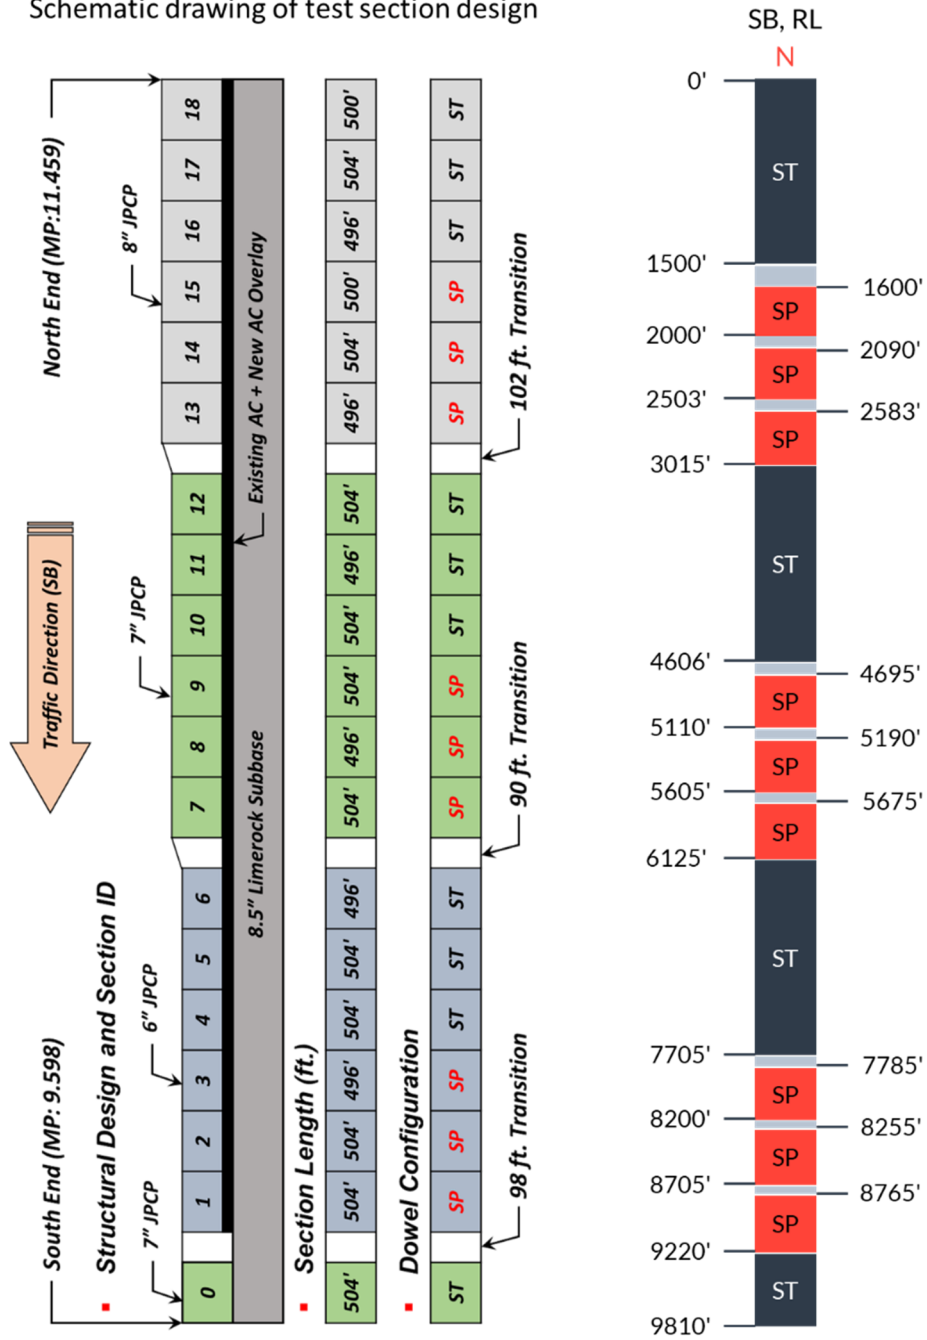
Figure 107: Schematic drawing of test section design dimensions provided by FDOT (left). Figures on the right represent the difference between the proposed and observed Test Section designs.

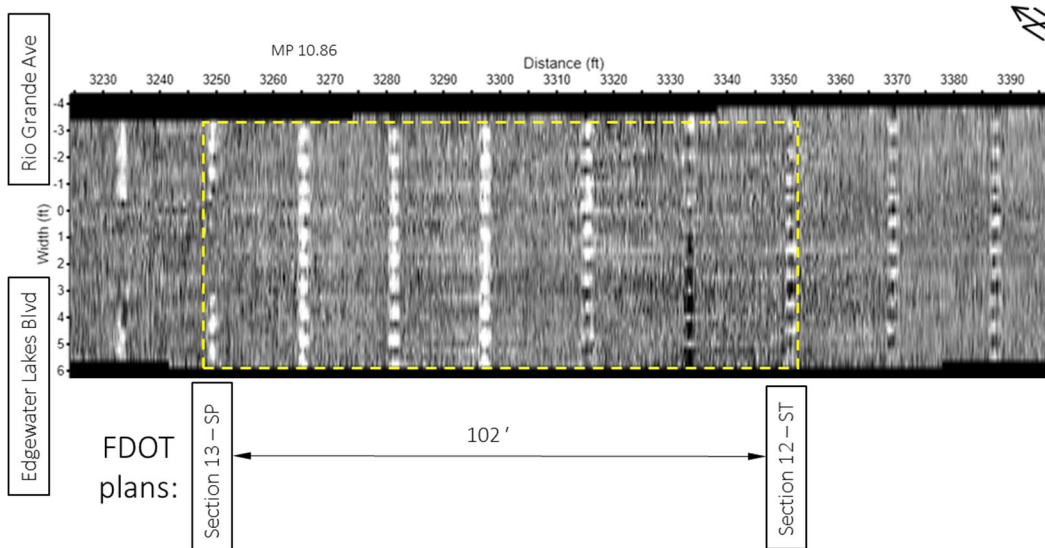
The design of the proposed transition zones with no dowels do not agree with the plan. As it can be seen on the 3D-Radar data (Figure 108, first of the proposed transition zones), transition zone contains additional ST doweled joints. Figure 109 contains the comparison of proposed (left) and measured by 3D-Radar slab length for sections 18 - 0. The misalignment (horizontal skew and vertical tilt) of dowel bars can be accessed and examined to the limited extent, as it shown in Figure 106 . However, it is difficult to evaluate the lateral positioning of a single dowel bar.

Figure 108: Segment of 3D-Radar data in proximity of the proposed transition section location (framed with dashed yellow line).

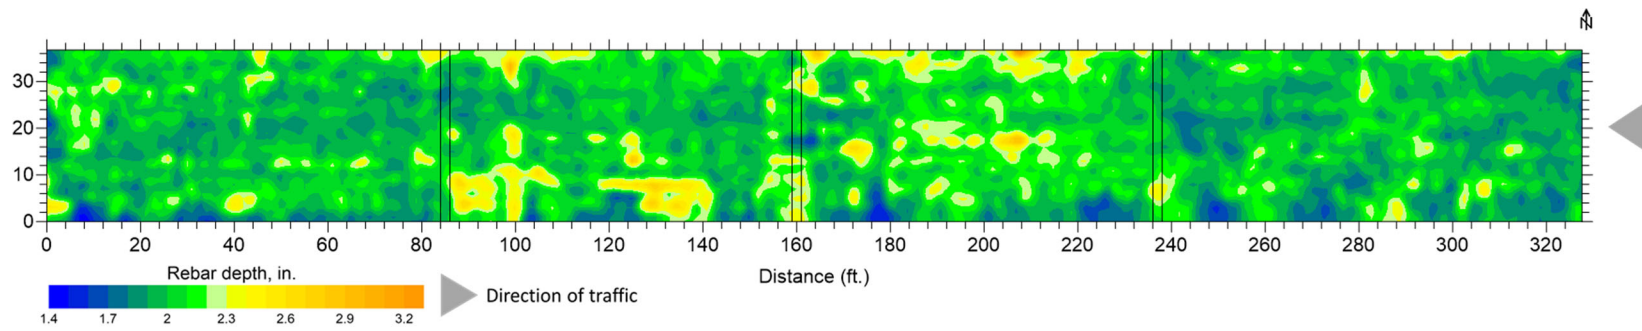
Representative results for Broward County bridge are shown in Figures below. Figure 114 and Figure 115 show the spatial distribution of deterioration detected with GPR using a thresholded contour plots for westbound and eastbound lanes, respectively. Areas shown are those where the attenuation levels exceed a threshold value, indicating chloride contamination and corrosion. The color scale indicates the degree to which the threshold is exceeded, which represents the severity. Shades of blue delineate areas, where detected deterioration level exceeds the set threshold, shades of magenta color indicate more severe deterioration. Figure 116 and Figure 117 show contour maps of the rebar depth for westbound and eastbound lanes, respectively. Shades of blue and green colors represent rebar cover from 1.4 to 2.25 inches, and shades of yellow and brown represent rebar cover from 2.5 to 3.2 inches.

Figure 116: Rebar depth contour plot, generated from the results of 3D-Radar survey on westbound lane.

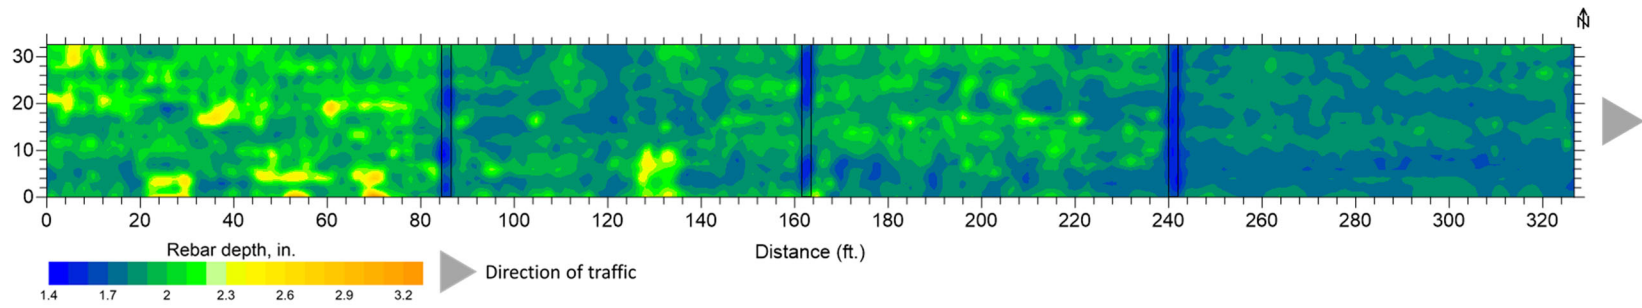
Figure 117: Rebar depth contour plot, generated from the results of 3D GPR survey on EB lane.

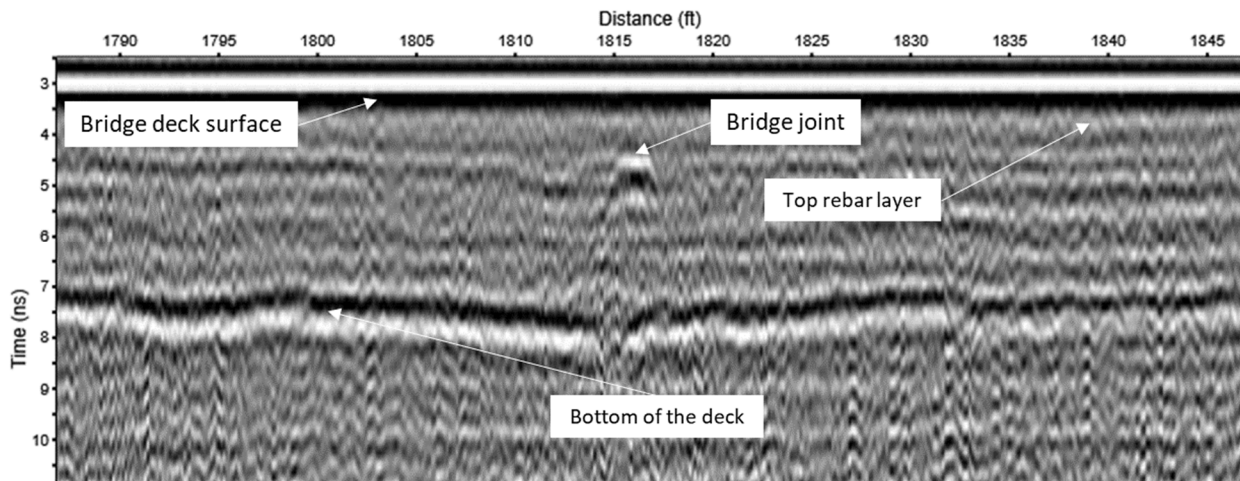
Figure 118: Vertical 3D-Radar cross-section showing the identified rebar layer and deck bottom, left side of the right driving lane, eastbound. Top layer rebar reflection is barely detectable.

Reflection Activity analysis approach was employed for this project. As it can be seen from Figure 118, the quality of 3D-Radar data does not allow to precisely pick the rebar layer reflector. As an alternative, ExploreGPR was used to examine and analyze 3D GPR data collected both in the westbound and eastbound lanes. Each span's activity was analyzed individually to neglect the possible smoothing of anomalous reflection activity and to avoid the impact of strong joint reflections on amplitude values distribution. Interval of 1 ns (from 3.5 to 4.5 ns) was selected to represent the activity within the upper part of bridge deck, where the top layer of rebar is present. Figure 119 displays the reflection activity mode of ExploreGPR software showing the segment of stitched file, covering the eastbound lane of the bridge. Figure 119b displays horizontal slice of 3D-Radar data with color-coded reflection activity distribution patterns. Shades of orange/yellow represent lower resulting amplitudes, shades of blue represent higher reflection activity.

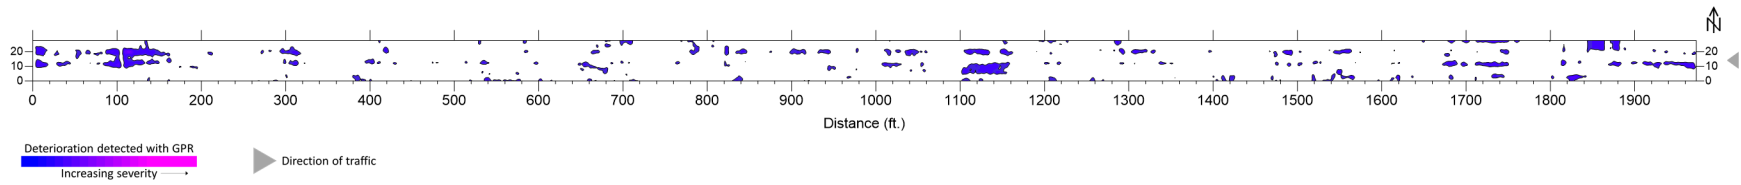
Representative results for Blue Heron bridge are shown in Figure 120 and Figure 121 that show the spatial distribution of increased reflection activity within the defined depth interval using a thresholded contour plots for westbound and eastbound lanes, respectively. Areas shown are those where the reflection activity levels exceed a threshold value, manifesting the deviations of dielectric properties and presence of internal reflectors at variable depths which are not normally seen within intact materials and can be indicative of delamination and/or deterioration. The color scale indicates the degree to which the threshold is exceeded, which represents the severity. Shades of pink color represent areas where moderate levels of reflection activity were observed, shades of blue color delineate areas associated with minor activity levels. Presented maps are not to scale on Y-axis; stretched to be informative and fit the screen well without compromising the visual data representation.

Figure 120: Reflection activity map, generated from the results of analysis of 3D GPR data collected over the westbound lane.

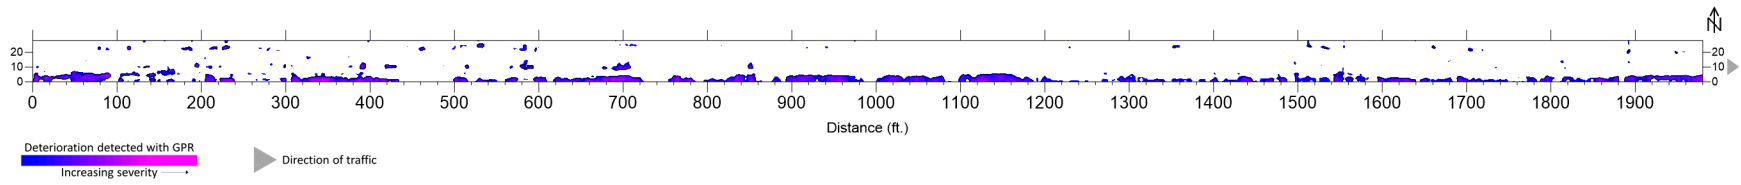
Figure 121: Reflection activity map, generated from the results of analysis of 3D GPR data collected over the eastbound lane.
