ESTIMATING THE AS-PLACED GROUT VOLUME OF AUGER CAST PILES – PART 1

BED25-977-04

Final Report

October 2024

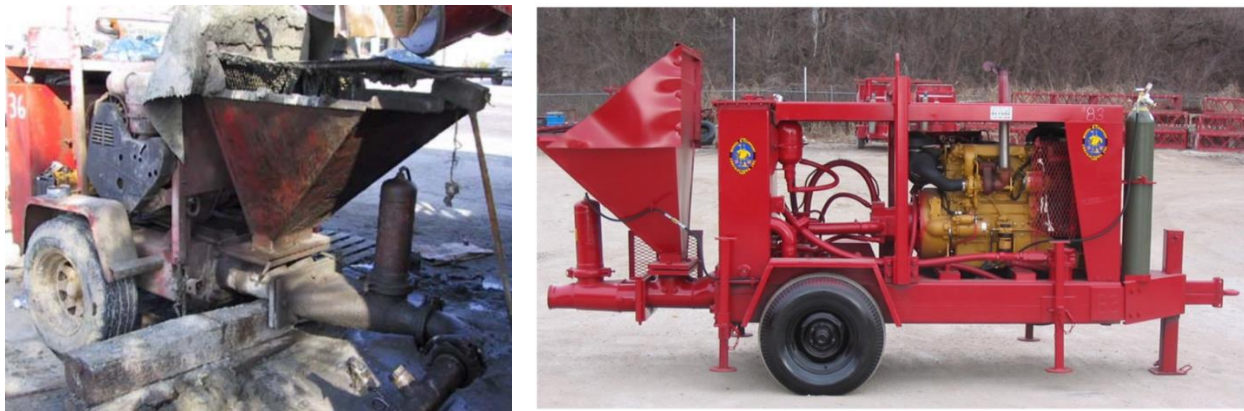
Figure 1.4 Two examples of grout pumps used during auger cast installation; left (Brown et al., 2007) and right (Marinucci & NeSmith, 2017)

Grout can either be mixed off-site by a ready-mix supplier and delivered in standard 8CY concrete trucks or mixed on-site in a batch plant. Once on-site, grout is fed into the hopper of a grout pump. Two examples of grout pumps used for auger cast pile installation can be seen in Figure 1.4.

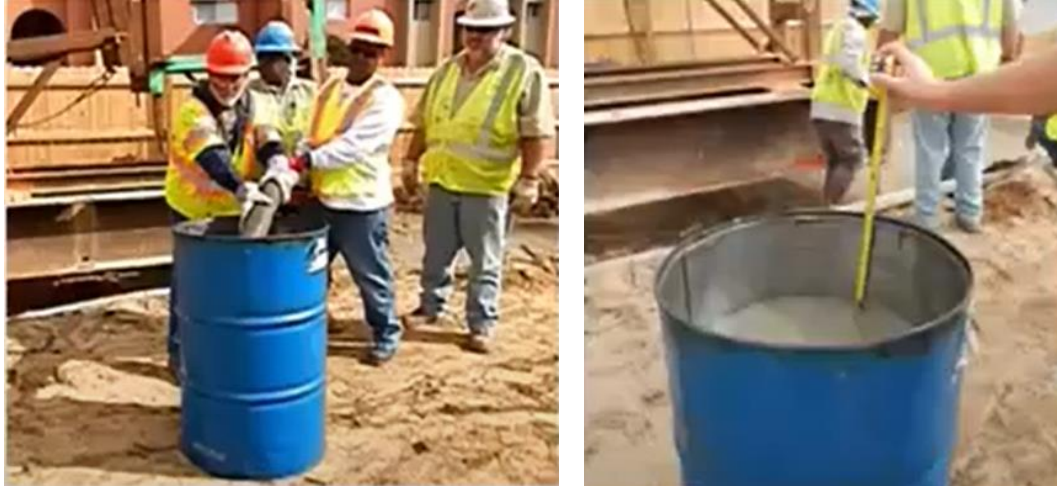
Grout pumps are calibrated by pumping several strokes of grout into a 55-gallon drum on-site. Before pumping, the drum diameter and internal height are measured. After pumping, the distance from the top of the drum to the top of the pumped grout is measured. The calculated grout volume in the drum is divided by the number of strokes required to achieve that volume, providing a cuft/stroke pump calibration constant. Grout pumps are calibrated following the *Florida Method of Test for Displacement Grouting Pump Calibration with a Cylindrical Container – Designation FM 5-612* (FDOT, 2016). Figure 1.6 shows a grout pump calibration being performed.

Figure 1.6 Grout pump calibration using 55-gallon drum (Castellanos, 2015)

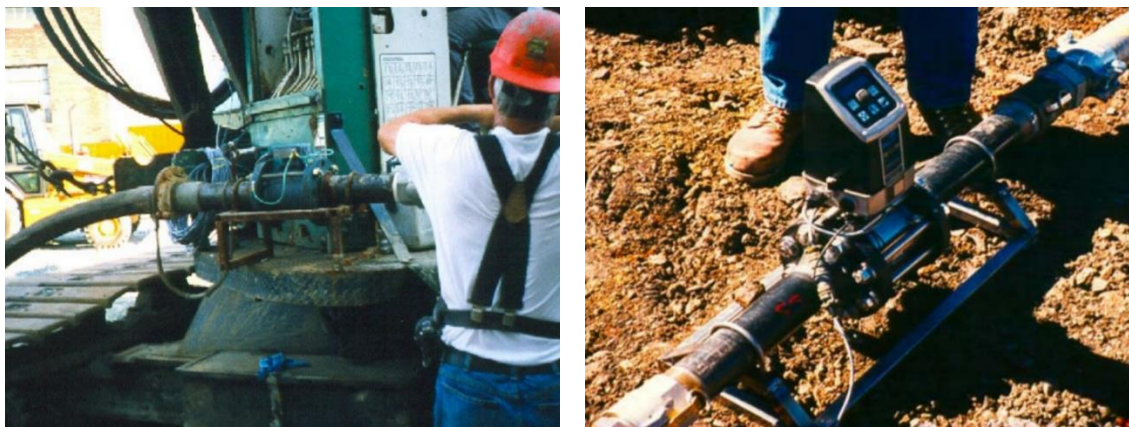
An in-line magnetic flow meter can also be installed to provide a complimentary method of tracking grout volume during auger cast pile installation. This flow meter produces a magnetic field around the internal circular cross-section where grout flows. The fluid flow induces a voltage, measured by Automated Measuring Equipment (AME), which is proportional to the average flow velocity (Brown et al., 2007). The flow rate is then calculated using the known cross-sectional area of the flow meter and the measured grout velocity. The flow rate is integrated over time giving the cumulative grout volume. An in-line flow meter used during the construction of auger piles can be seen in Figure 1.7.

Figure 1.7 In-line magnetic flow meter (Brown et al., 2007).

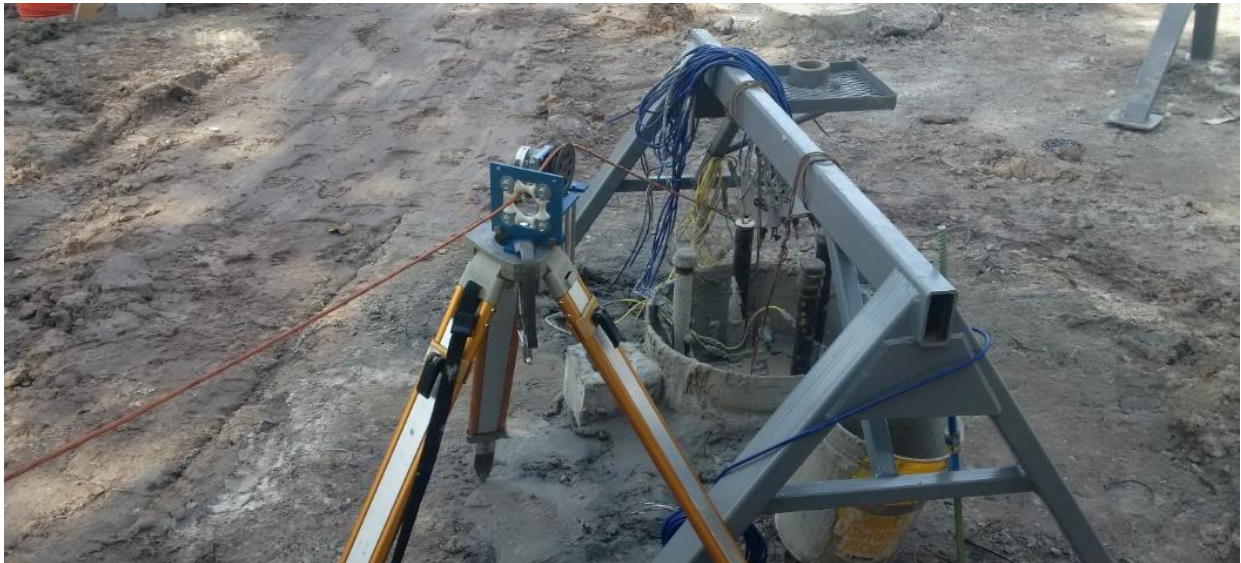
In both drilled shafts and auger cast piles, TIP can be performed by either lowering an instrumented probe down through access tubes installed along the length of the cage or by using thermal wires that are affixed to the cage and cast into the foundation element. Figure 1.9 shows a probe instrumented with four infrared sensors being lowered into the access tubes of an auger cast pile while a rotary encoder assembly recorded the depth of the probe. The probe-based procedure would typically be performed once at the time of near peak temperature (e.g. 24 to 72hrs after casting) (Mullins & Johnson, 2017).

Figure 1.9 Infrared sensor probe being lowered into an auger cast pile access tube (Mullins & Johnson, 2017)

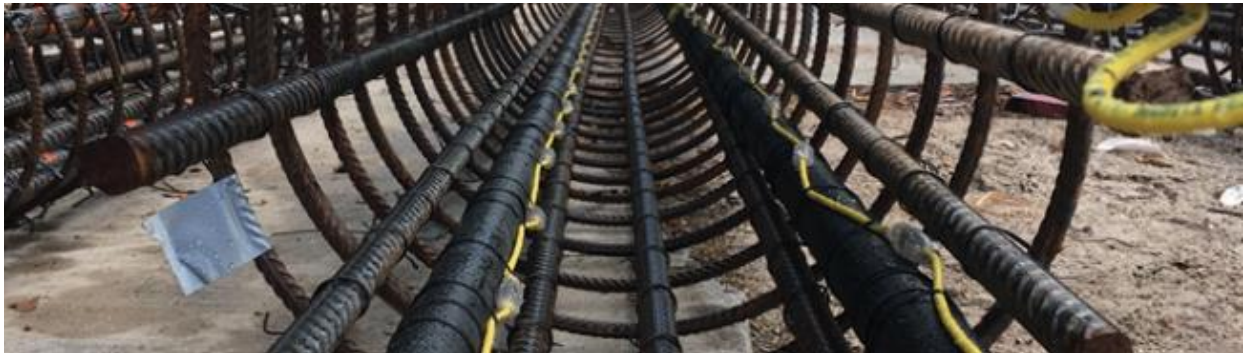
Thermal wires can also be tied to the reinforcement cage, allowing for continuous data collection over multiple days at the expense of not recovering the thermal wires after testing. The thermal wires most commonly have temperature sensors spaced at 1ft intervals. While the number of thermal wires installed may vary, four thermal wires are generally installed in auger cast piles in a north-south-east-west configuration, with each thermal wire 90 degrees from the last. Figure 1.10 shows thermal wires tied along the length of an auger cast reinforcement cage.

Figure 1.10 Thermal wires (yellow) tied along the length of an auger cast reinforcement cage

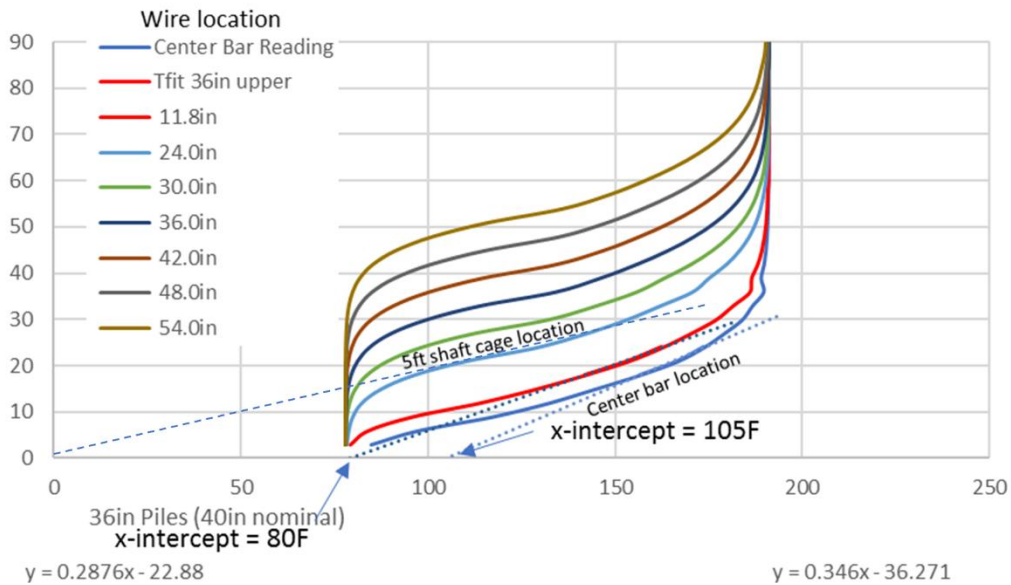
The radius of a drilled shaft or ACIP pile can be predicted from the measured temperature using an average shaft (or pile) temperature corrected for end effects and the overall shaft (or pile) volume converted to an average radius of a cylindrical prism with a length that of the shaft (or pile). This analysis produces a time, mix design, cage diameter, and shaft diameter dependent temperature to radius (T-R) relationship. For larger diameter shafts (>3ft in diameter) a linear temperature to radius relationship is computed that is valid for radii within the linear region of the true hyperbolic T-R relationship. Figure 1.12 shows how the true hyperbolic T-R relationship changes for small and large diameter concrete elements.

Figure 1.12 Relationship between shaft size and temperature for a given cage position (Johnson, 2014)

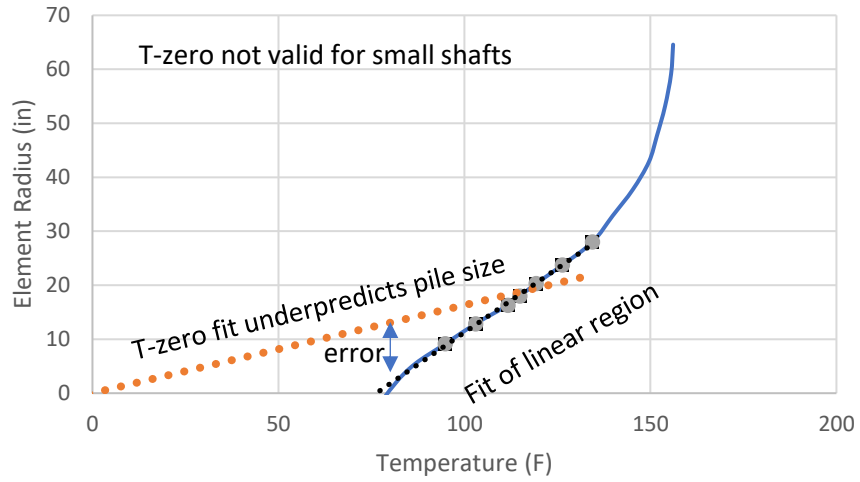
Figure 1.13 Tsoil method better suited for small elements.

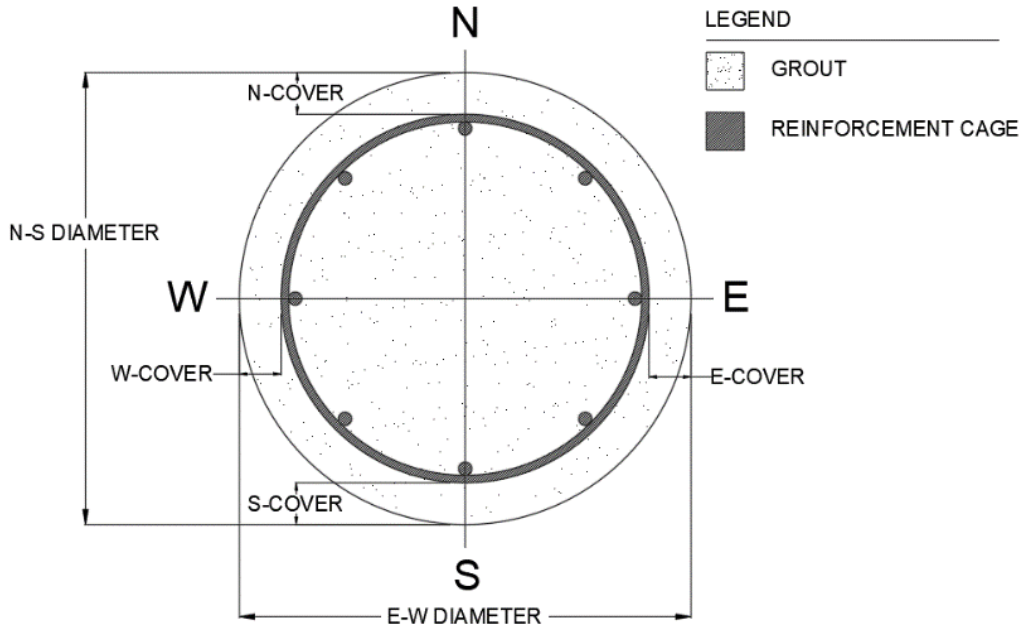
The two diameter measurements taken at the cut-off elevation are orientated in the north-south and east-west directions. This orientation is also used in the identification of the four thermal wires installed along the length of steel reinforcement. The circumference measurement is taken by wrapping a soft tape around the pile. The inspectors also take cover measurements at each of the four thermal wire locations (N-S-E-W). It is important to note that at the cutoff elevation, the stirrups of the reinforcement cage are not always visible, leading inspectors to reference the vertical rebar when recording cover measurements. To obtain the true cover measurement, the bar diameter of the stirrups is subtracted from the reported cover measurements. A complete diagram of the as-built dimensions at the cut-off elevation can be seen in Figure 2.8.

Figure 2.8 Diagram of all as-built measurements taken at pile cut-off elevation (Mee, 2022)

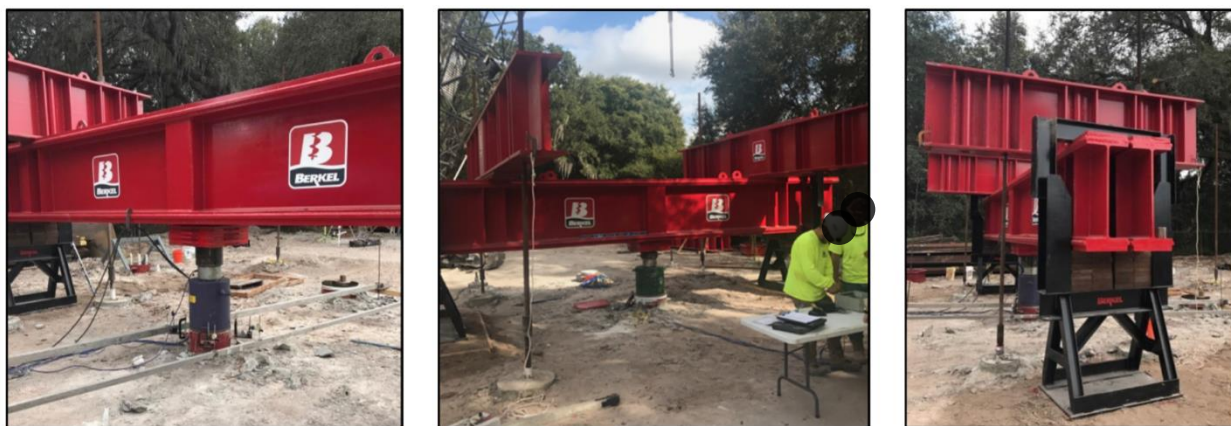
After pile installation, load tests were performed to verify pile capacity. Two piles were loaded compressively, two were loaded laterally, and two were loaded in tension. The complete test pile layout and corresponding legend can be seen in Figure 2.10. The test piles denoted with the letter ‘R’ are reaction piles. These piles were used as support during load testing. For example, during the compressive load tests, large, stiffened I-beams spanned over the test pile and were tied into the reaction piles. Figure 2.11 shows the load test setup during a compressive load test.

Figure 2.11 DFI pilot study compressive load test setup (Marinucci & NeSmith., 2017)

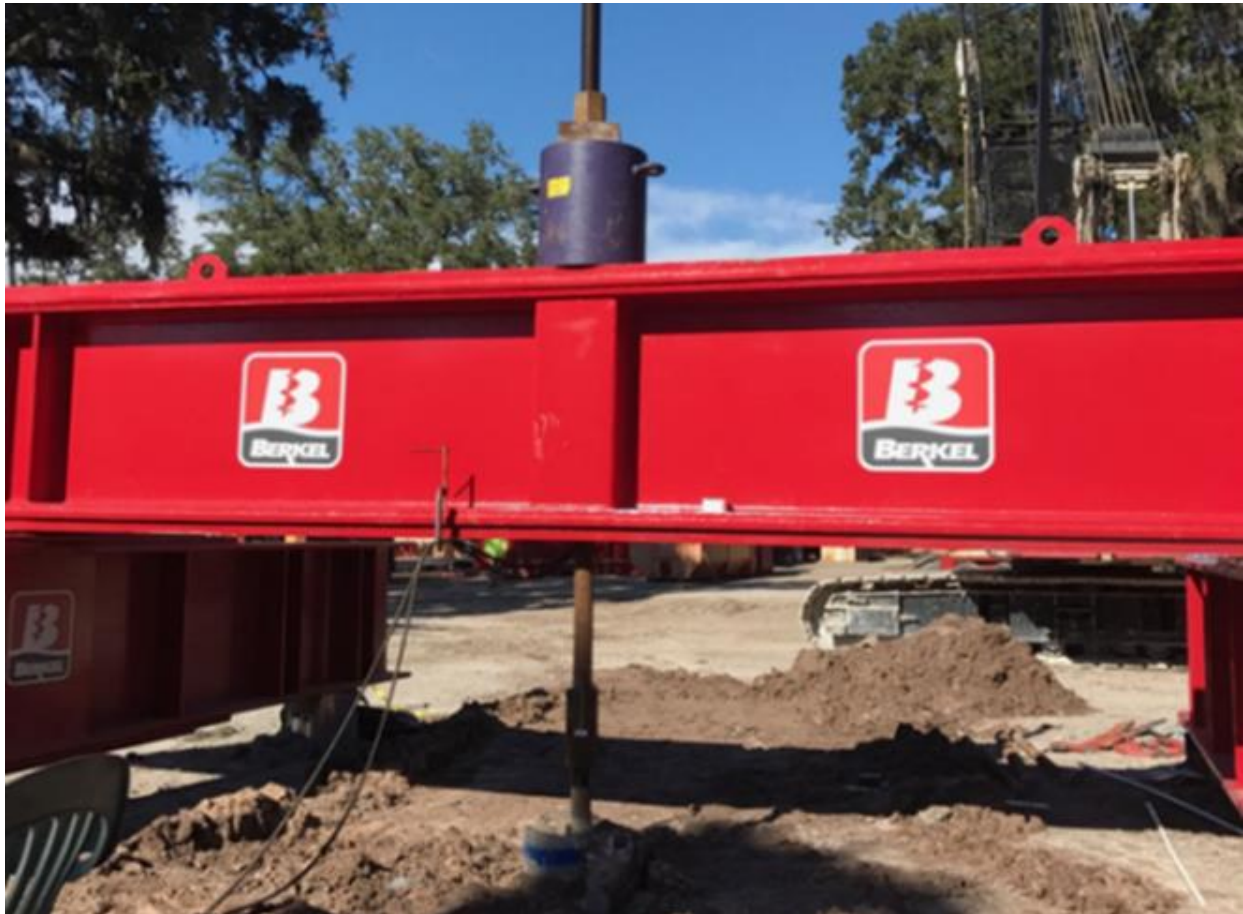
To extract the pile, 14-inch diameter relief holes were drilled around the pile to reduce the uplift capacity of the pile and facilitate extraction. Four reaction piles and the load test frame were configured for a pile tension test, as seen in Figure 2.12.

Figure 2.12 Tension load test setup used to extract auger cast pile E-1 (Marinucci & NeSmith., 2017)

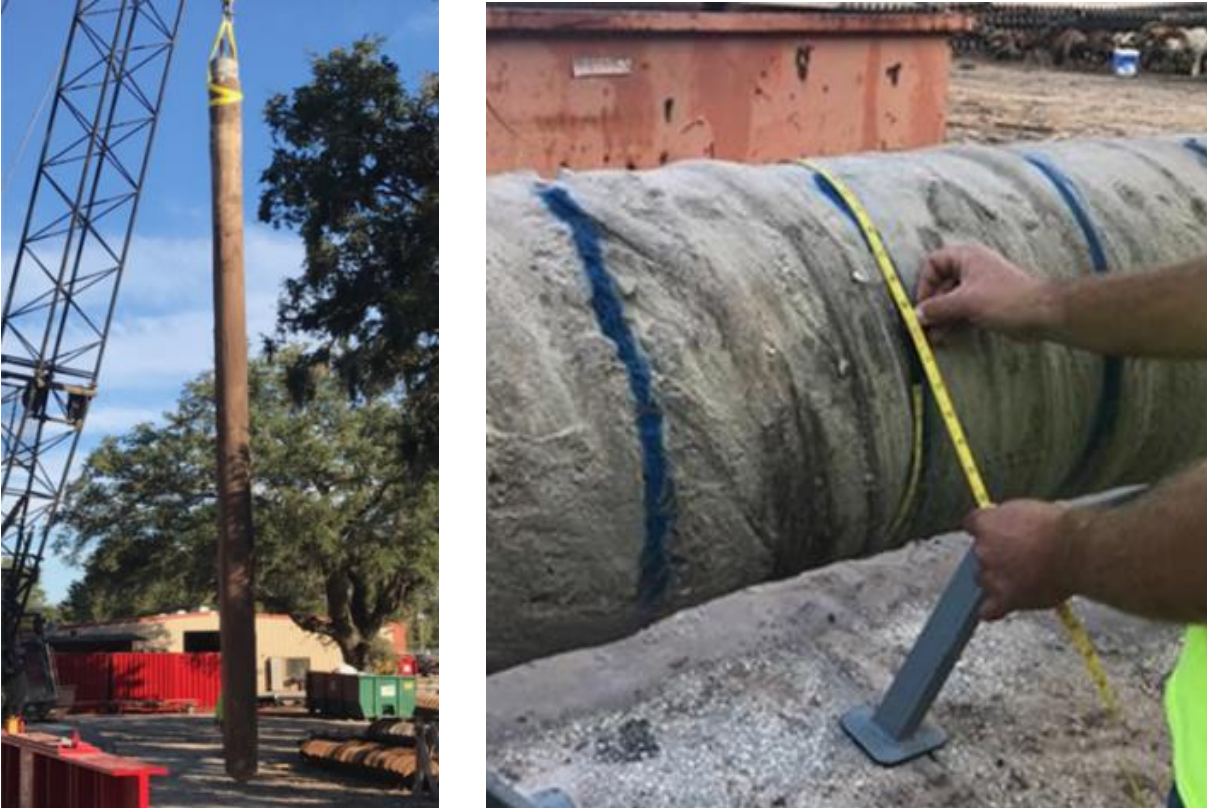
Once extracted 2 to 3ft using the tension load testing setup, a crawler-crane was used to extract the pile completely out of the ground, as seen in Figure 2.13. After extraction, the pile was pressure washed to remove any dirt and debris, allowing for accurate measurements of the as-placed grout and pile size. The pile was placed horizontally on supports and circumference measurements were taken at 1ft intervals (Figure 2.13) along the length of the pile. While the total pile length for pile E-1 was 40ft, Figure 2.14 provides the first 10 circumference measurements.

Figure 2.13 Pile completely extracted using crawler-crane (left) circumference measurements taken at 1-foot intervals along pile length (right) (Marinucci & NeSmith., 2017)

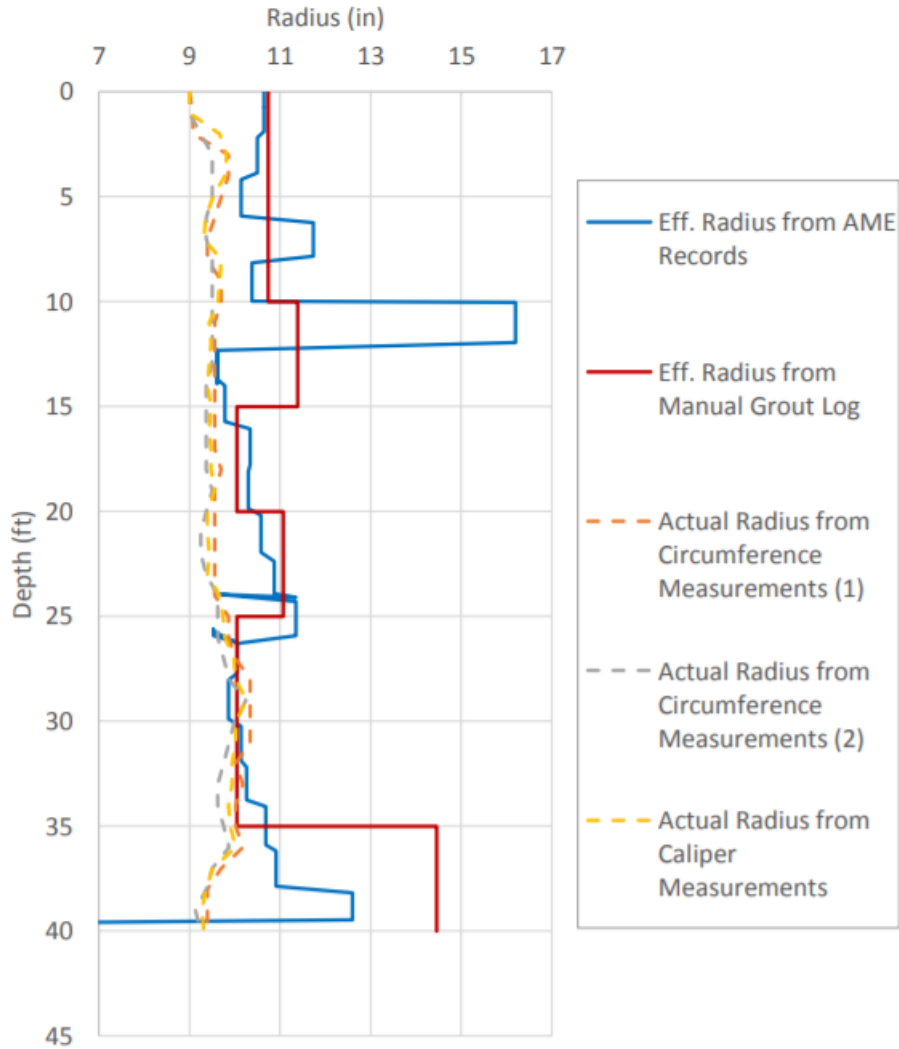
Figure 2.15 Pile E-1 measured and predicted dimensions (Mullins & Johnson, 2017)

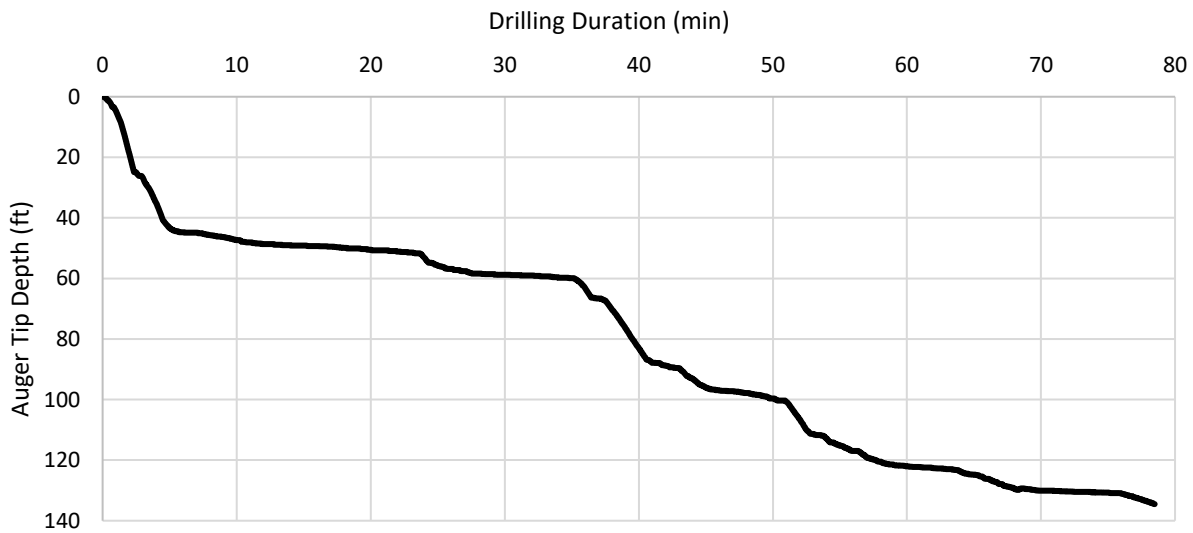
Figure 3.1 Auger tip depth over duration of drilling (data from Bridge 8 – Center Pier – Pile 1)

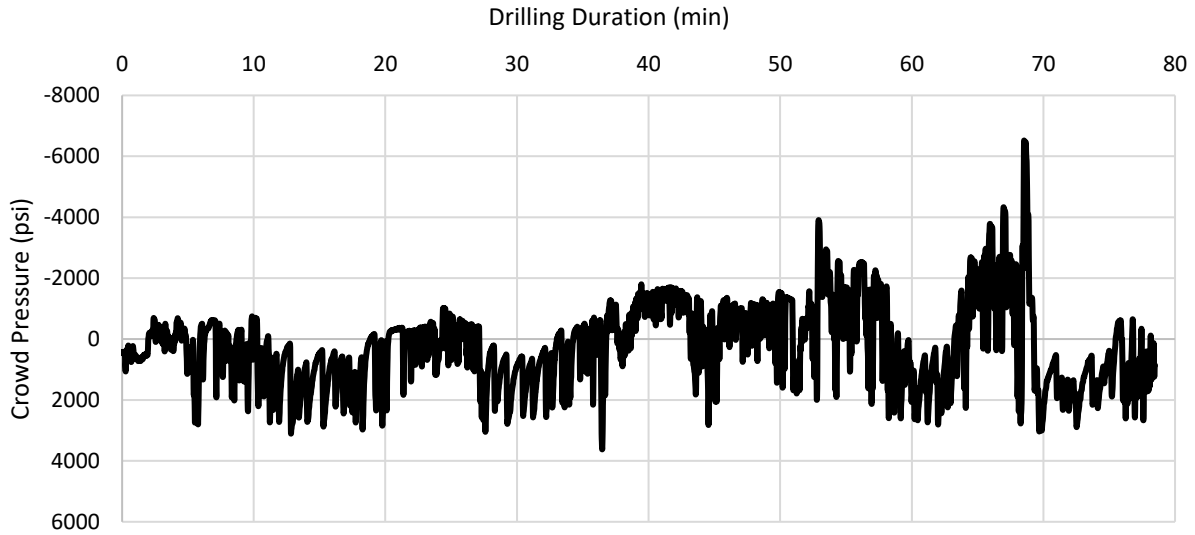
Figure 3.2 Crowd pressure during drilling (data from Bridge 8 – Center Pier – Pile 1)

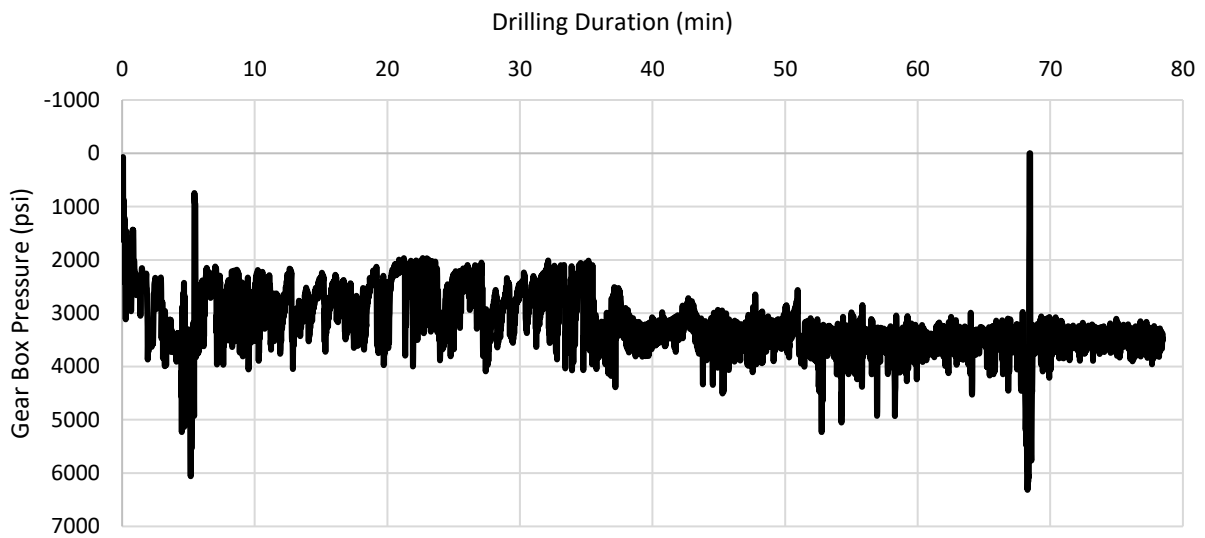
Figure 3.3 Gear box pressure over duration of drilling (data from Bridge 8 – Center Pier – Pile 1)

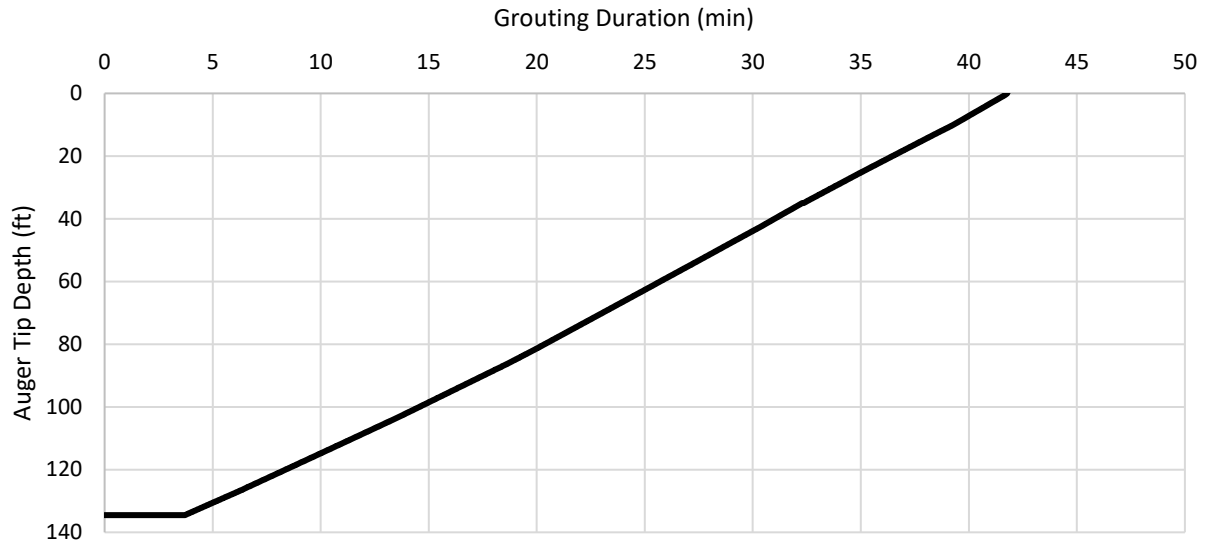
Figure 3.4 Auger tip depth over duration of grouting (data from Bridge 8 – Center Pier – Pile 1)

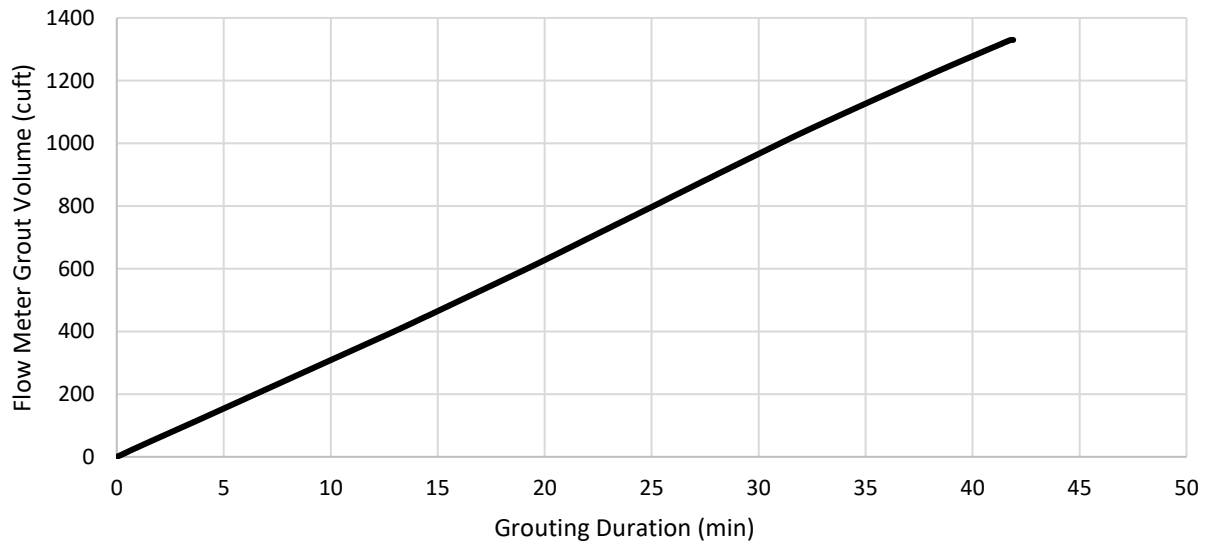
Figure 3.5 Flow meter grout volume over duration of grouting (data from Bridge 8 – Center Pier – Pile 1)

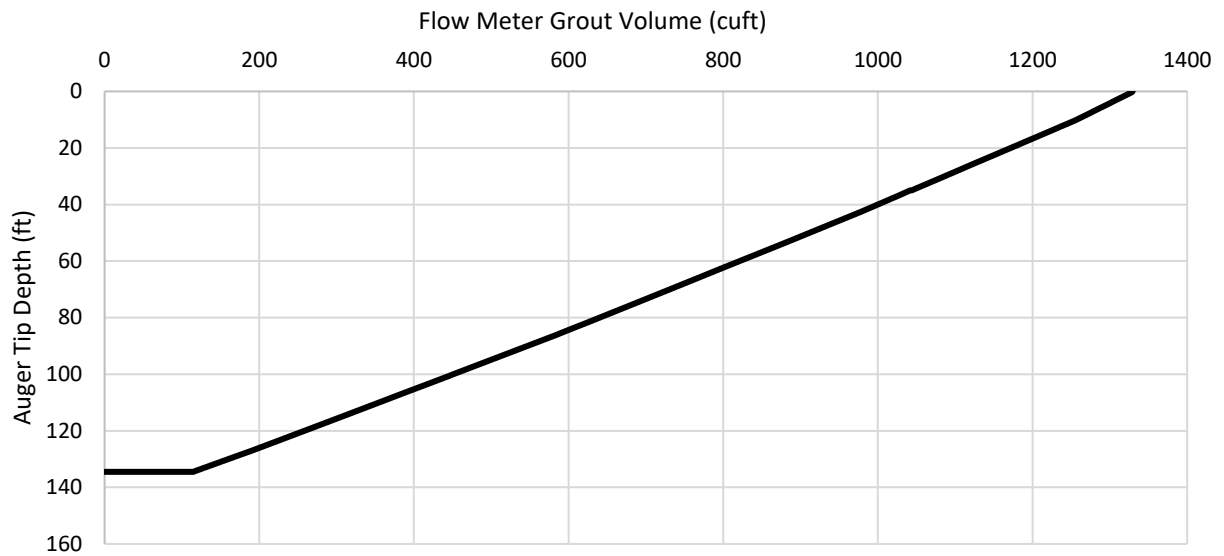
Figure 3.6 Flow meter grout volume as a function of auger tip depth (data from Bridge 8 – Center Pier – Pile 1)

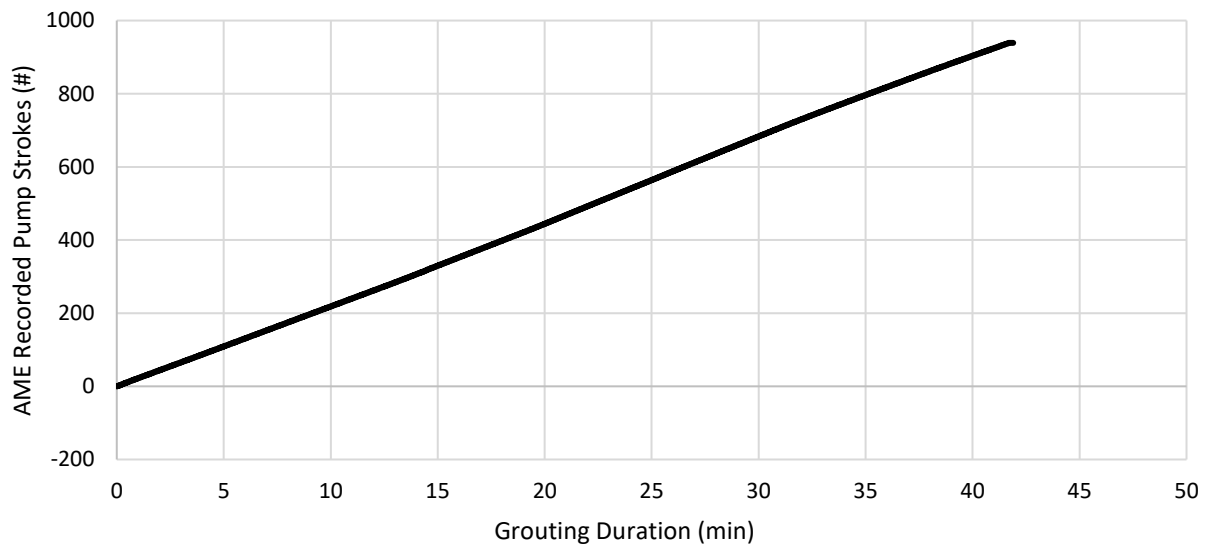
Figure 3.7 AME recorded pump strokes over duration of grouting (data from Bridge 8 – Center Pier – Pile 1)

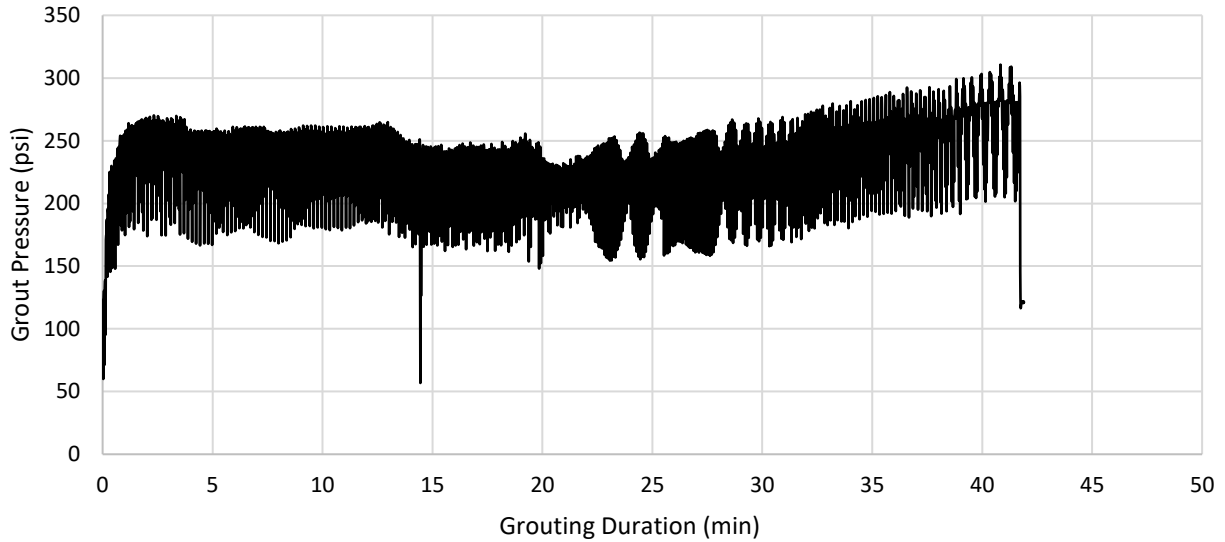
Figure 3.8 Grout pressure over duration of grouting (data from Bridge 8 – Center Pier – Pile 1)

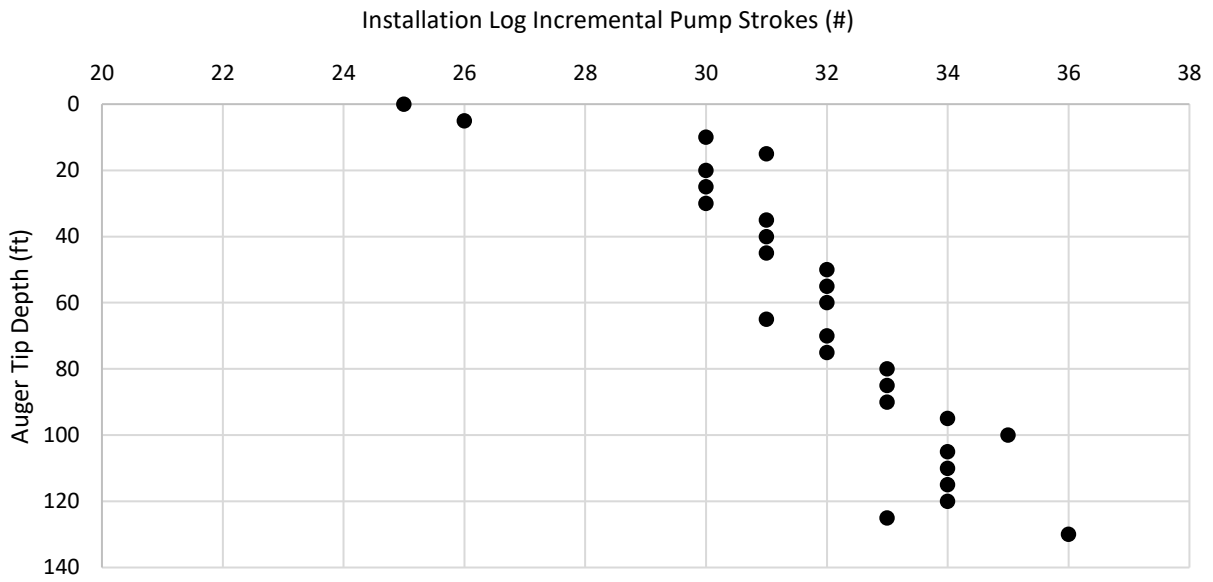
Figure 3.10 Incremental pump stroke count at every 5ft of auger extraction (data from Bridge 8 – Center Pier – Pile 1)

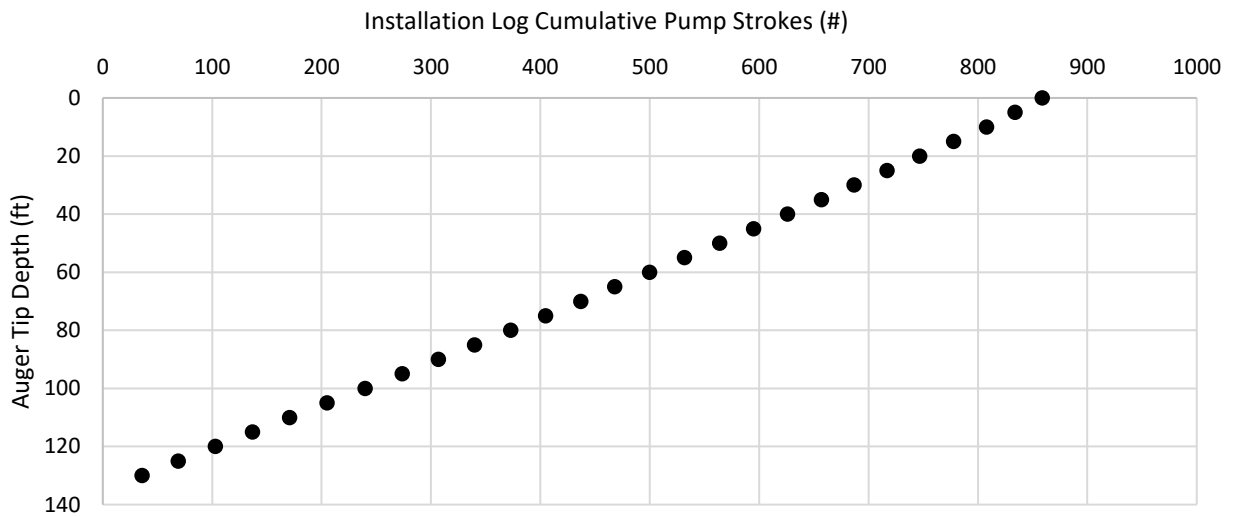
Figure 3.11 Cumulative pump strokes over entire grouting operation (data from Bridge 8 – Center Pier – Pile 1)

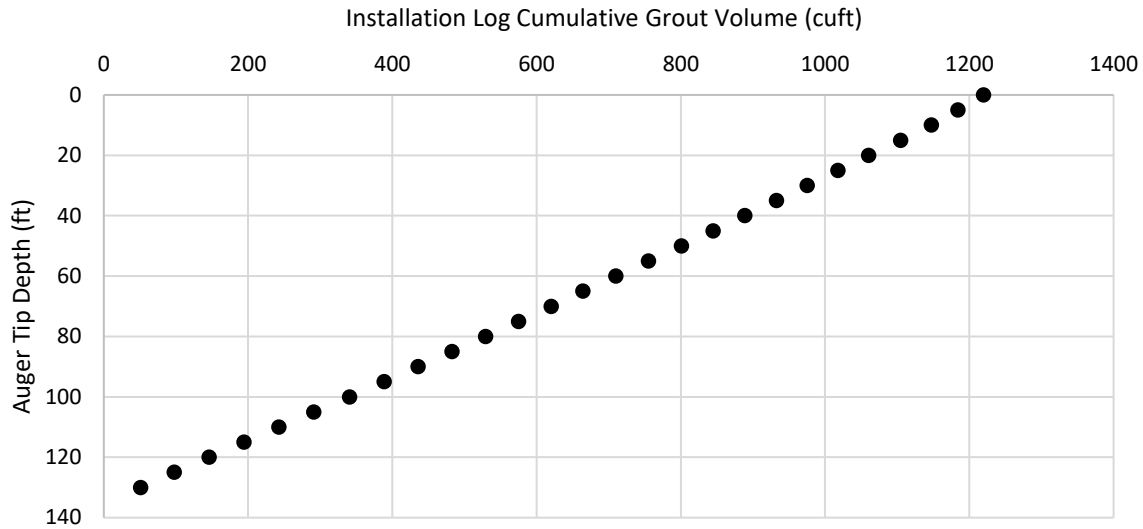
Figure 3.12 Cumulative grout volume versus auger tip depth (data from Bridge 8 – Center Pier – Pile 1)

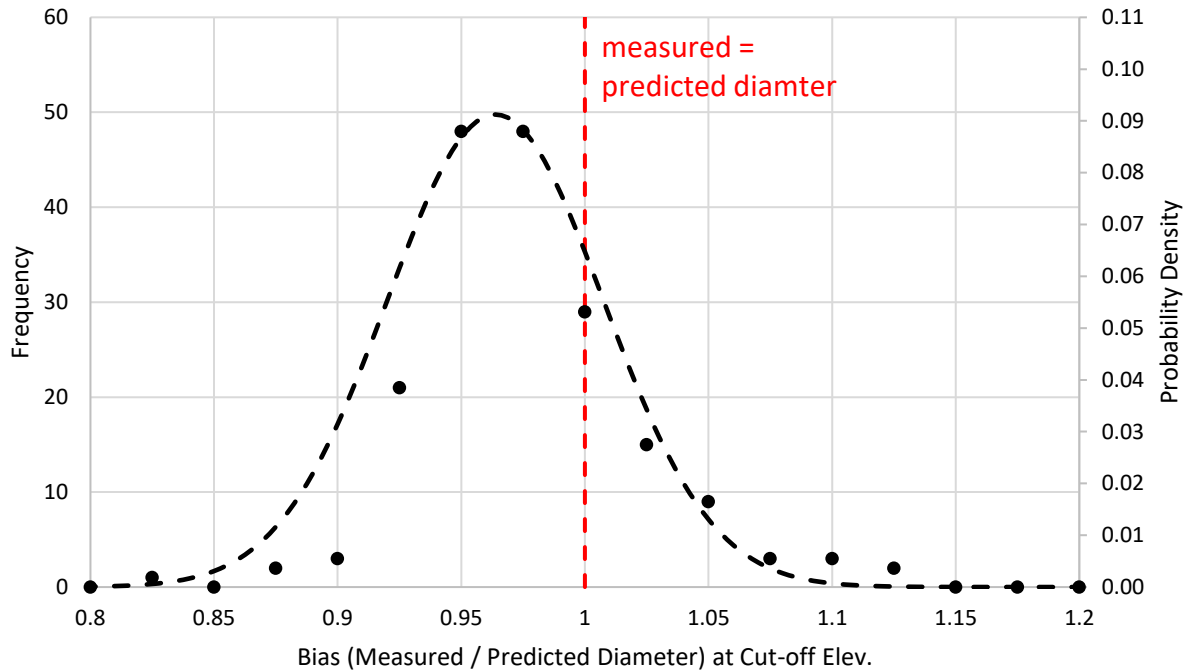
Figure 3.14 Bias distribution and superimposed normal distribution for 184 piles

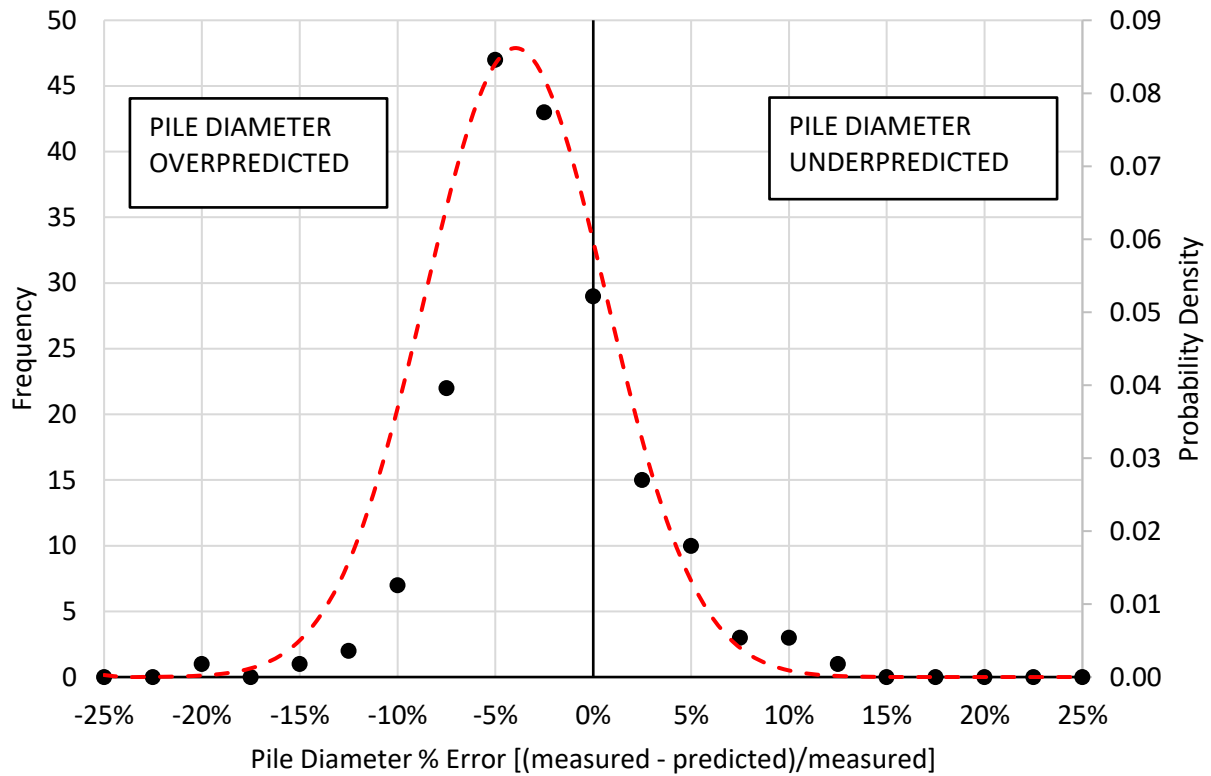
Figure 3.15 Percent error in pile diameter predictions for 184 piles

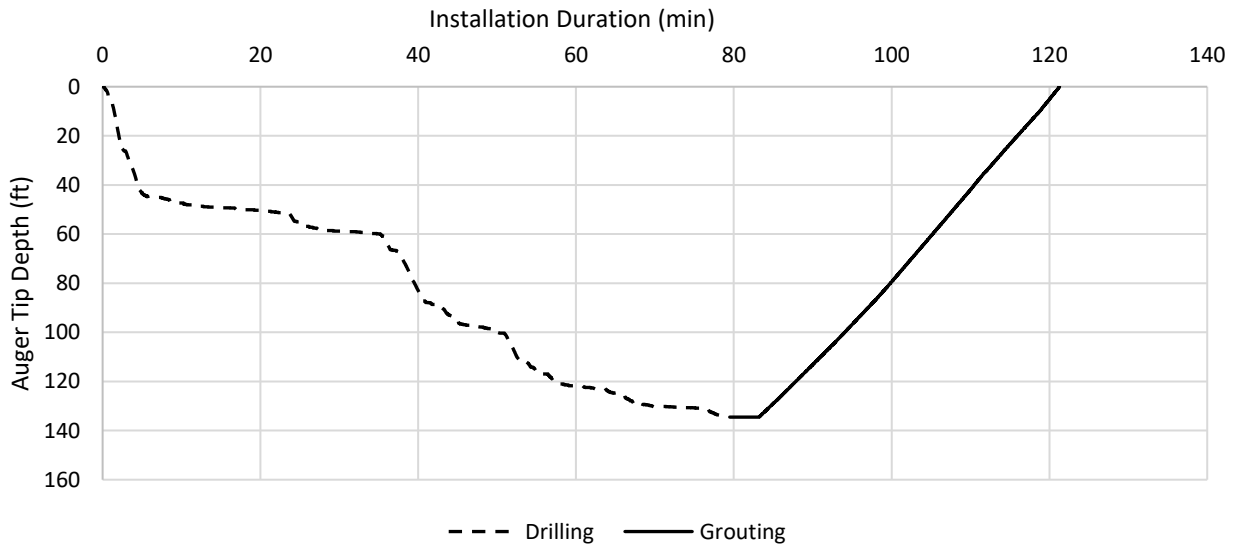
Figure 3.16 Auger cast pile construction with no re-stroking (data from Bridge 8 – Center Pier – Pile 1)

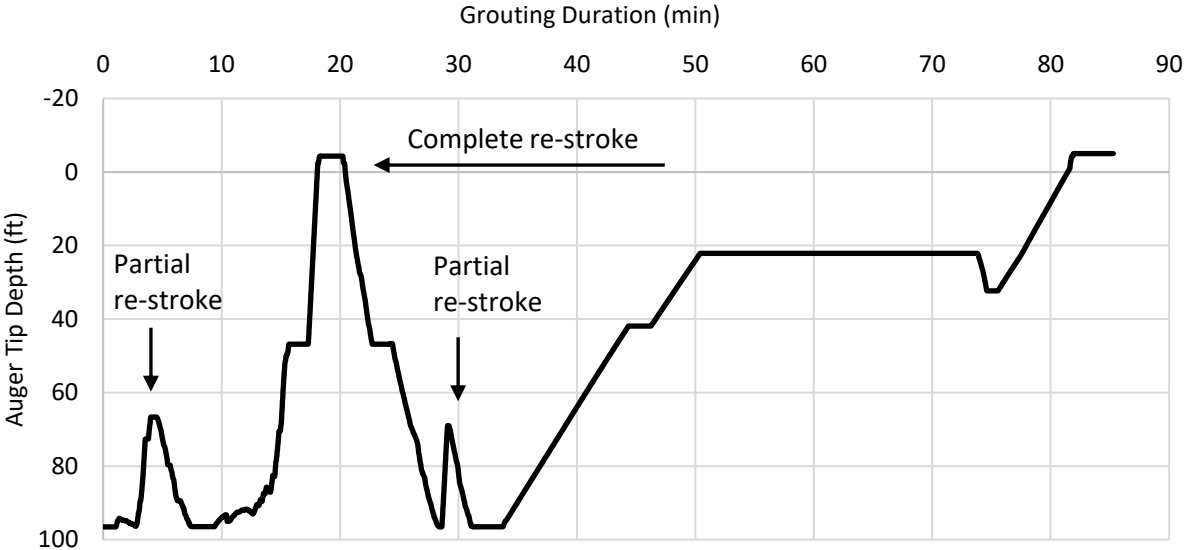
Figure 3.18 Example of two partial re-strokes and one complete re-stroke during grouting (data from Bridge 7 – Pier 9L – Pile 5)

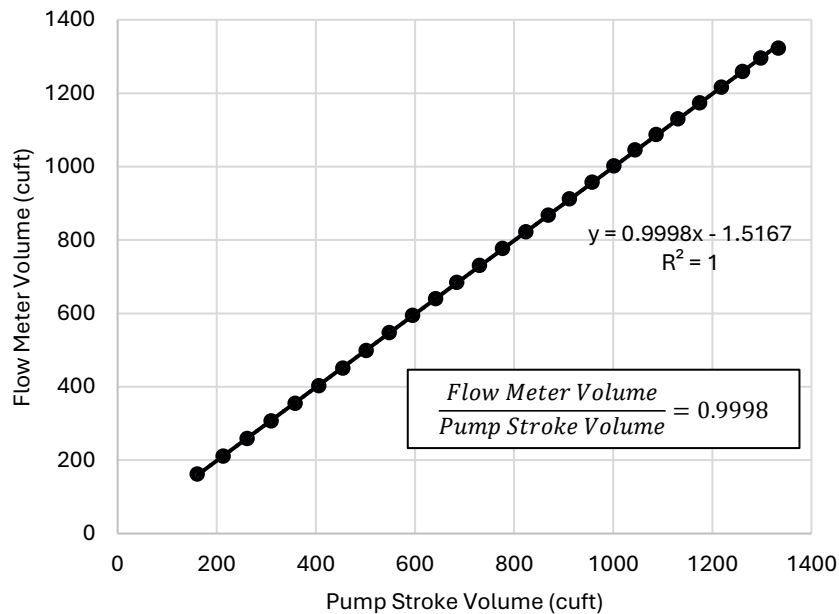
Figure 4.1 Both volume accounting methods (pump stroke counting and flow meter) showing strong agreement

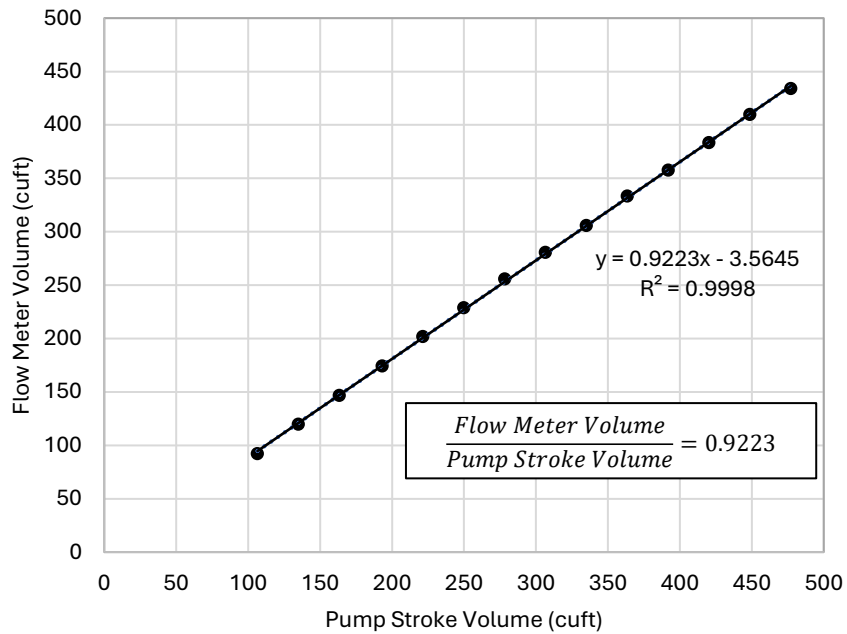
Figure 4.2 Pump stroke volume vs. AME flow meter volume showing 7.8% disagreement in tracked grout volume

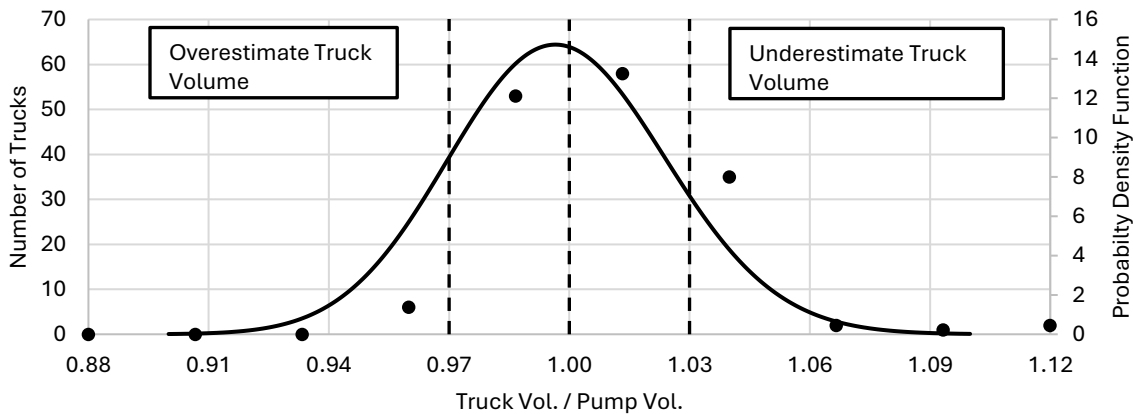
Figure 4.4 Truck volume over pump stroke calculated truck volume ratio for 158 trucks

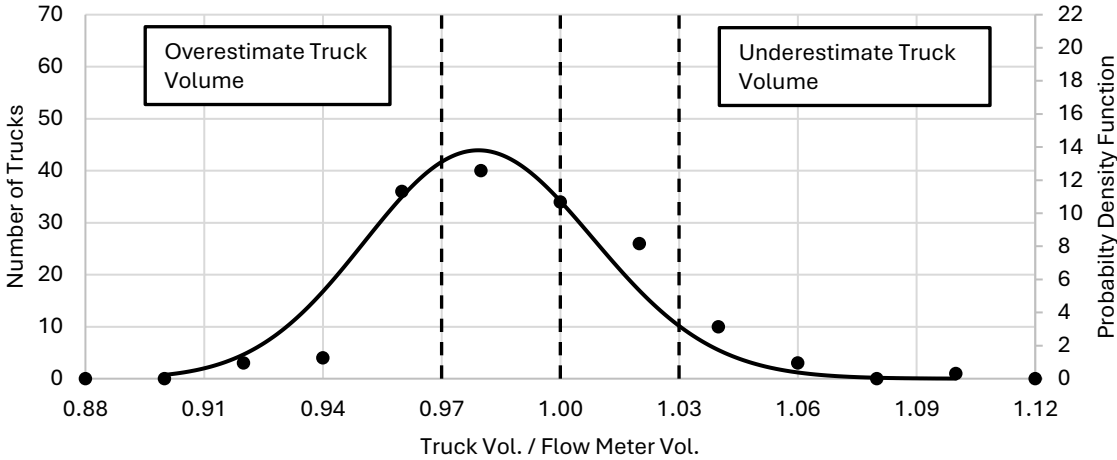
Figure 4.5 Truck volume over flowmeter calculated truck volume ratio for 158 trucks
