ESTIMATING THE AS-PLACED GROUT VOLUME OF AUGER CAST PILES – PART 1

BED25-977-04

Final Report

October 2024

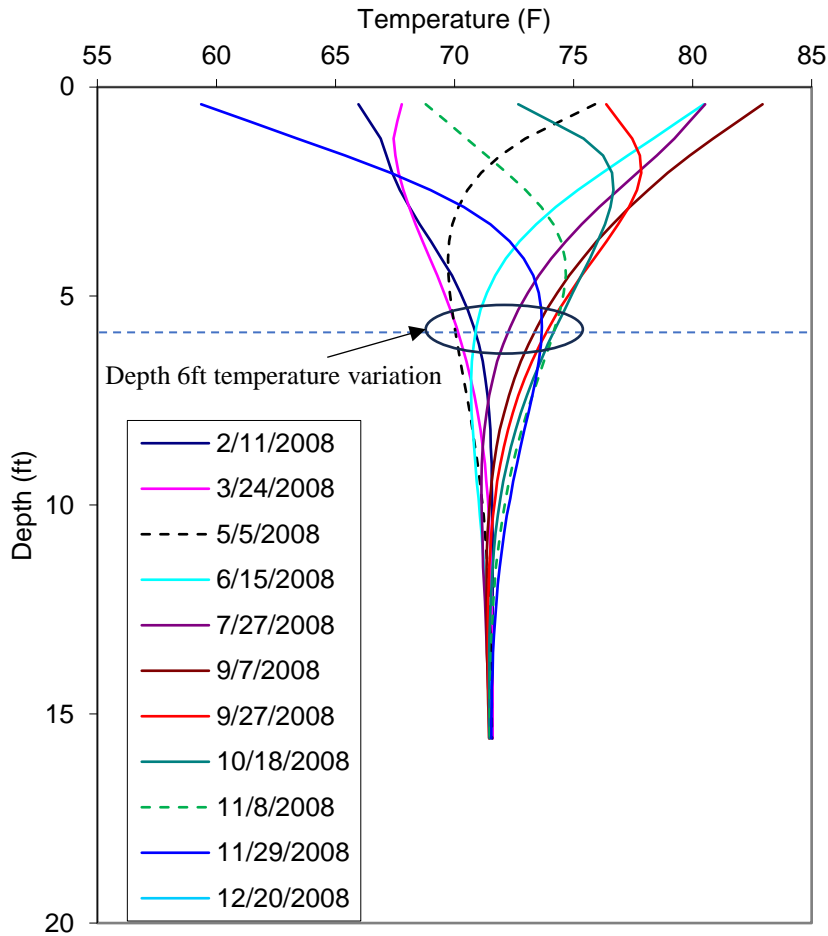
Figure 4.10 Ground temperature variation as a function of depth (Mullins et al., 2009)

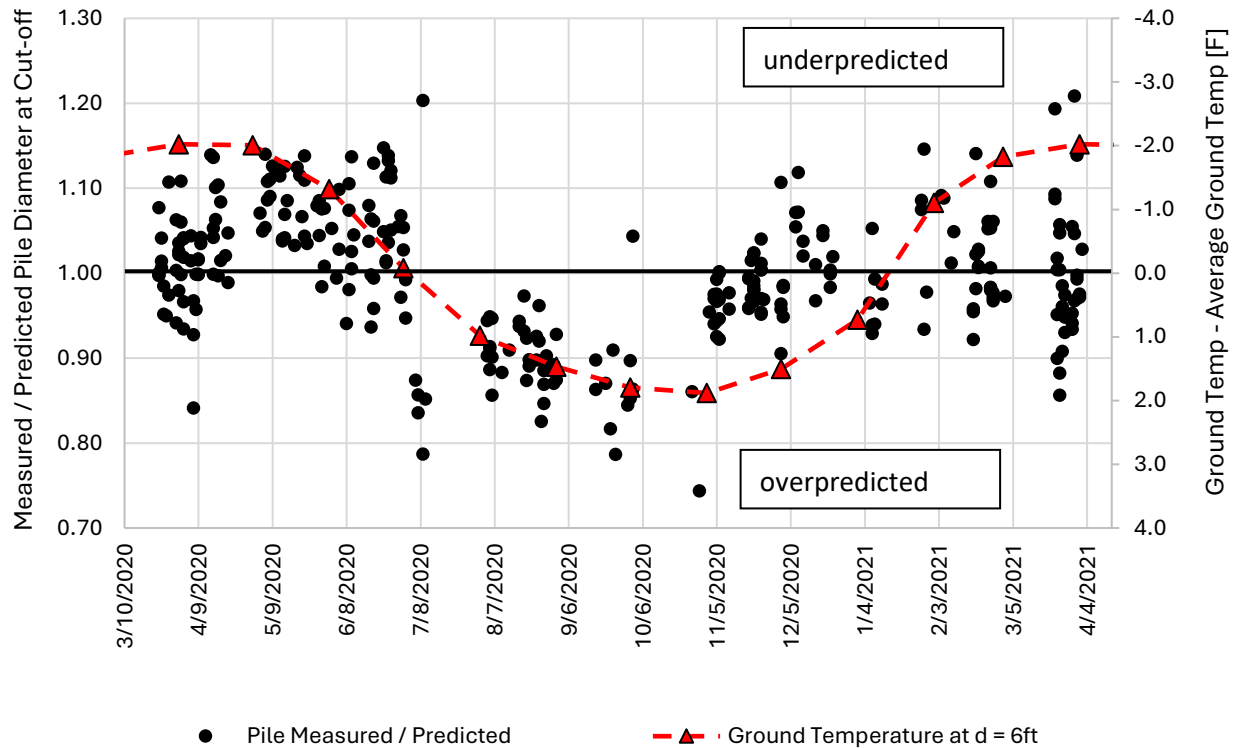
Figure 4.11 Measured over predicted pile size over time (334 piles cutoff depth 2 to 12ft)

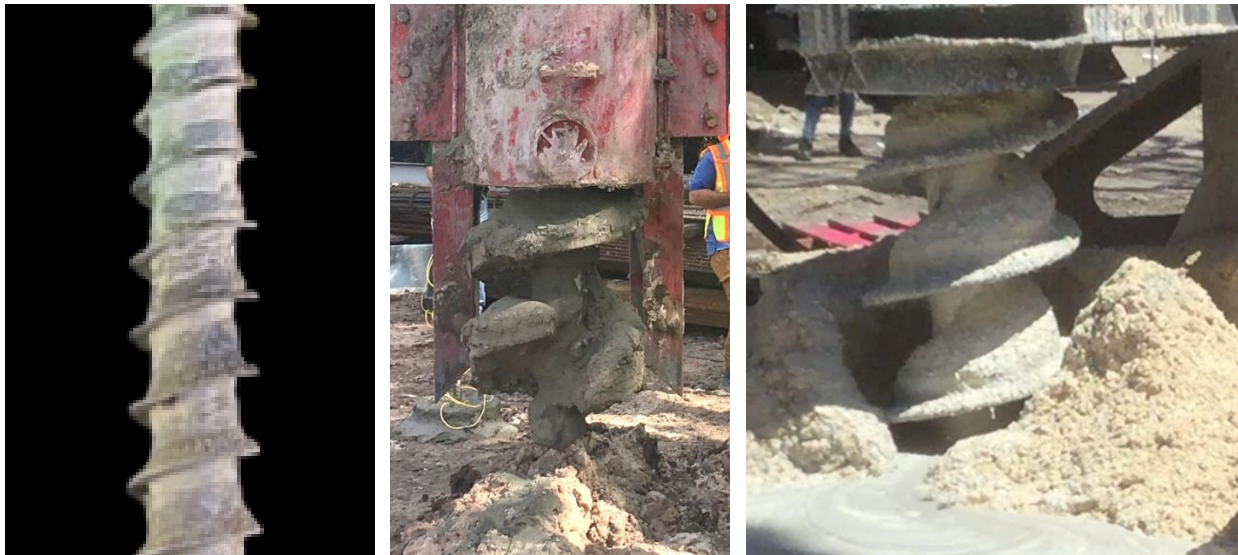
Figure 4.12 (from L to R) soil cuttings adhere to auger stem, soil cuttings sit on auger flights, and an example of a hybrid soil cling mode
